# DISTRICT WATER MANAGEMENT STRATEGY

Lots 1797 & 1798 Matison St  
Southern River

Revision No 1  
December 2019

**Lots 1797 and 1798 Matison Street  
Southern River**

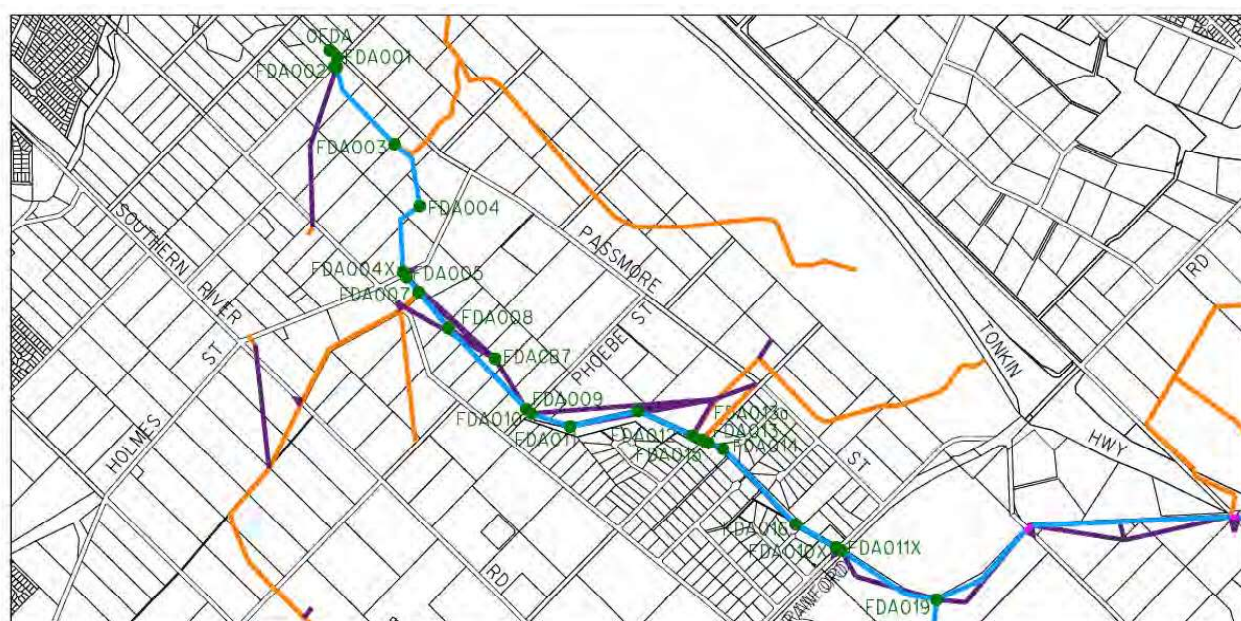
**Figure 9: FMD ADS – Existing Flow Paths**

Figure 10a of the FMD ADS shows an overland flow path occurring over the study area (Figure 9), with the discharge being at location FDA002. It should be noted that this flow path is mapped as outside of the proposed development area for the lots, and therefore this flow path would be retained without any impact on the subdivisional layout.

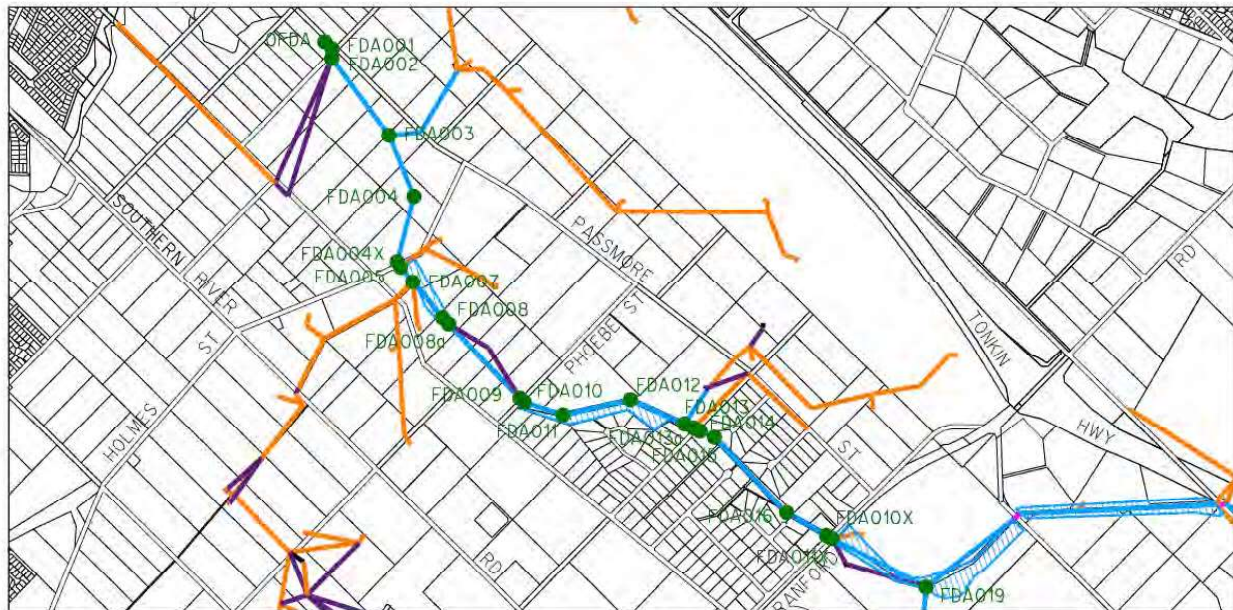
**Figure 10: FMD ADS – Adopted Strategy Flow Paths**

The FMD ADS Adopted Strategy shows a piped drainage structure along Matison St, with the overland flow path through the lots to node FDA002. This arterial drainage is still located outside of the proposed subdivisional footprint (Figure 10). Relevant values for the adopted strategy at node FDA002 are shown in Table 5 below and delineate the downstream criteria for the surface water management of the site.
