Appendix 2 – Bioscience Wetlands Assessment

GEOMORPHIC WETLANDS SWAN COASTAL
PLAIN DATASET

REQUEST FOR MODIFICATION

**Lots 13, 14, 21 and 22 Southern River Road
&
Lots 18, 19 and 20 Matison Street
Southern River Precinct 3
City of Gosnells
July 2009**

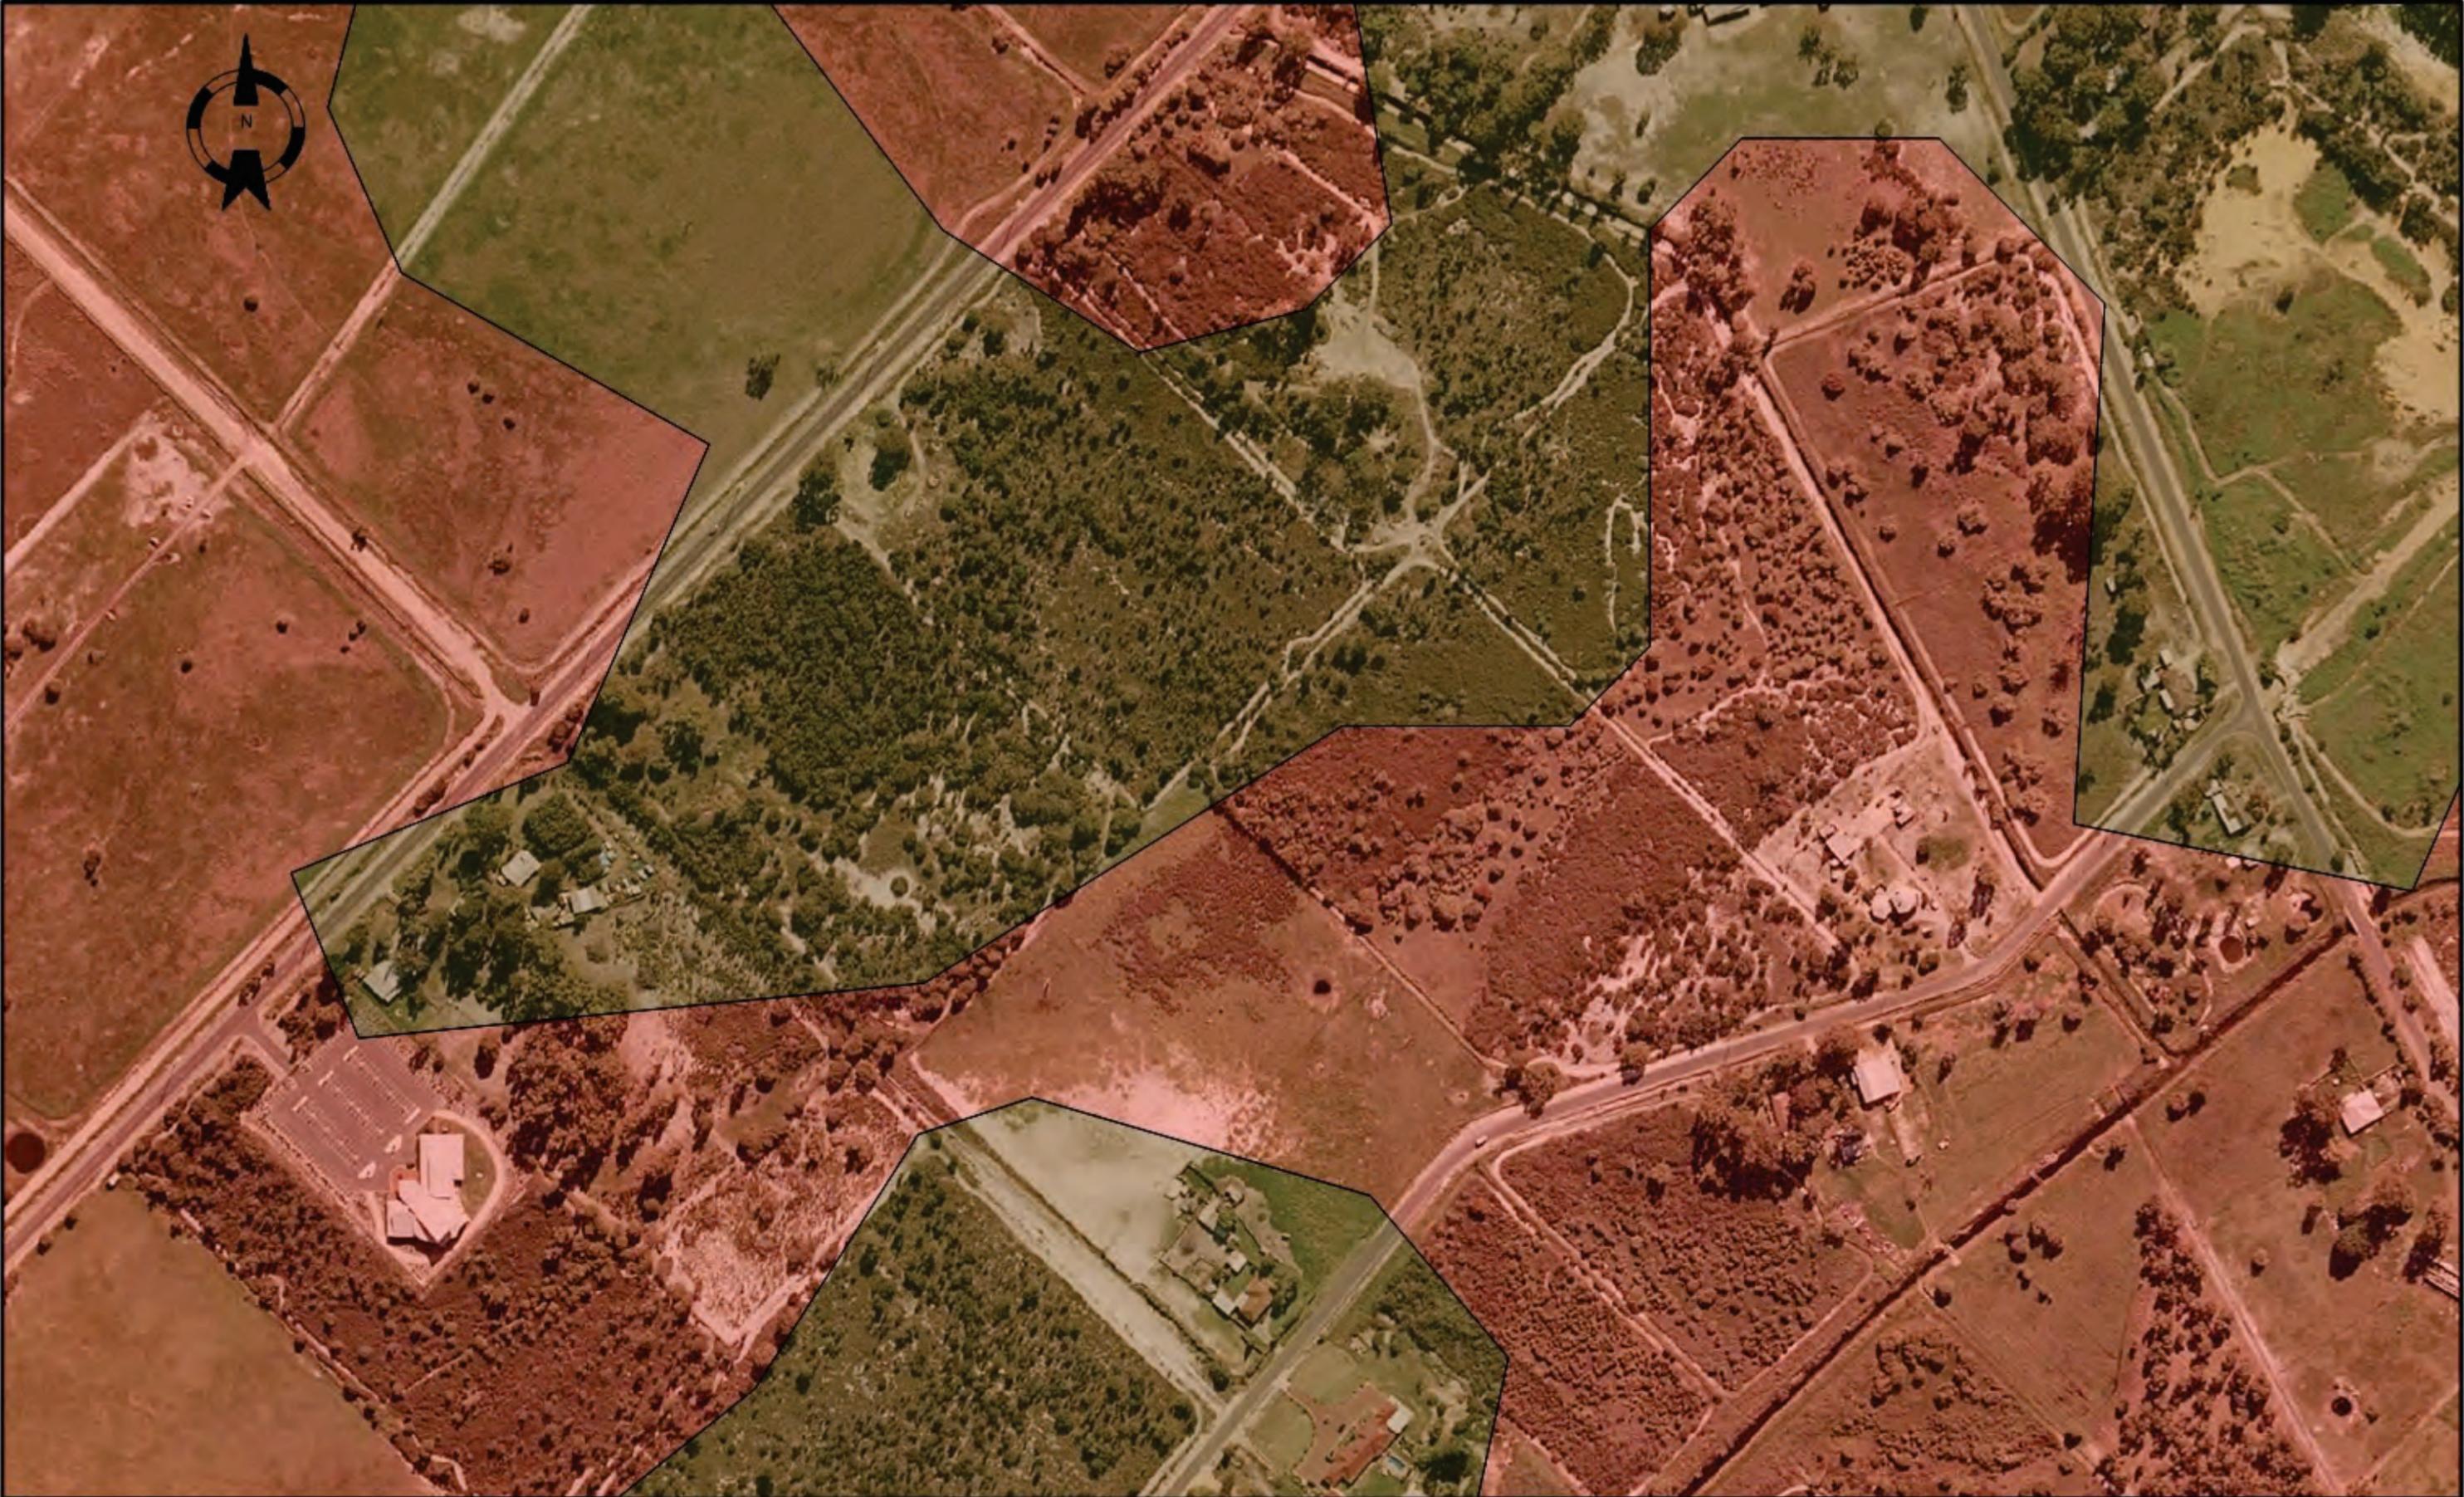
Figure 2 – Soil Types Mapped by the DoA.

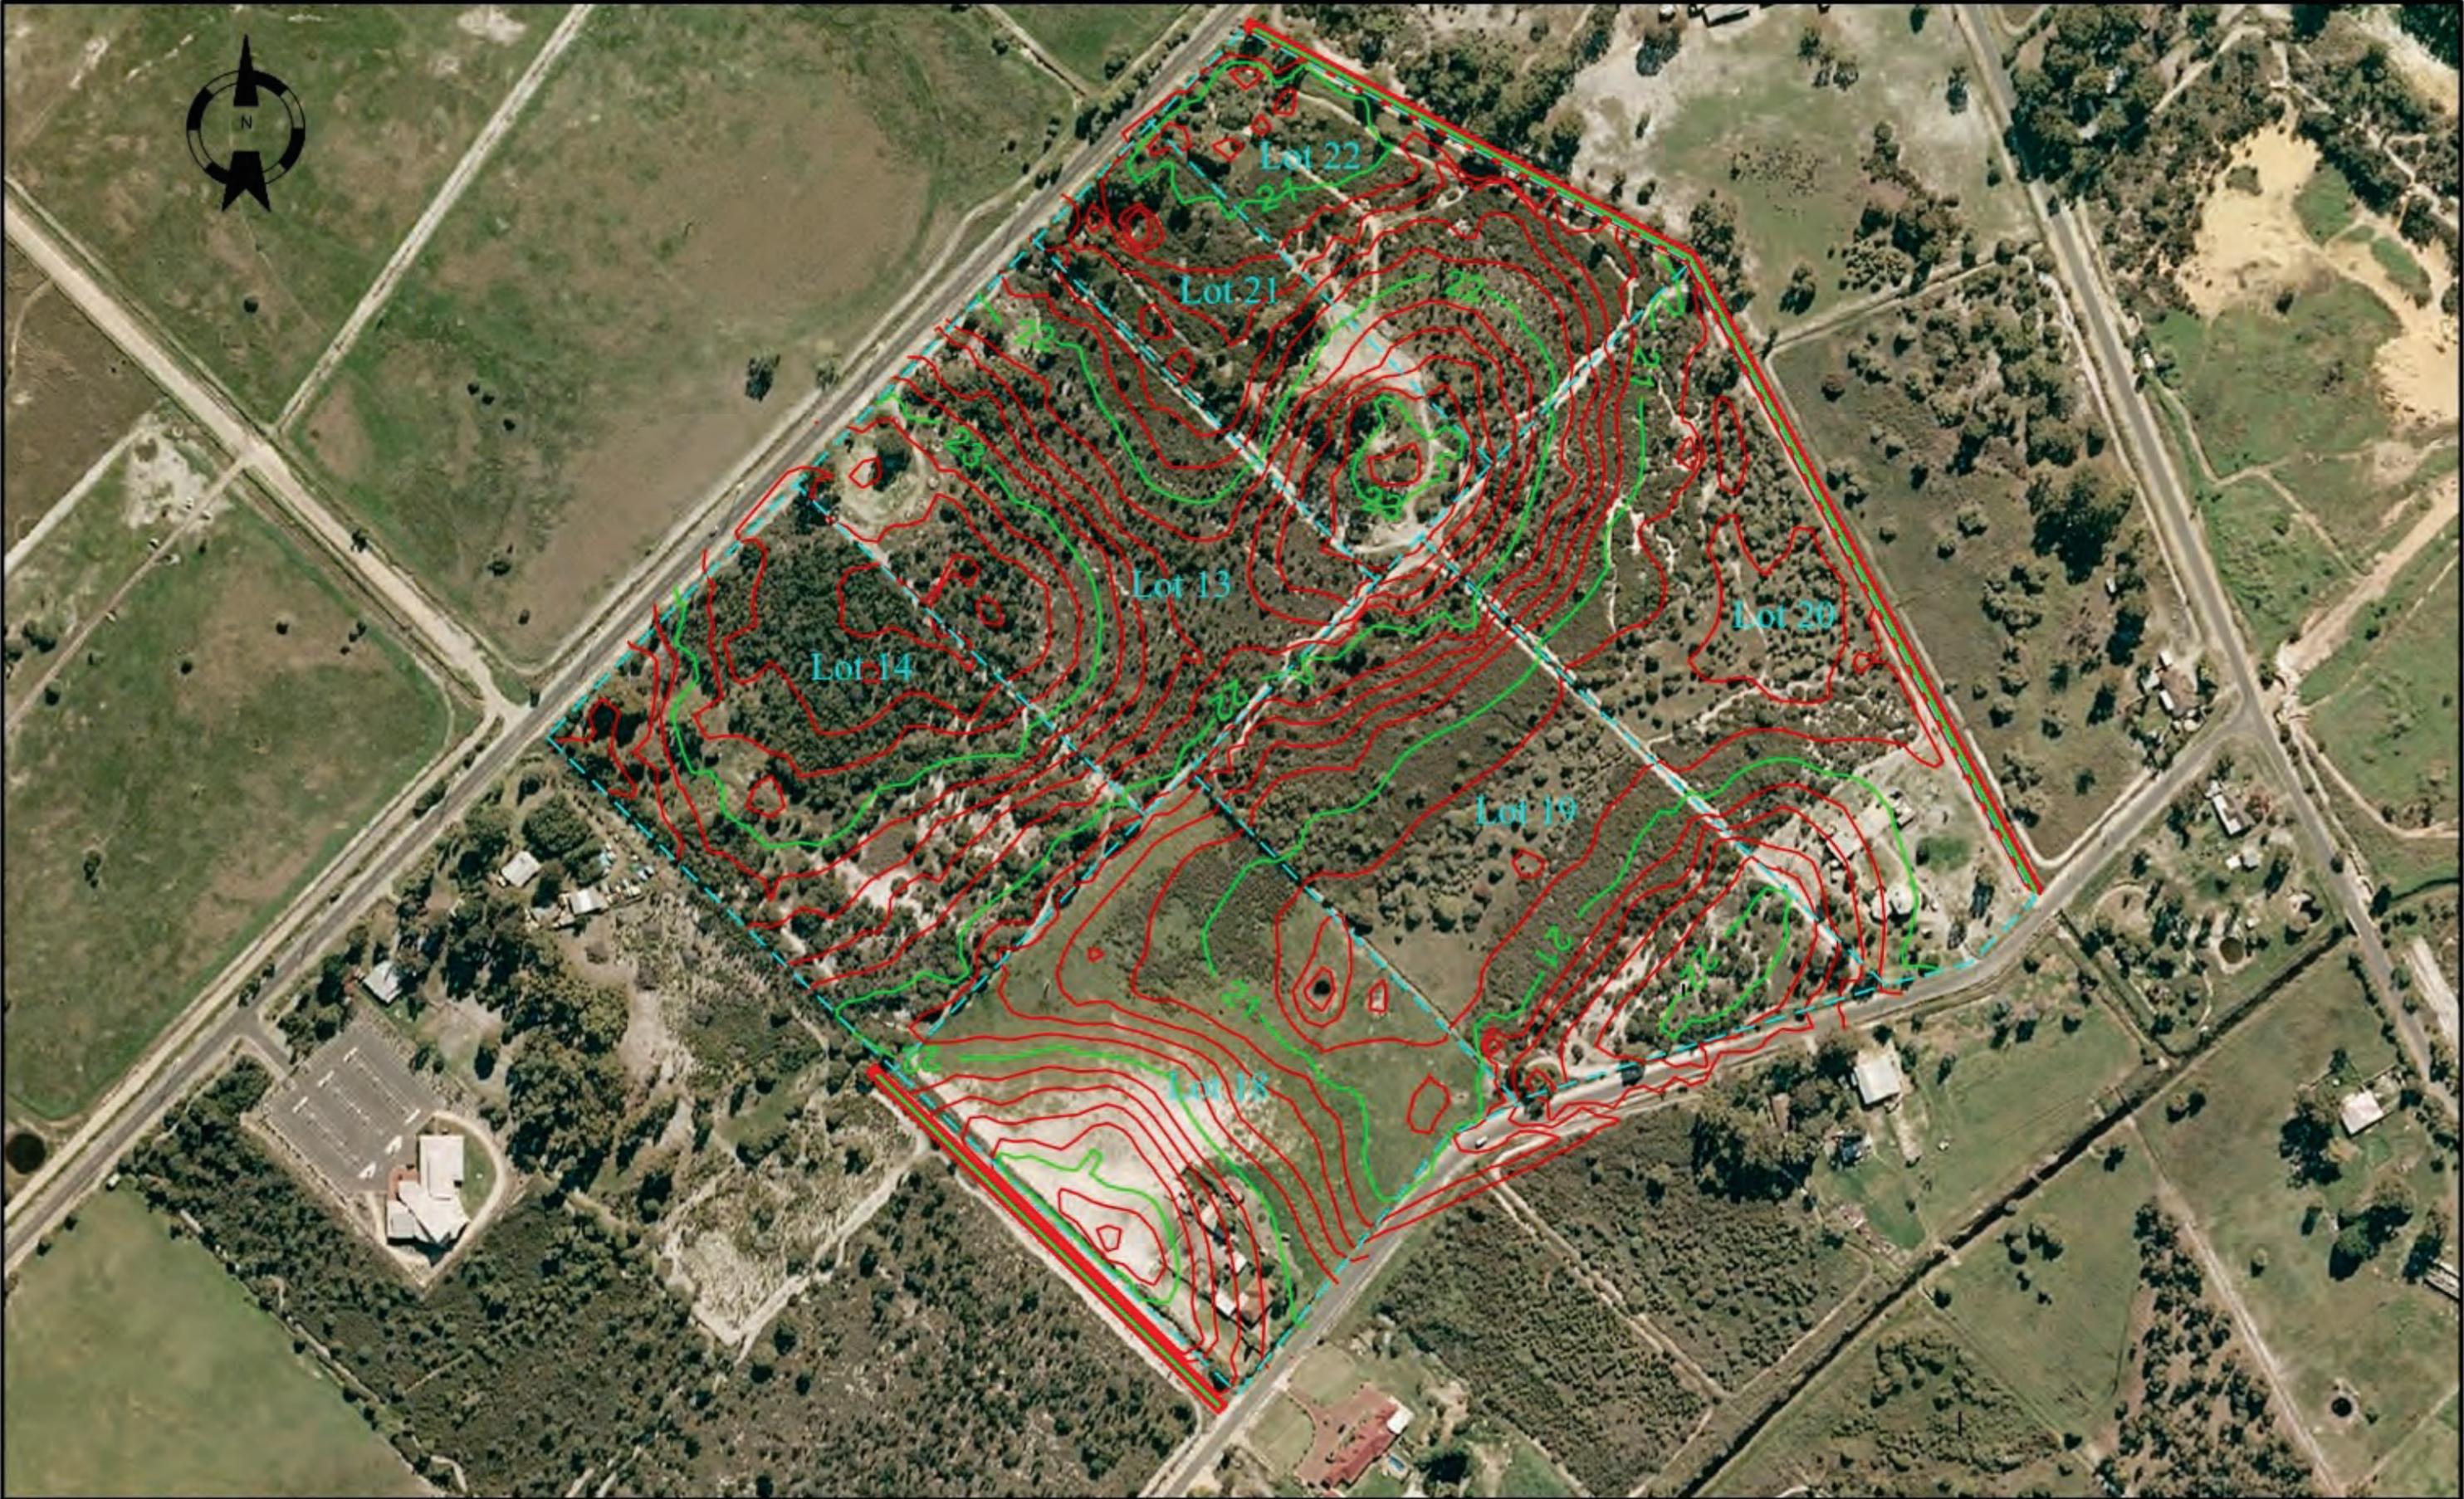
Figure 3 – Site Topography (mAHD)

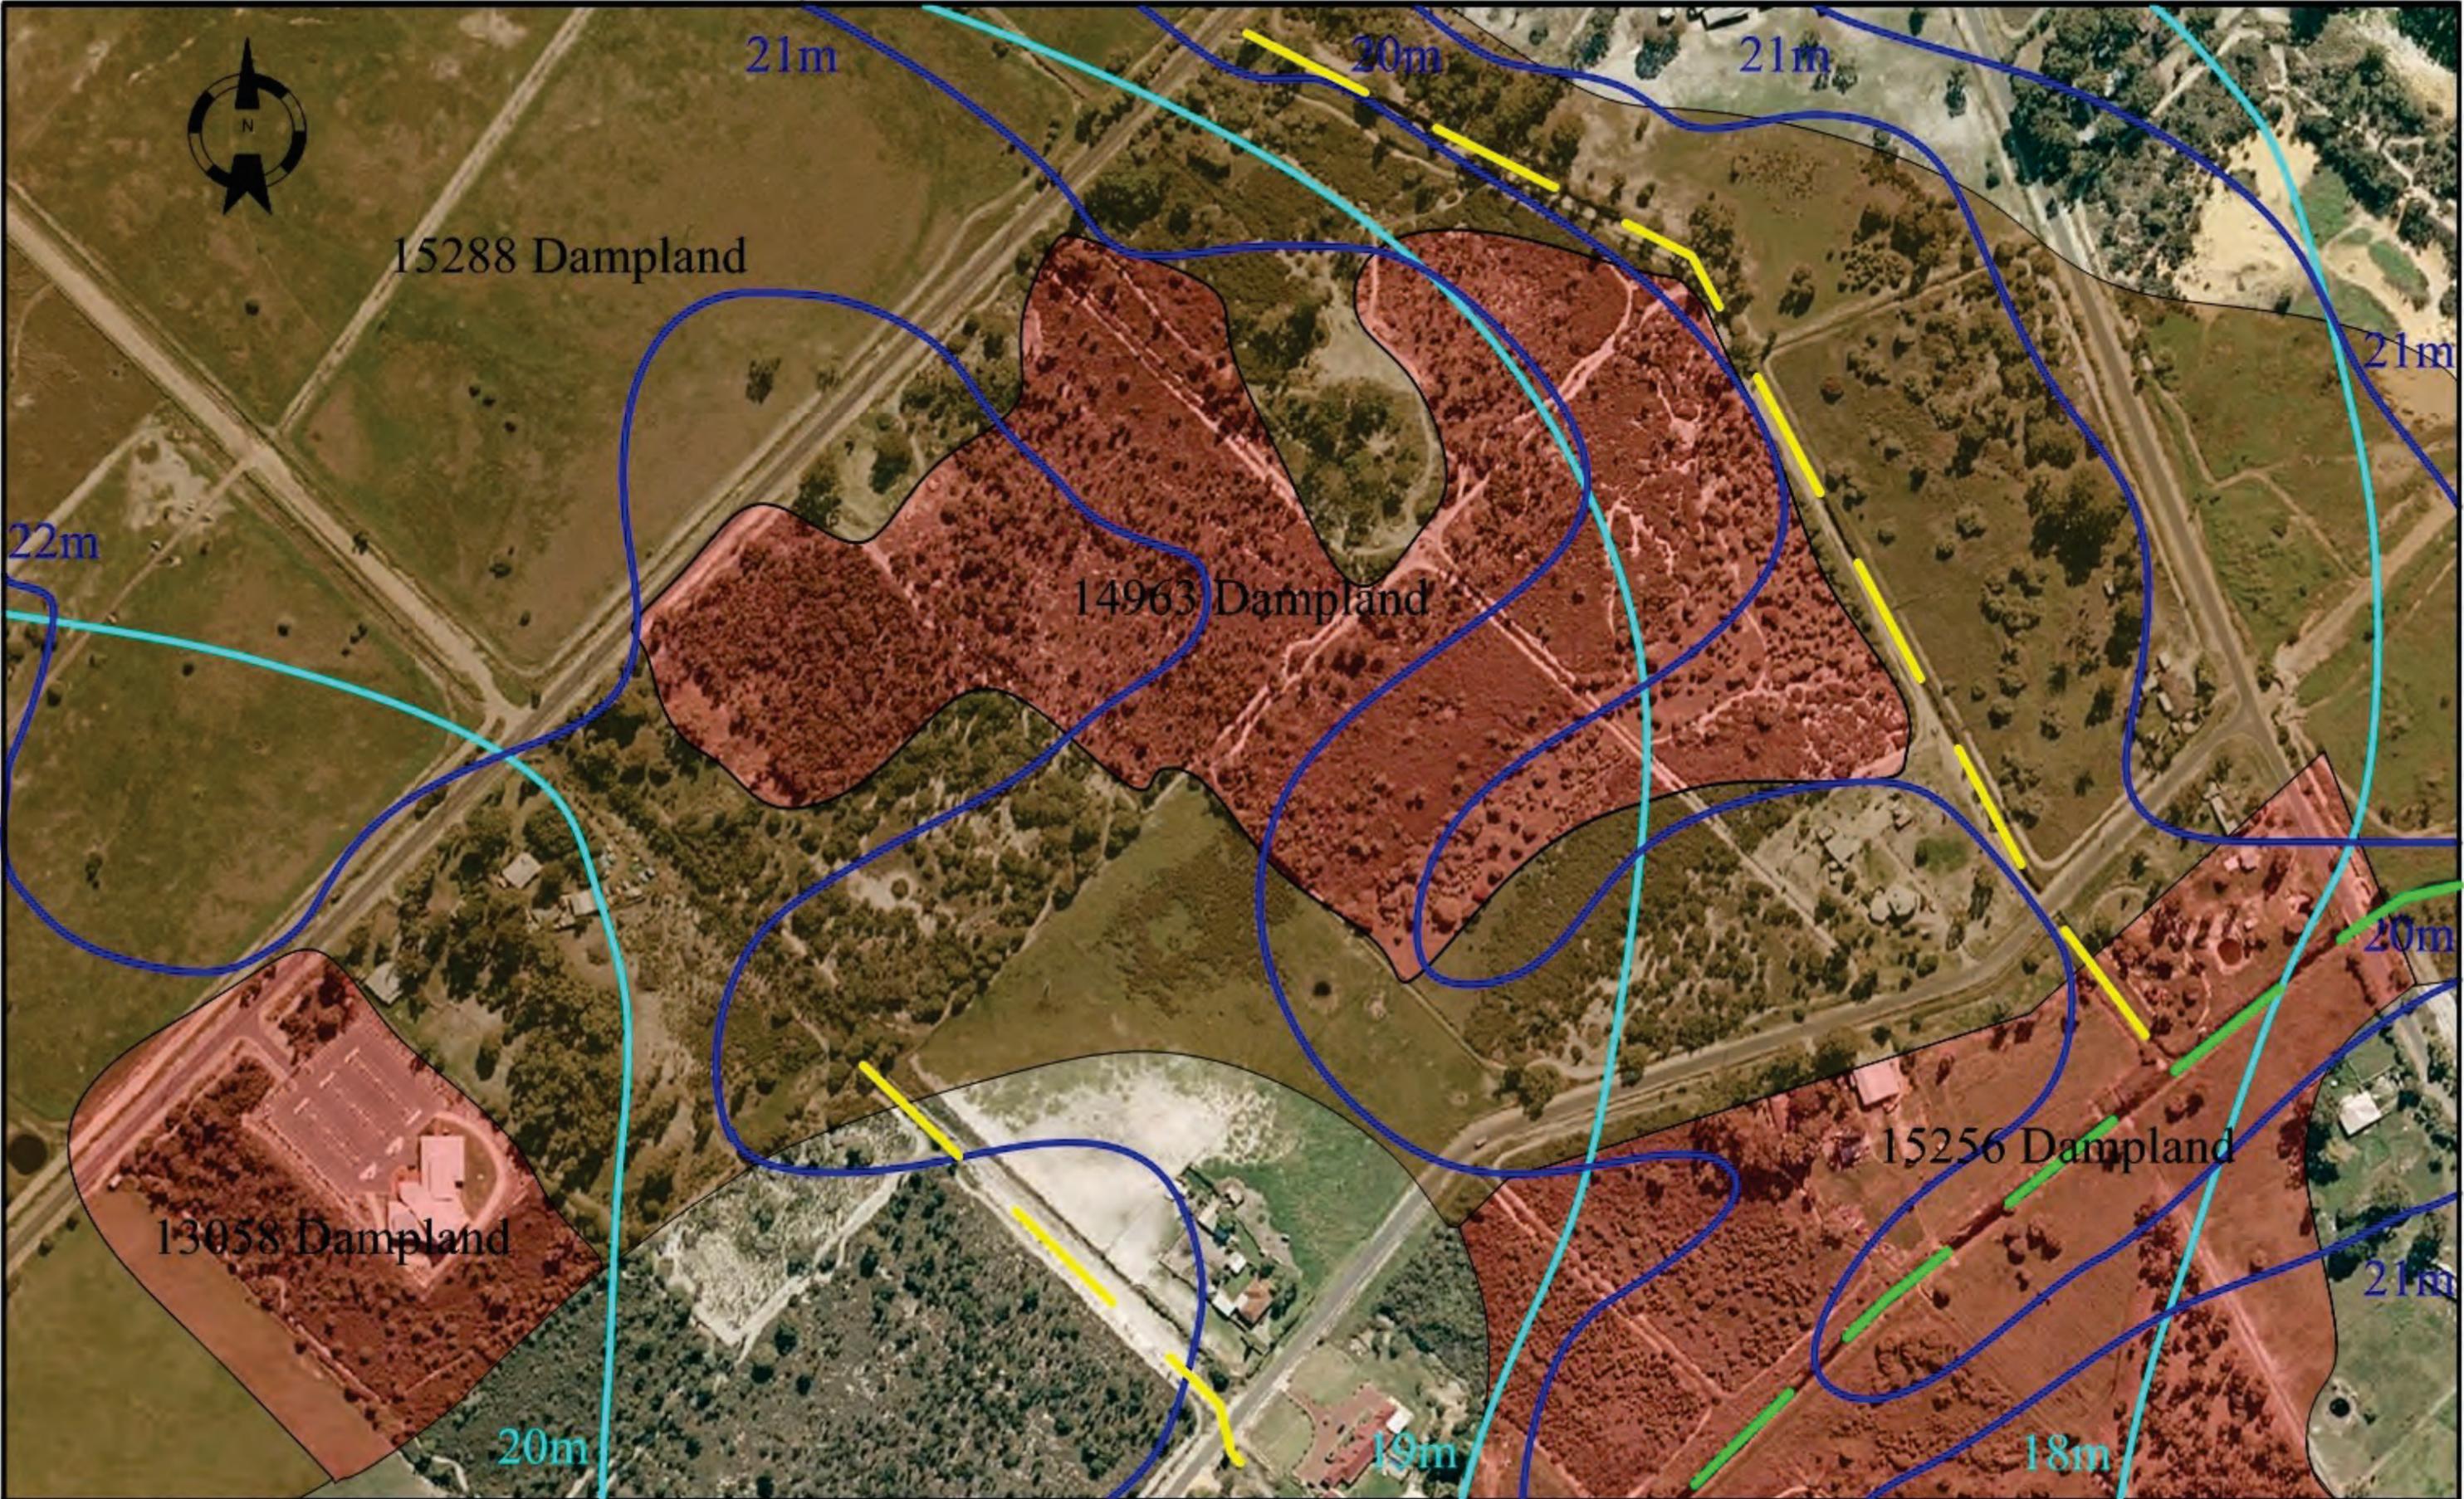
Figure 4 – Current DEC Wetlands and Department of Water Regional Groundwater Data

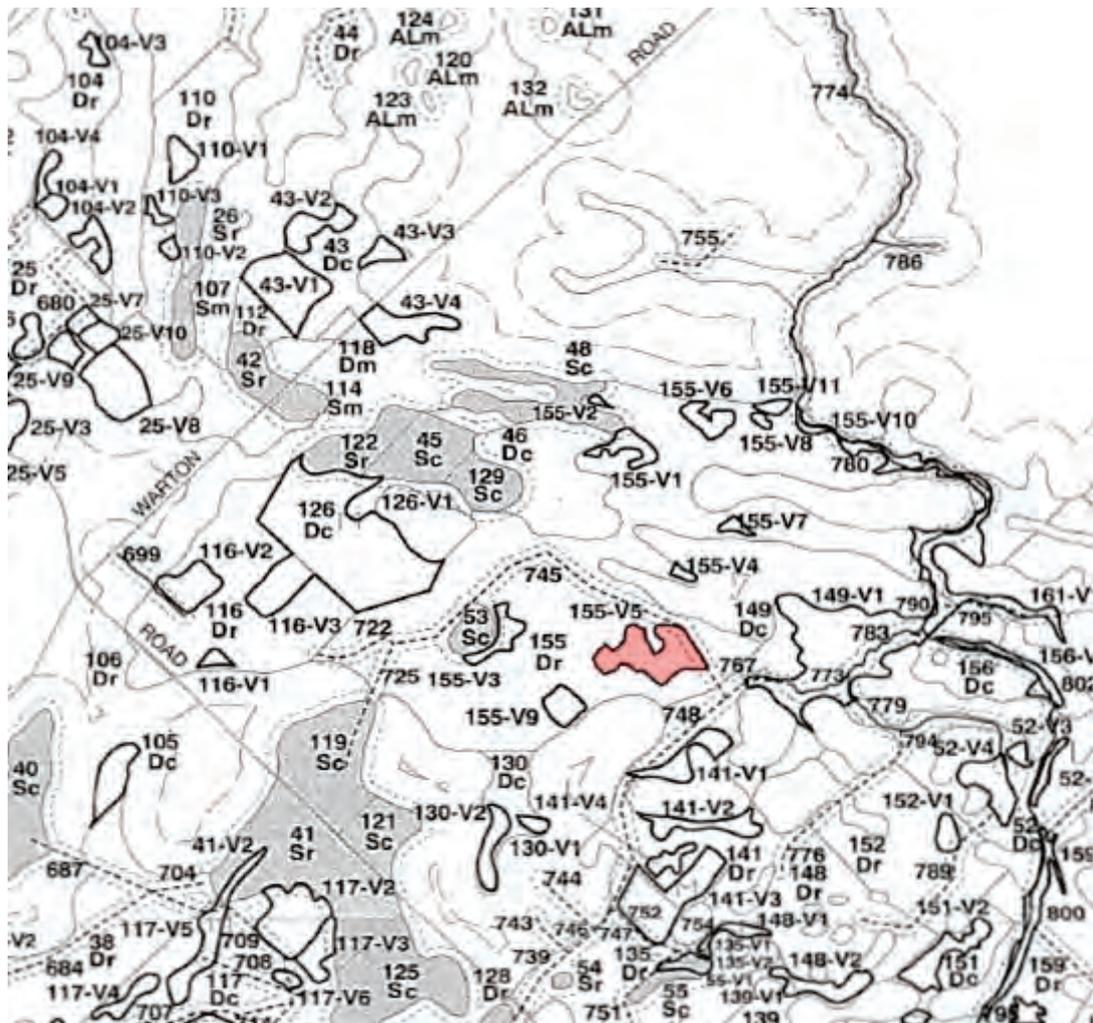
Figure 6 – Wetland classification and boundary as per Hill *et al* (1996)

Previous wetland mapping was examined in detail. Prior to 1993, the site was classified as a MUW via the application of Bulletin 374. As a result of the research conducted as part of the 1993 wetland vegetation assessment project, areas of this MUW were sub-classified by remnant vegetation. Consequently, as of Hill *et al* (1996) two wetlands were marked within the site, a MUW (i.e. No. 155, aka WIN No. 40204644804) and a CCW (i.e. No155-V5, aka 40207644742) (Figure 6).

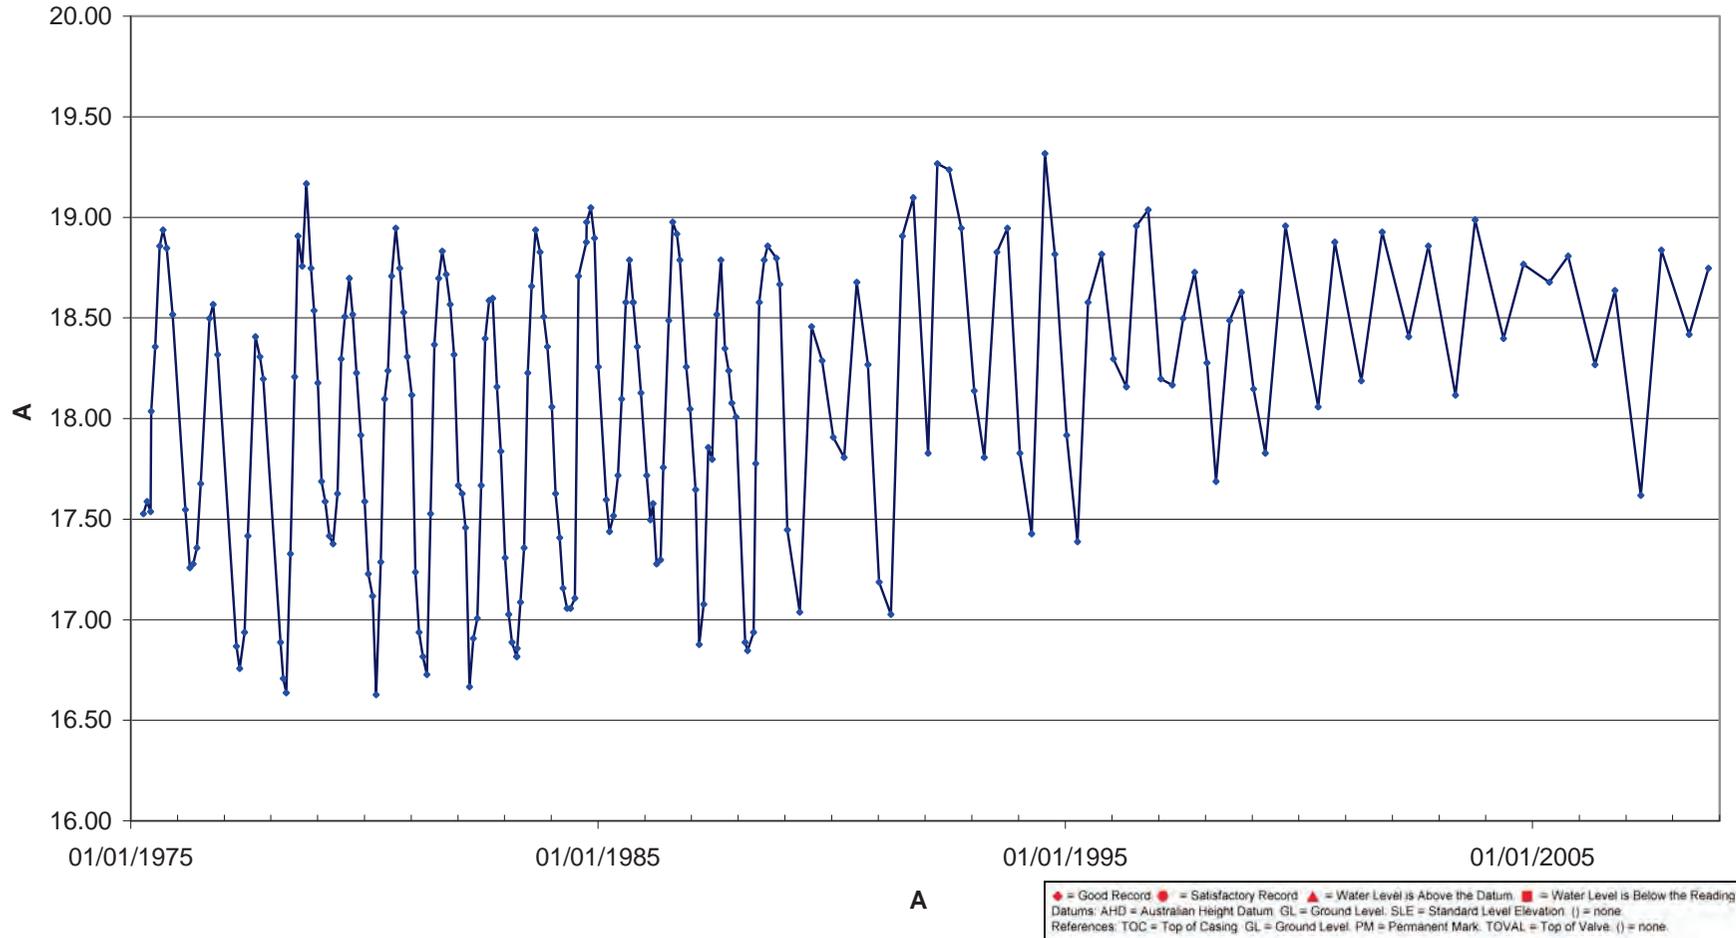
Easting = 402155.00 Northing = 6449167.00 Zone = 50 TOC = 20.357m AHD WIN SITE ID = 4880

Figure 7a - Hydrograph of Bore 4880 located 1.2 km due north of the site.

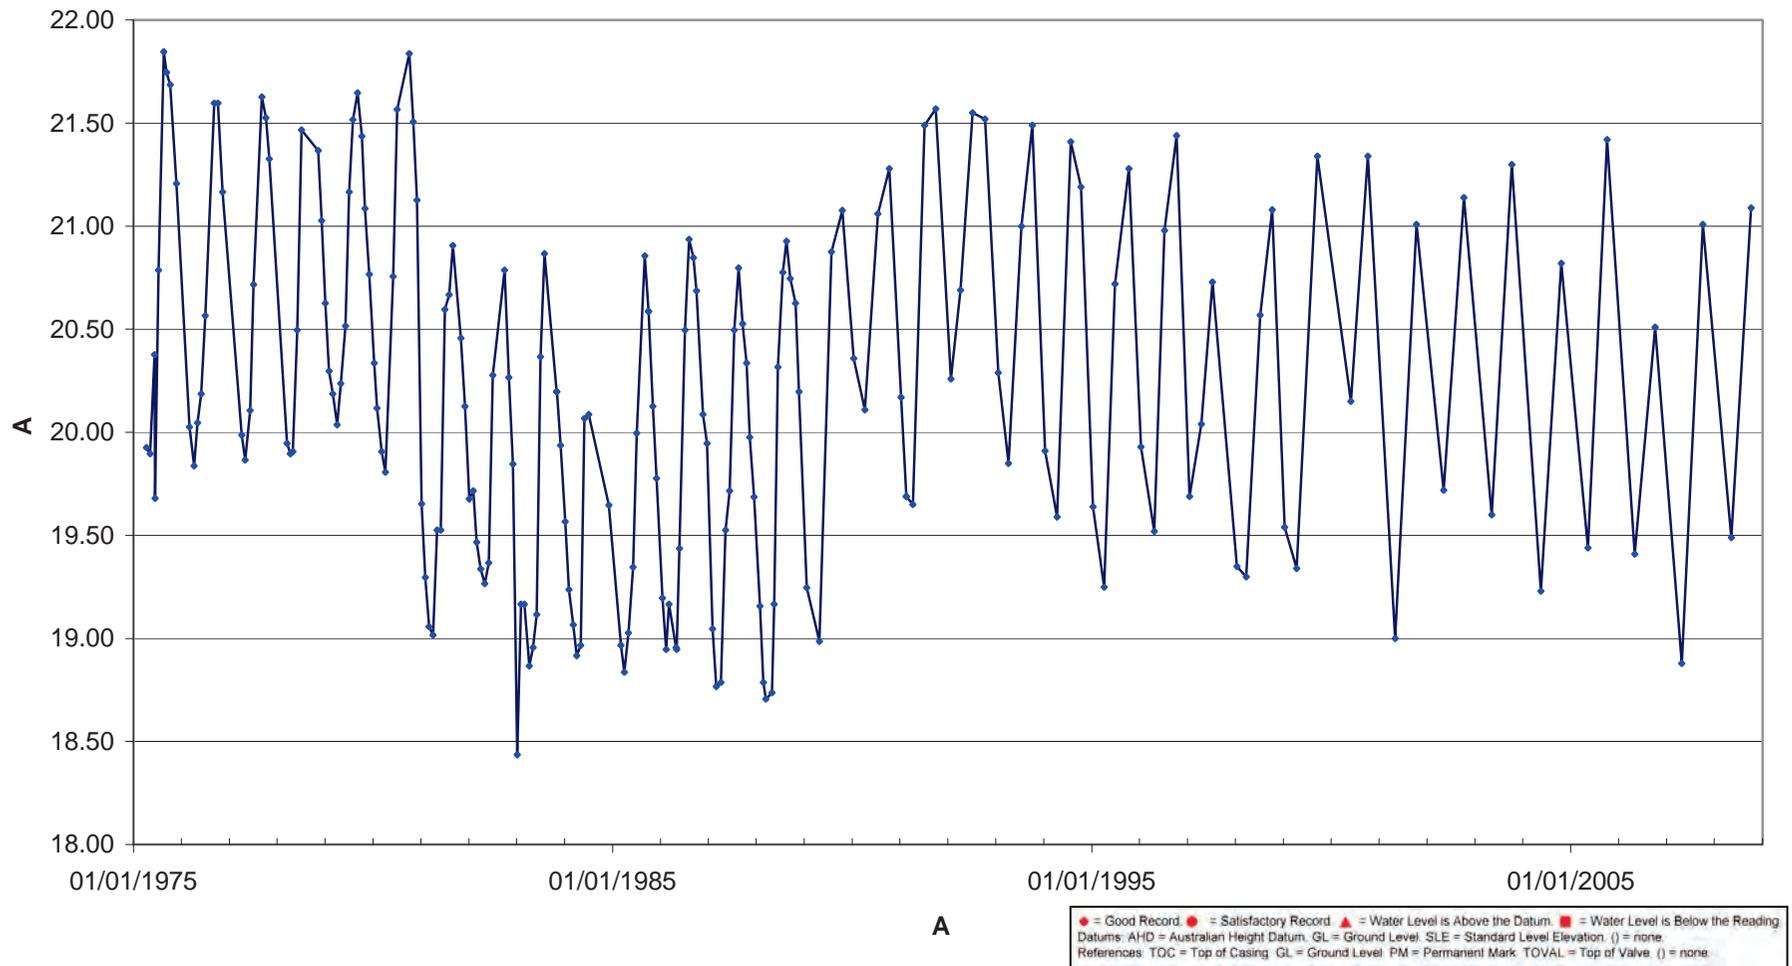
Easting = 402225.00 Northing = 6445829.00 Zone = 50 TOC = 21.789m AHD WIN SITE ID = 4879

Figure 7b - Hydrograph of bore 4879 located 1.6 km due south of the site.

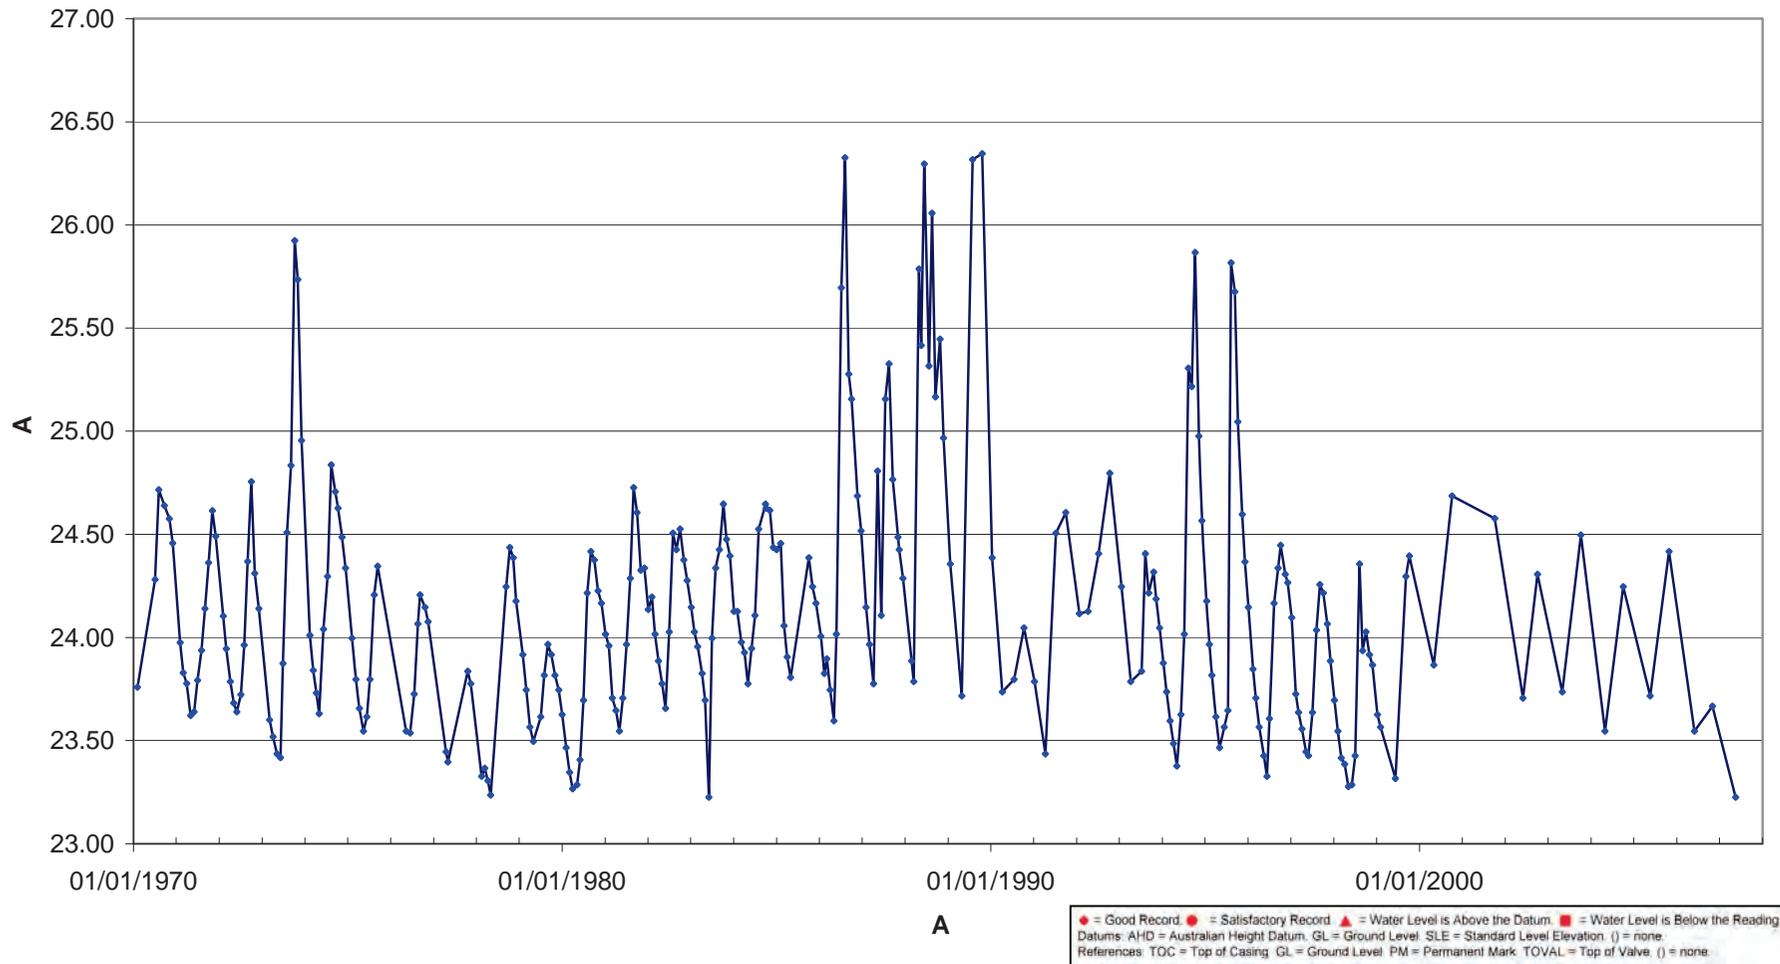
Easting = 399644.00 Northing = 6448474.00 Zone = 50 TOC = 27.016m AHD WIN SITE ID = 4846

Figure 7c - Hydrograph of bore 4864 located 2.1 km due west of the site.

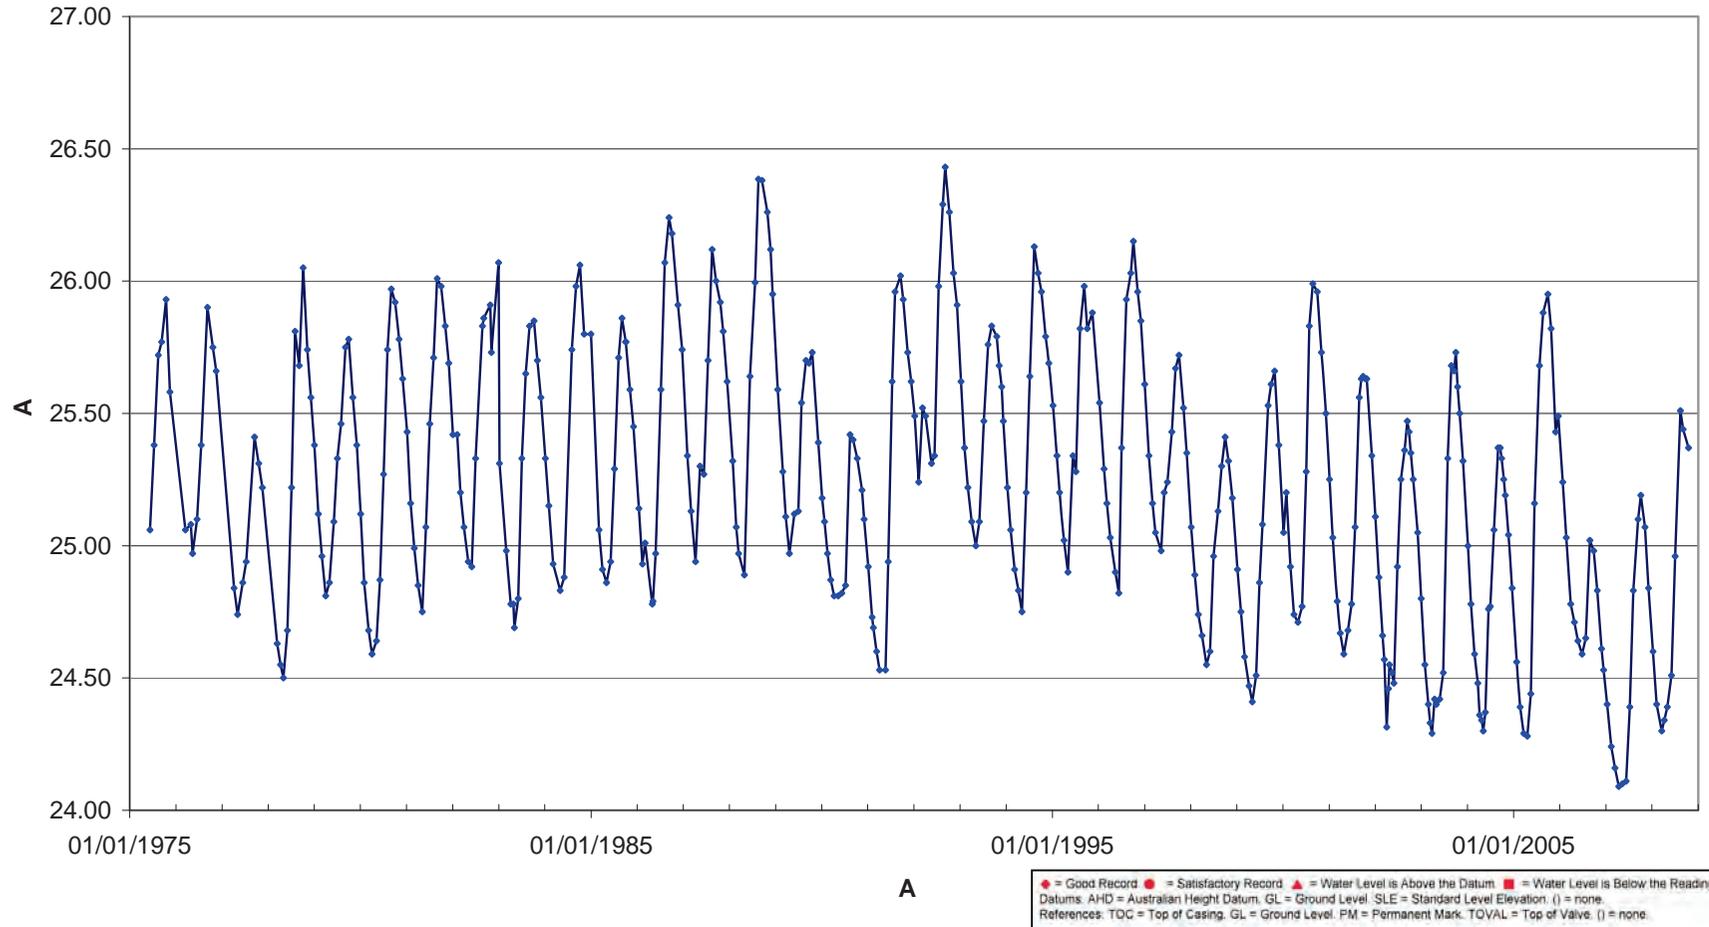
Easting = 398446.00 Northing = 6446981.00 Zone = 50 TOC = 27.63mAHD WIN SITE ID = 4786

Figure 7d - Hydrograph of bore 4786 located 2.9 km northwest of the site.

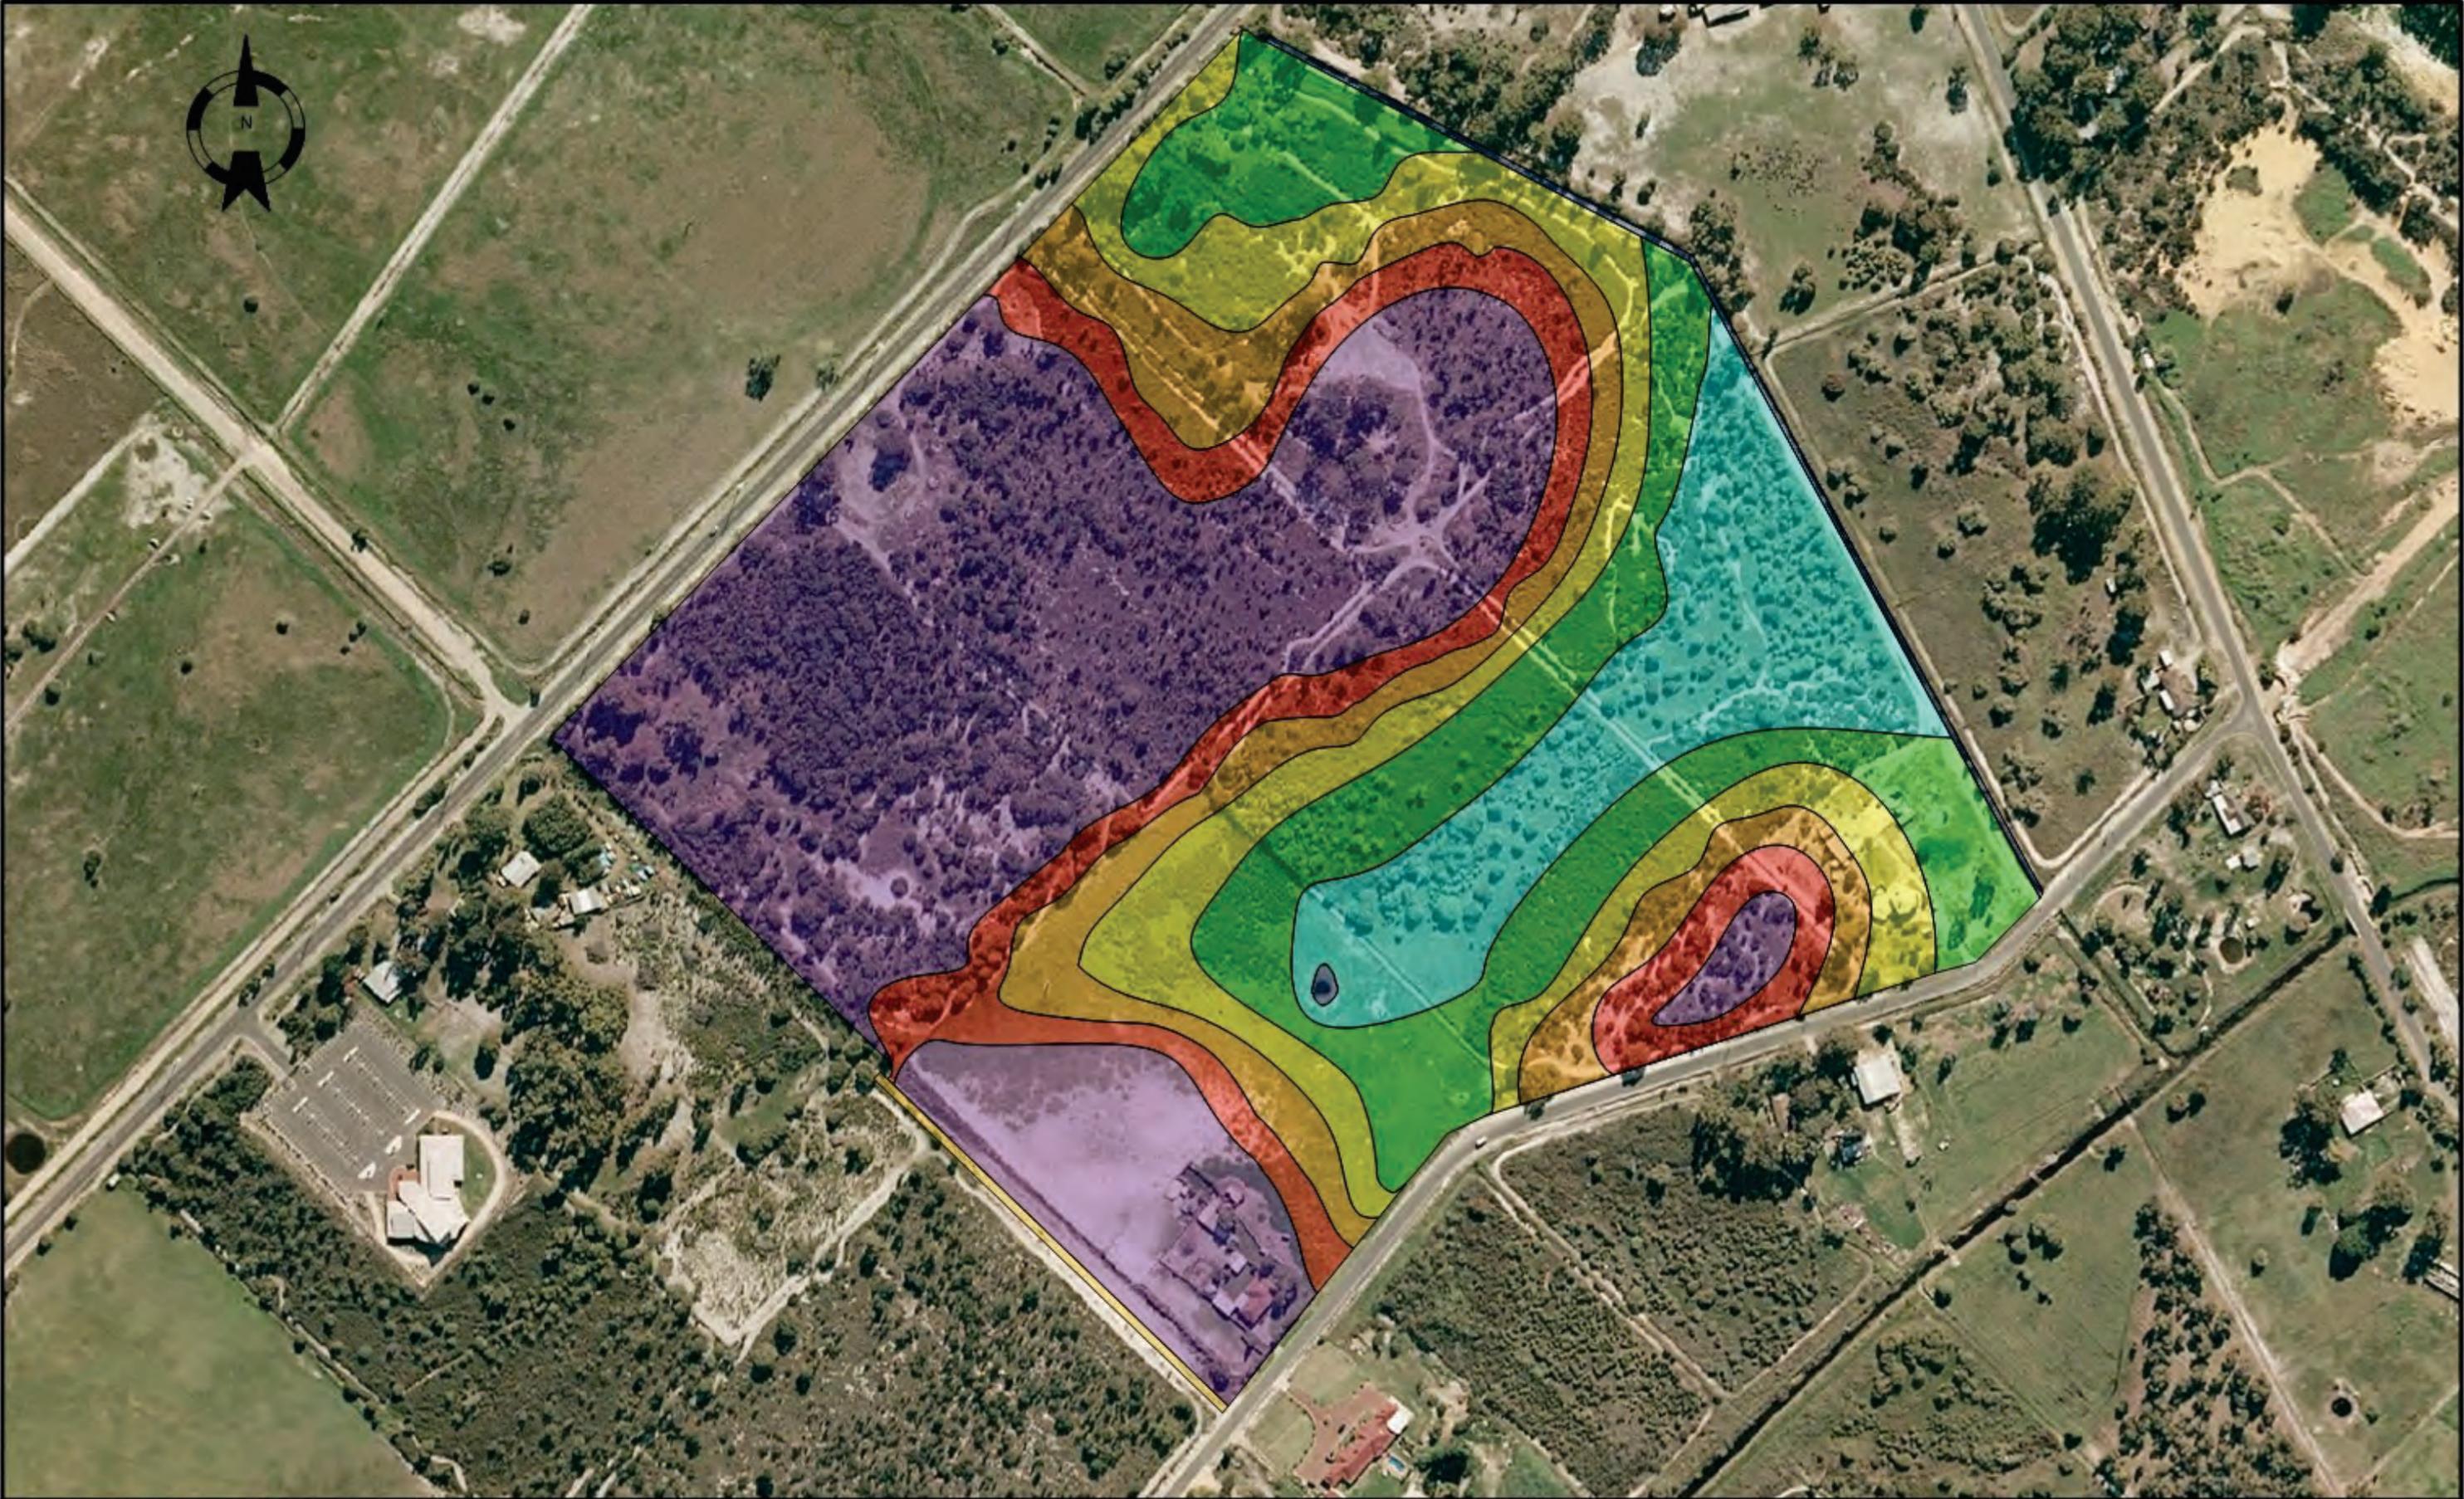
Figure 8 – AAMGL Depth to Groundwater (mBGL)

This work included correlating groundwater levels and change rates with Bureau of Meteorology rainfall records, and projecting the maximum groundwater levels possible in extreme rainfall events and rainfall years. Trend analyses details are contained in Appendix 4 and 5, but in summary, groundwater levels have remained quite constant since records commenced, and annual/monthly maximum very closely follows the annual/monthly rainfall, thereby enabling confident projections of Annual Average Maximum Groundwater Levels (AAMGL) which is estimated to be 20.47mADH, in addition to estimating extreme groundwater levels such as a 1 in 10 and 1 in 100 year events (Figures 8, 9 and 10).
