Appendix 2 – Bioscience Wetlands Assessment

GEOMORPHIC WETLANDS SWAN COASTAL
PLAIN DATASET

REQUEST FOR MODIFICATION

**Lots 13, 14, 21 and 22 Southern River Road
&
Lots 18, 19 and 20 Matison Street
Southern River Precinct 3
City of Gosnells
July 2009**

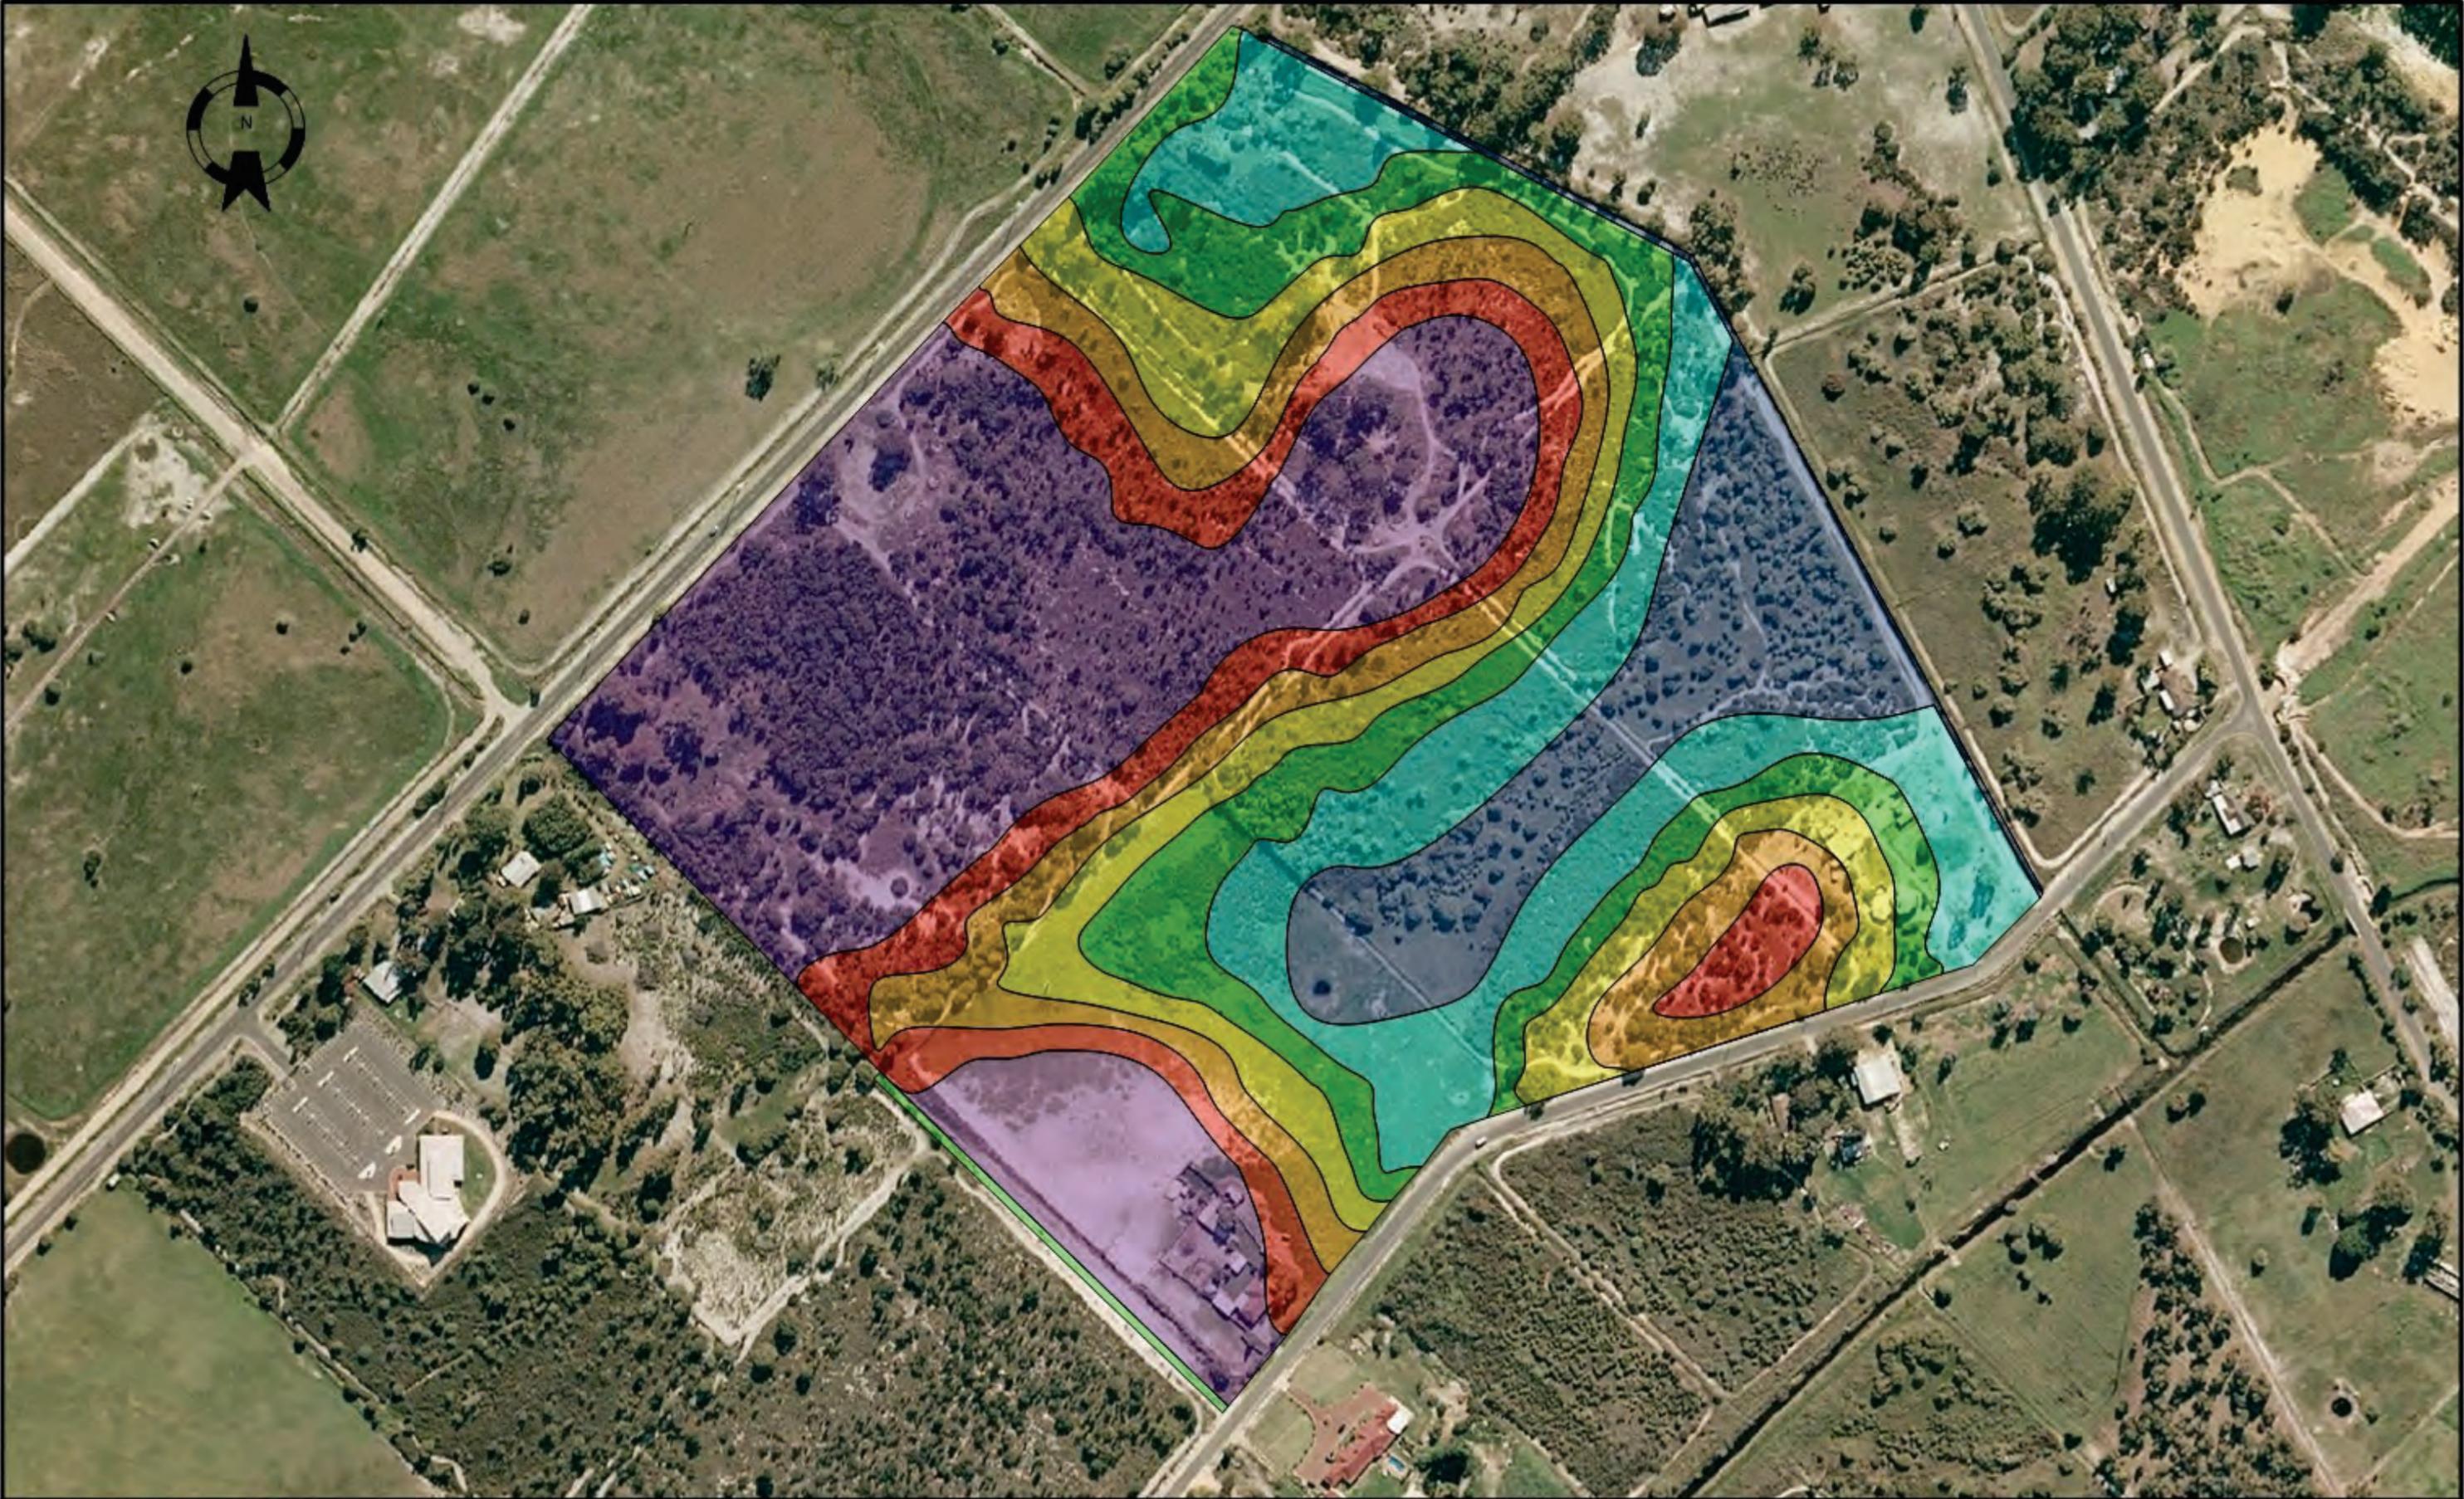
Figure 9 – Depth to Groundwater in a 1 in 10 Year Maximum Groundwater Event (mBGL)

This work included correlating groundwater levels and change rates with Bureau of Meteorology rainfall records, and projecting the maximum groundwater levels possible in extreme rainfall events and rainfall years. Trend analyses details are contained in Appendix 4 and 5, but in summary, groundwater levels have remained quite constant since records commenced, and annual/monthly maximum very closely follows the annual/monthly rainfall, thereby enabling confident projections of Annual Average Maximum Groundwater Levels (AAMGL) which is estimated to be 20.47mADH, in addition to estimating extreme groundwater levels such as a 1 in 10 and 1 in 100 year events (Figures 8, 9 and 10).

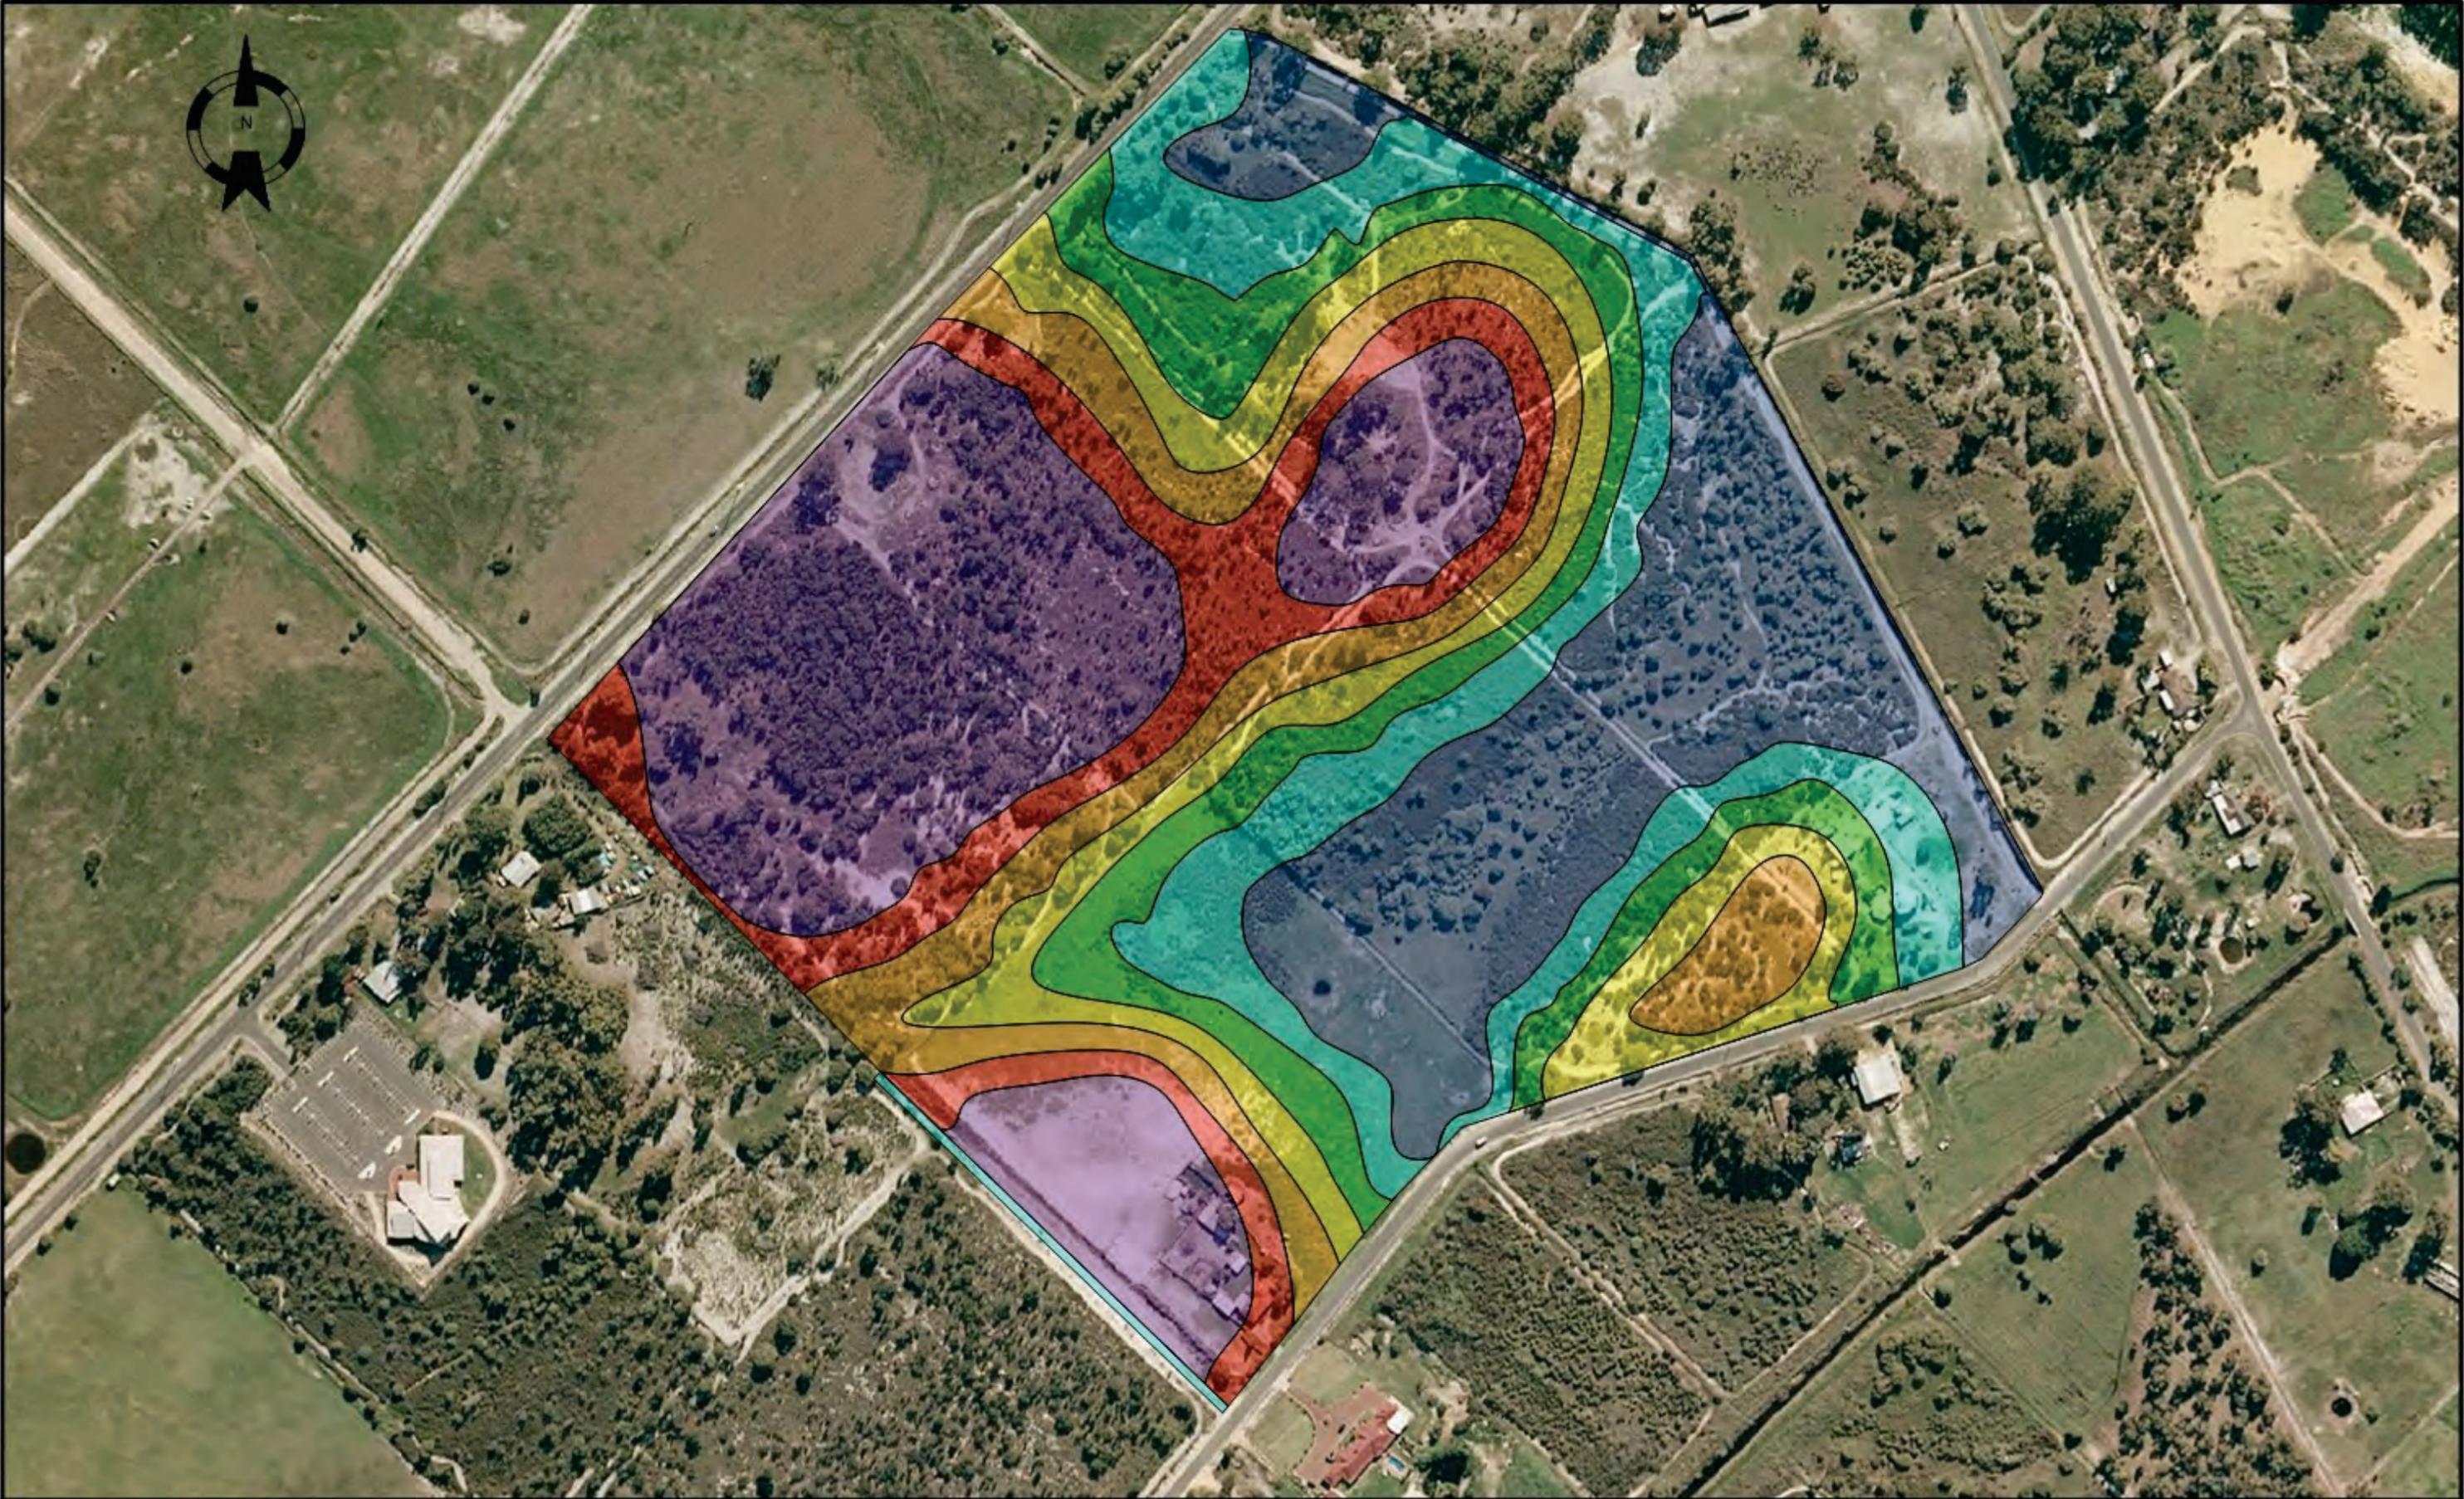
Figure 10 – Depth to Groundwater in a 1 in 100 Year Maximum Groundwater Event (mBGL)

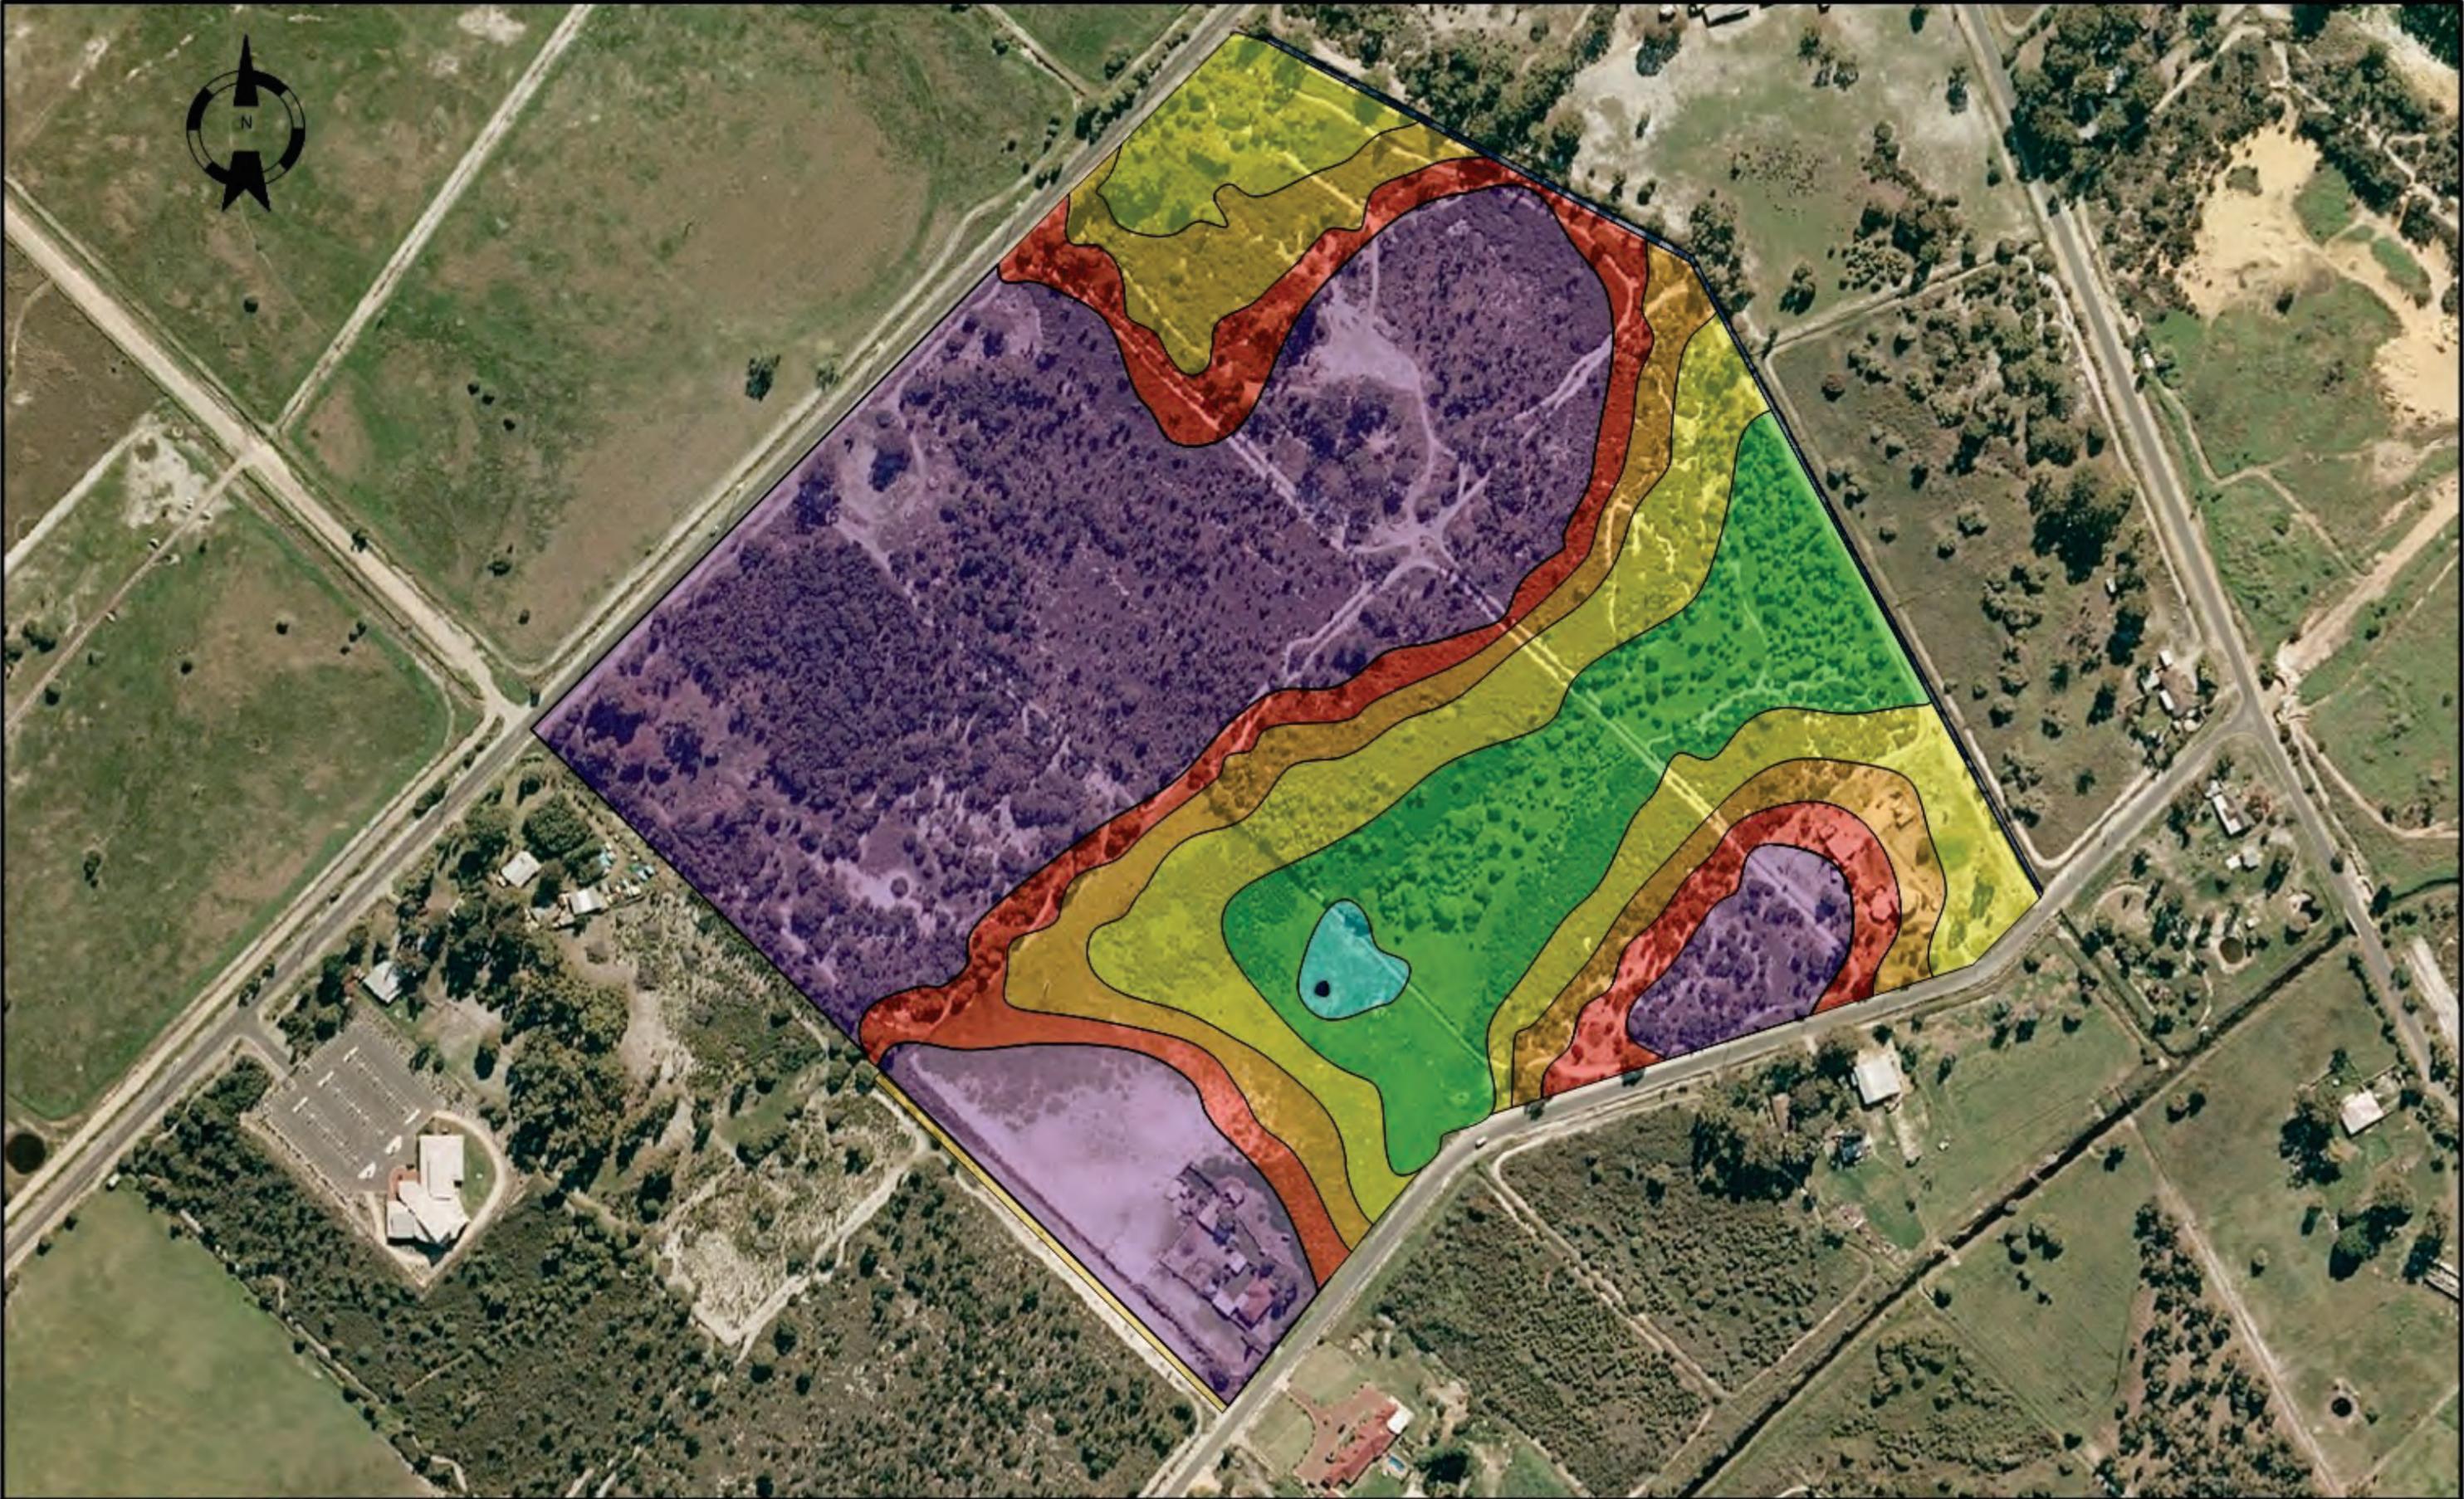
Figure 12 – Influence of the Drain on the AAMGL Depth to Groundwater (mBGL)

In relation to the site, the drain invert is approximately 0.9 m below AAMGL which is consistent with (JDA, 2002) findings of Local Authority drains within the area being 1m below AAMGL. Consequently, groundwater levels within 1km of this drain will decline logarithmically from between 0.57m to 0.008m (Figure 11), thus having a very significant impact on groundwater levels of the entire site. Several models were created to help visualise the extent this drain effects the site hydrology (Figures 12, 13, and 14).

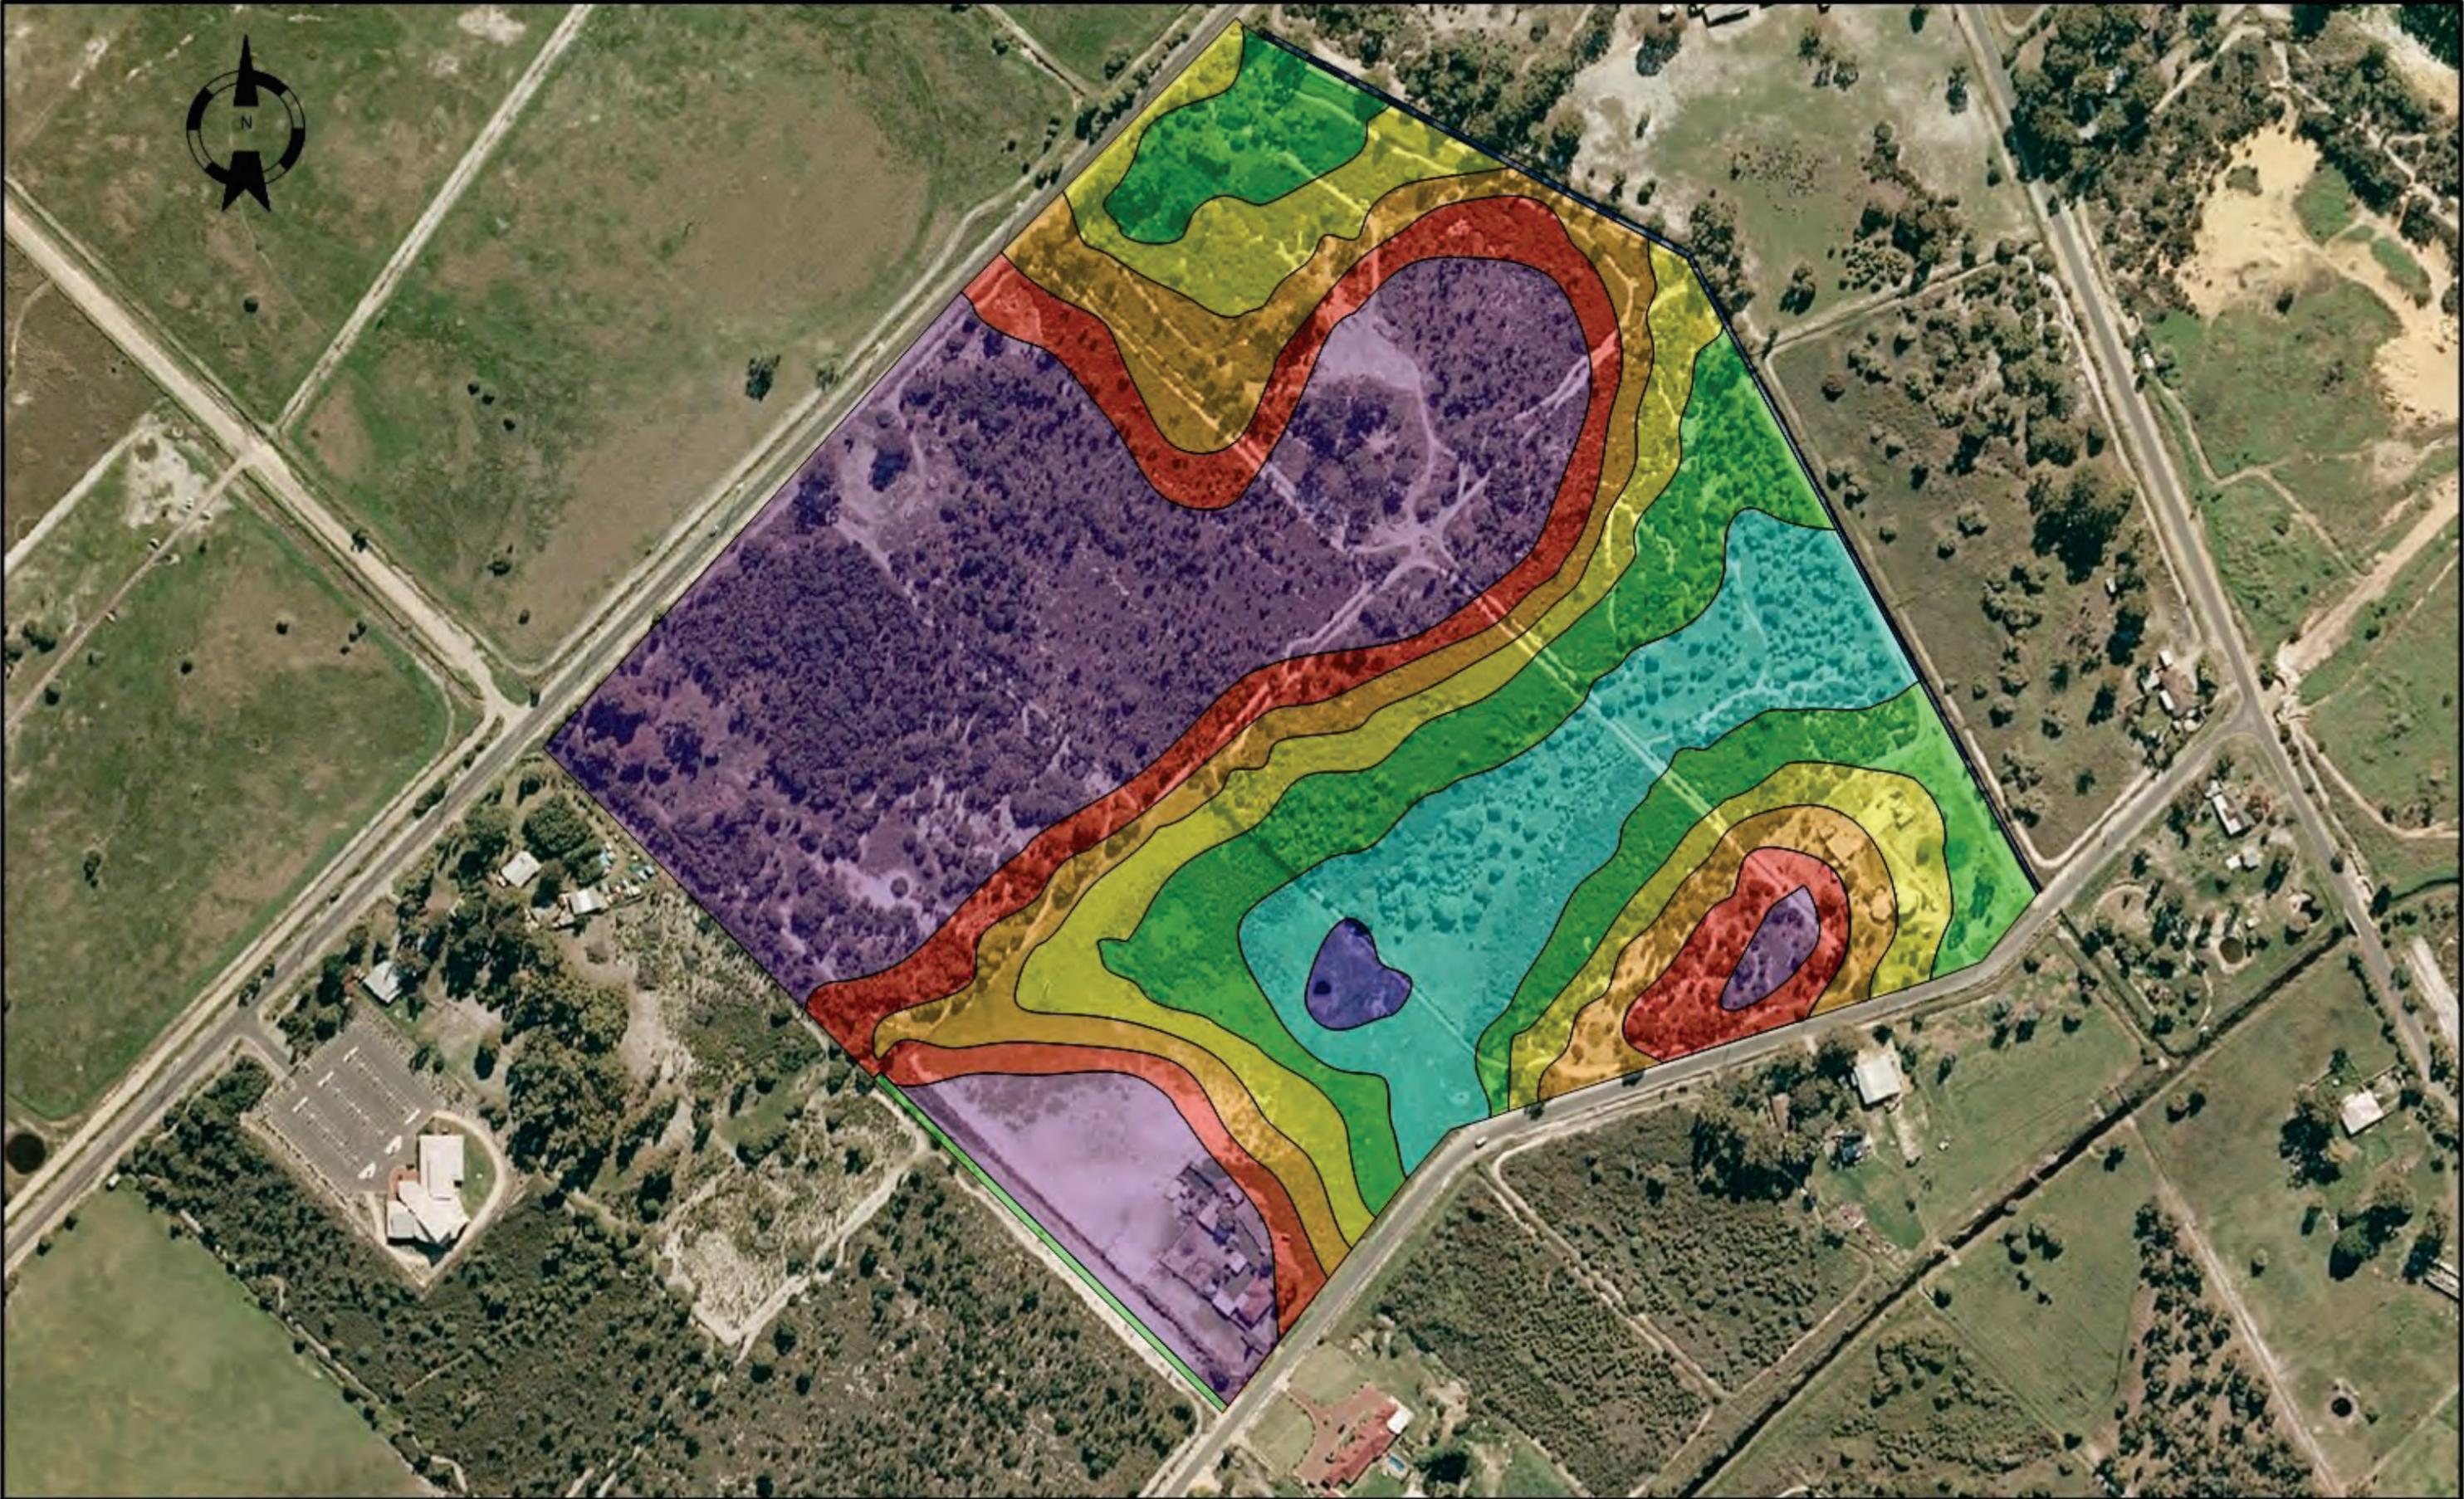
Figure13 – Influence of the Drain on a 1 in 10 Year Maximum Groundwater Event (mBGL)

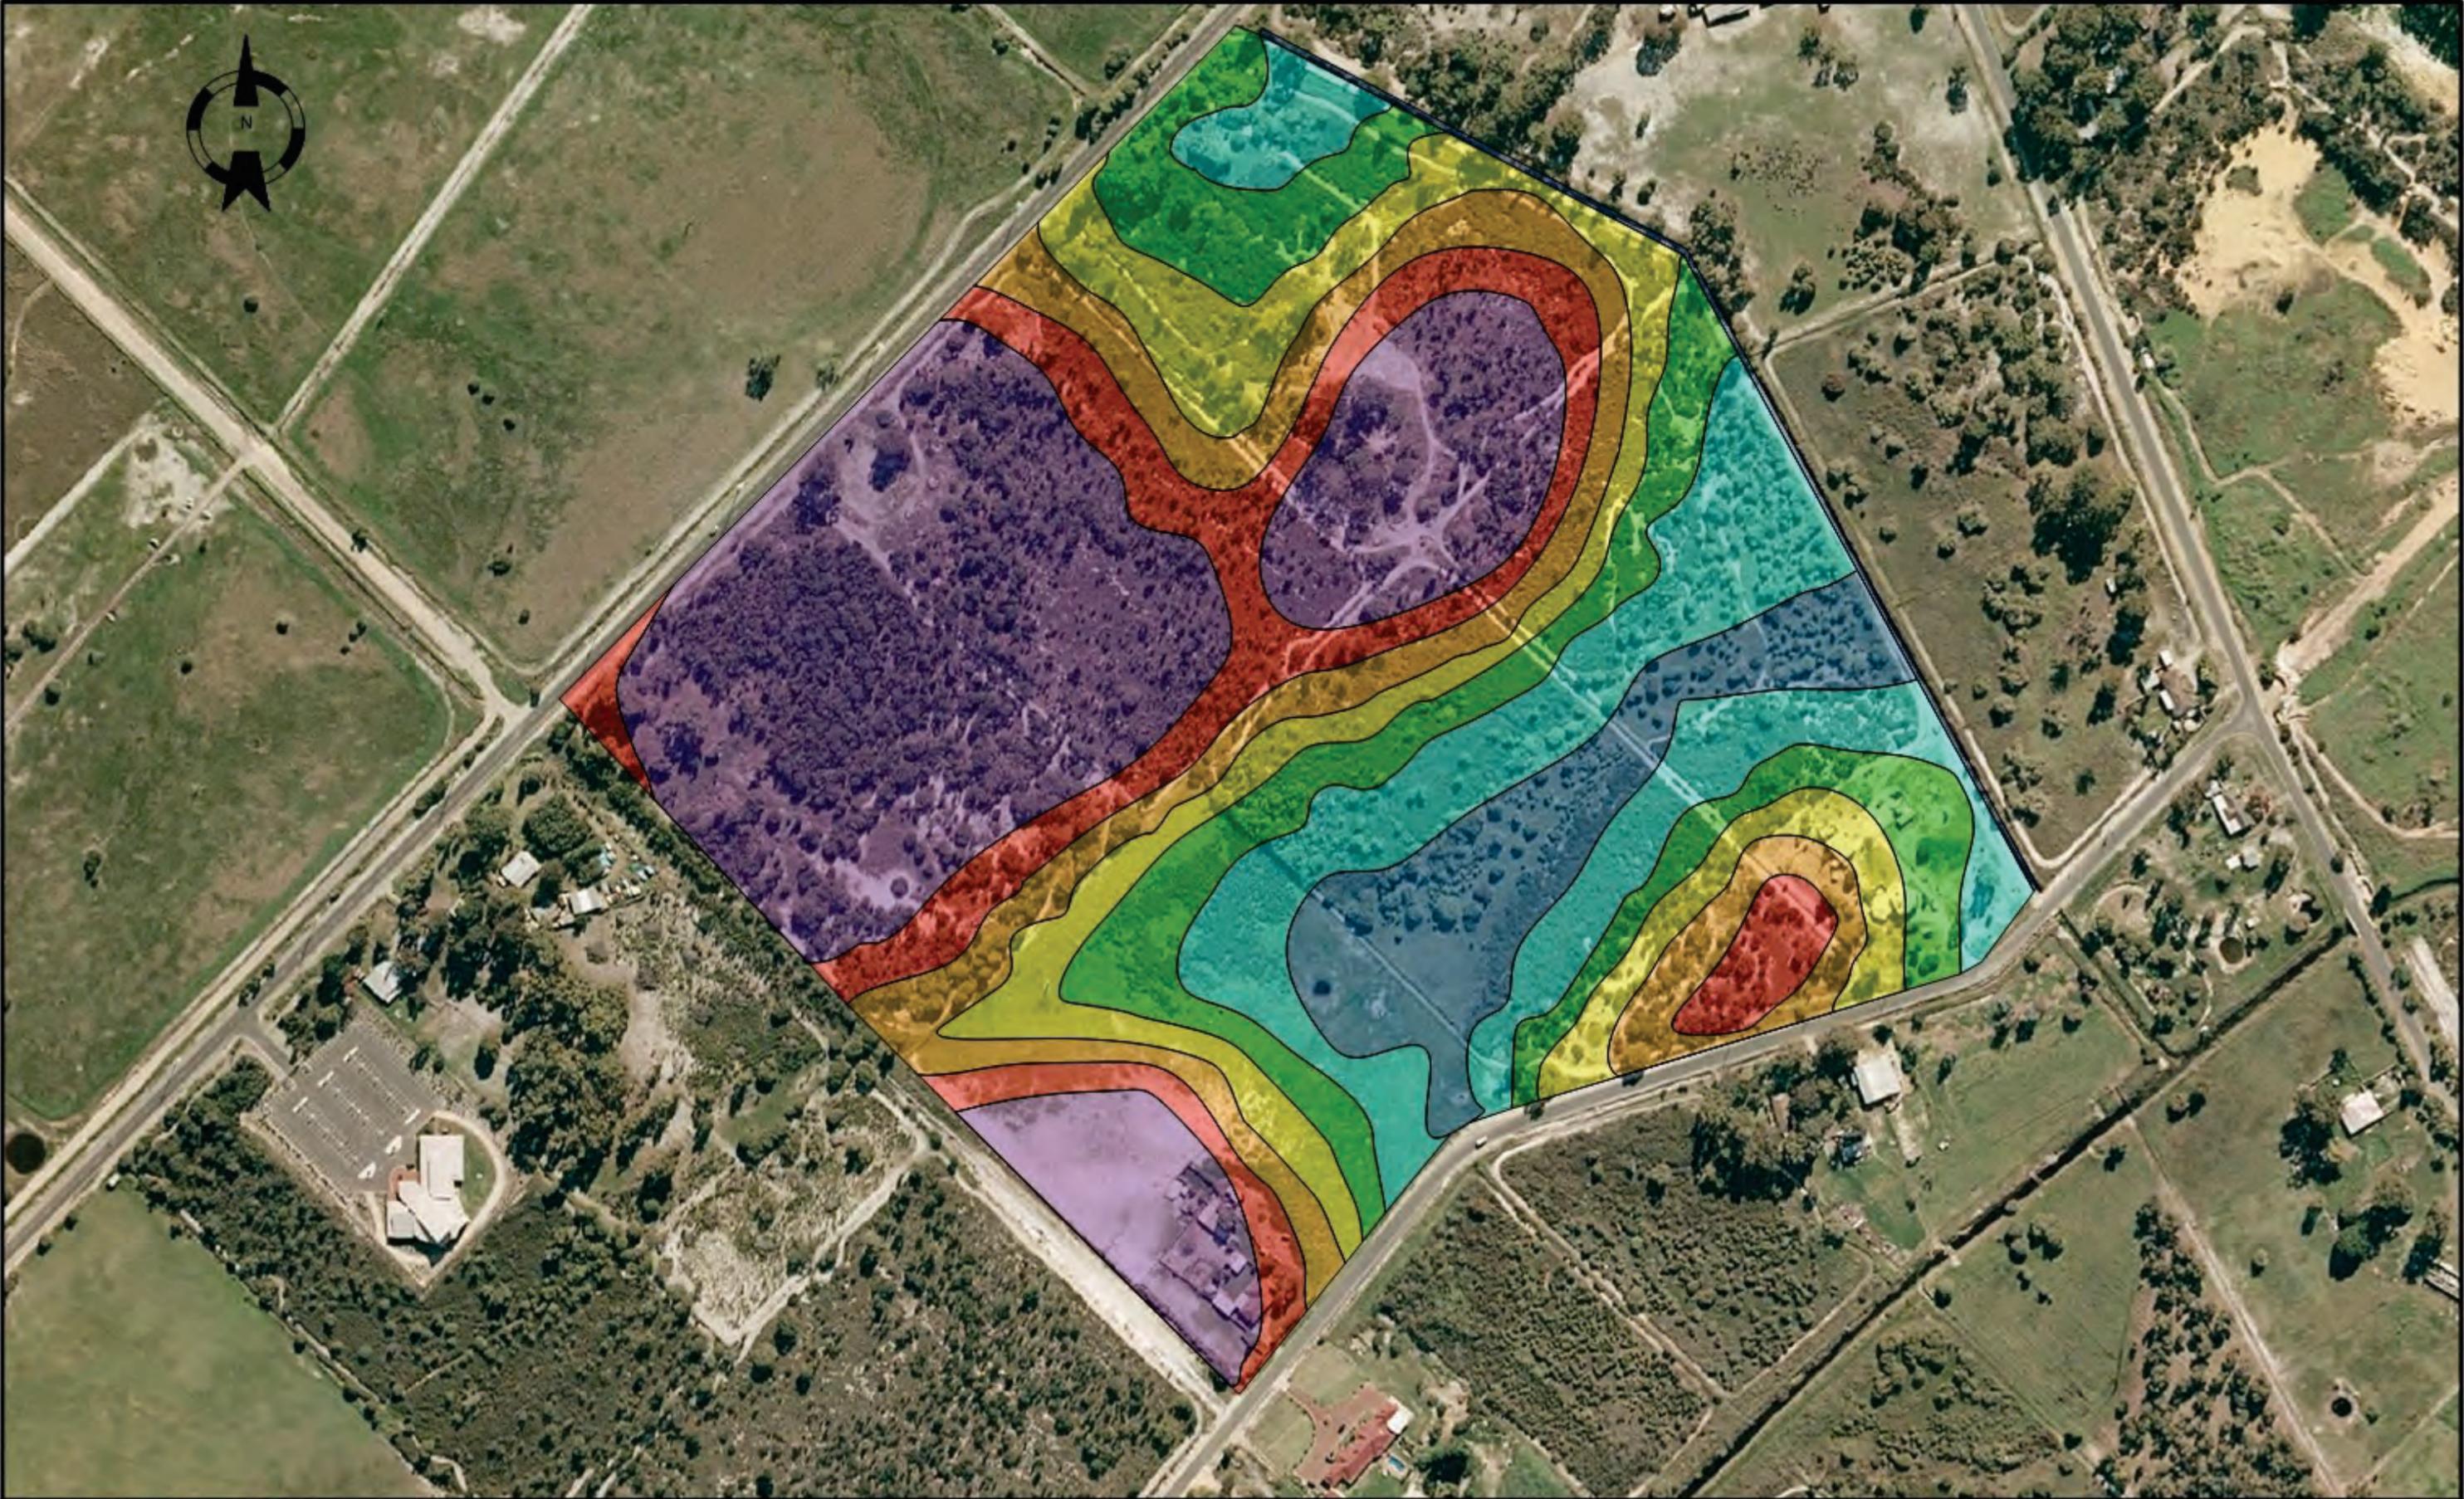
Figure14 – Influence of the Drain on a 1 in 100 Year Maximum Groundwater Event (mBGL)

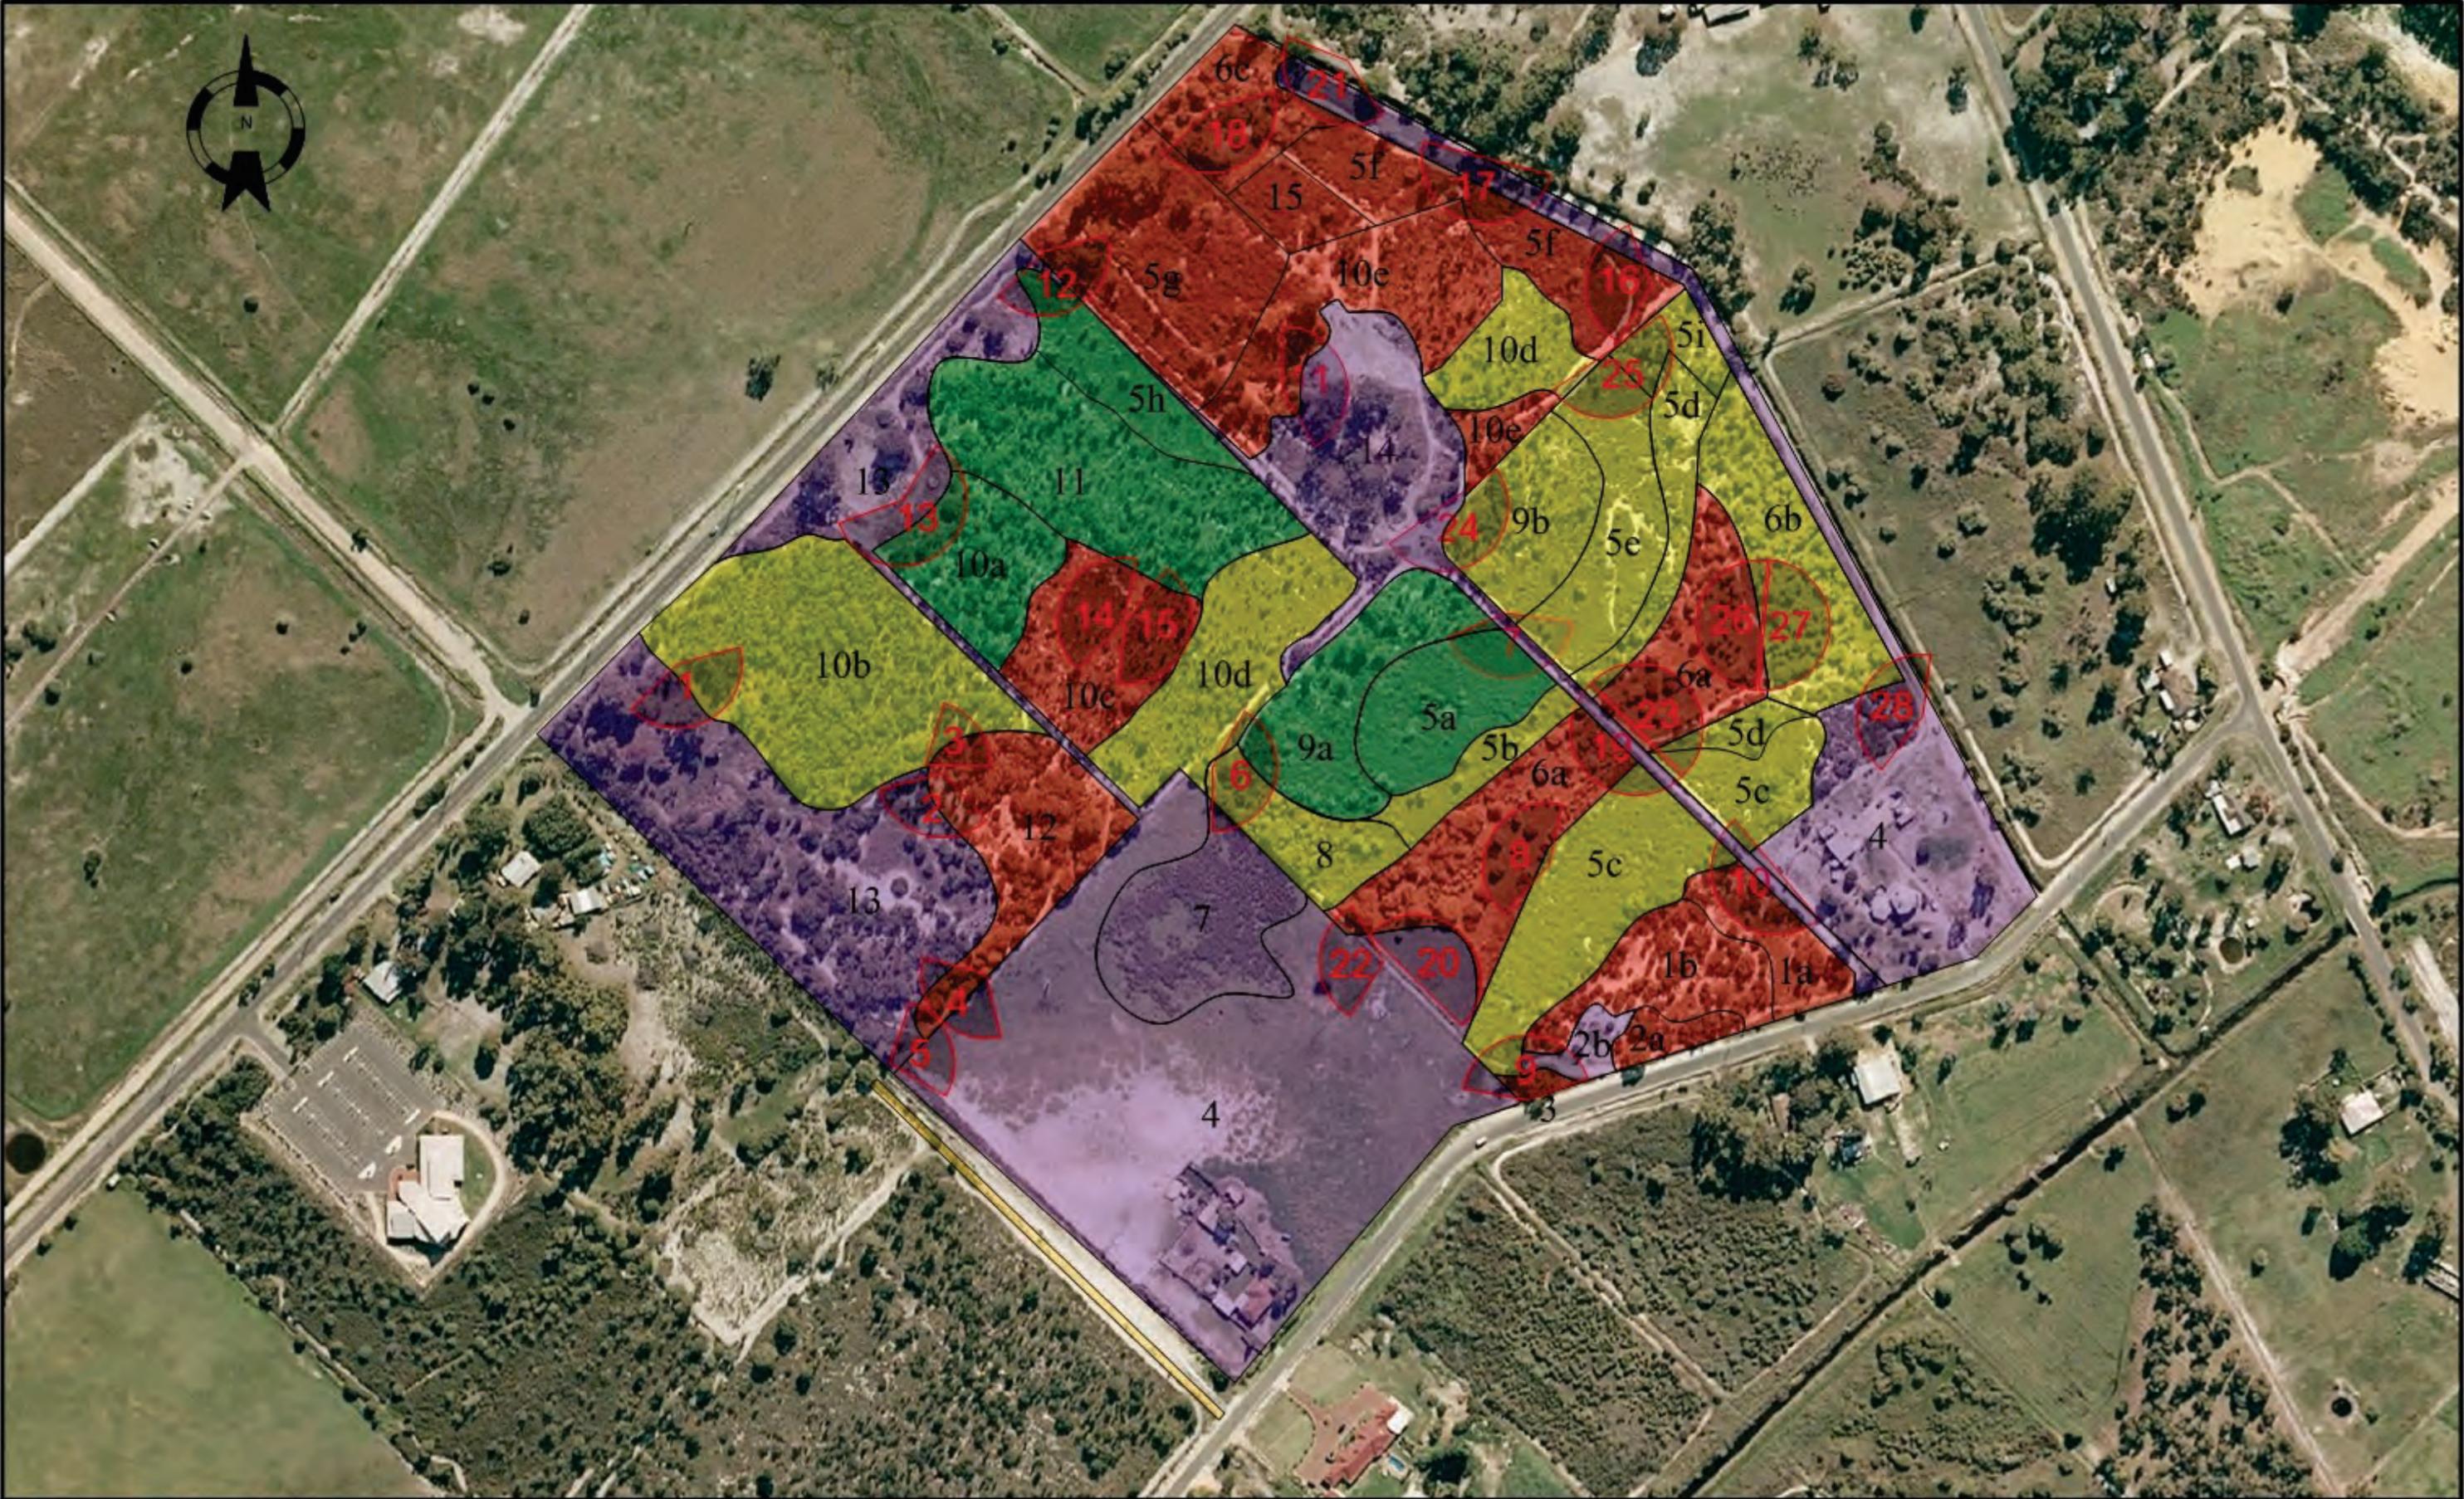
Figure 15 – Vegetation Community Type and Condition, and Photograph Location with Field of View

In a more pragmatic sense, the scoring system provides to those charged with rehabilitation and maintenance tasks, a scored set of priority issues to conserve native flora diversity and highlights factors causing detriment of vegetation values upon which to target remediation and management strategies. The conditions of the sectors defined in the vegetation map are colour coded as described on the map (Figure 15). The basis of scoring is defined in Appendix 6.
