Appendix 2 – Bioscience Wetlands Assessment

GEOMORPHIC WETLANDS SWAN COASTAL
PLAIN DATASET

REQUEST FOR MODIFICATION

**Lots 13, 14, 21 and 22 Southern River Road
&
Lots 18, 19 and 20 Matison Street
Southern River Precinct 3
City of Gosnells
July 2009**

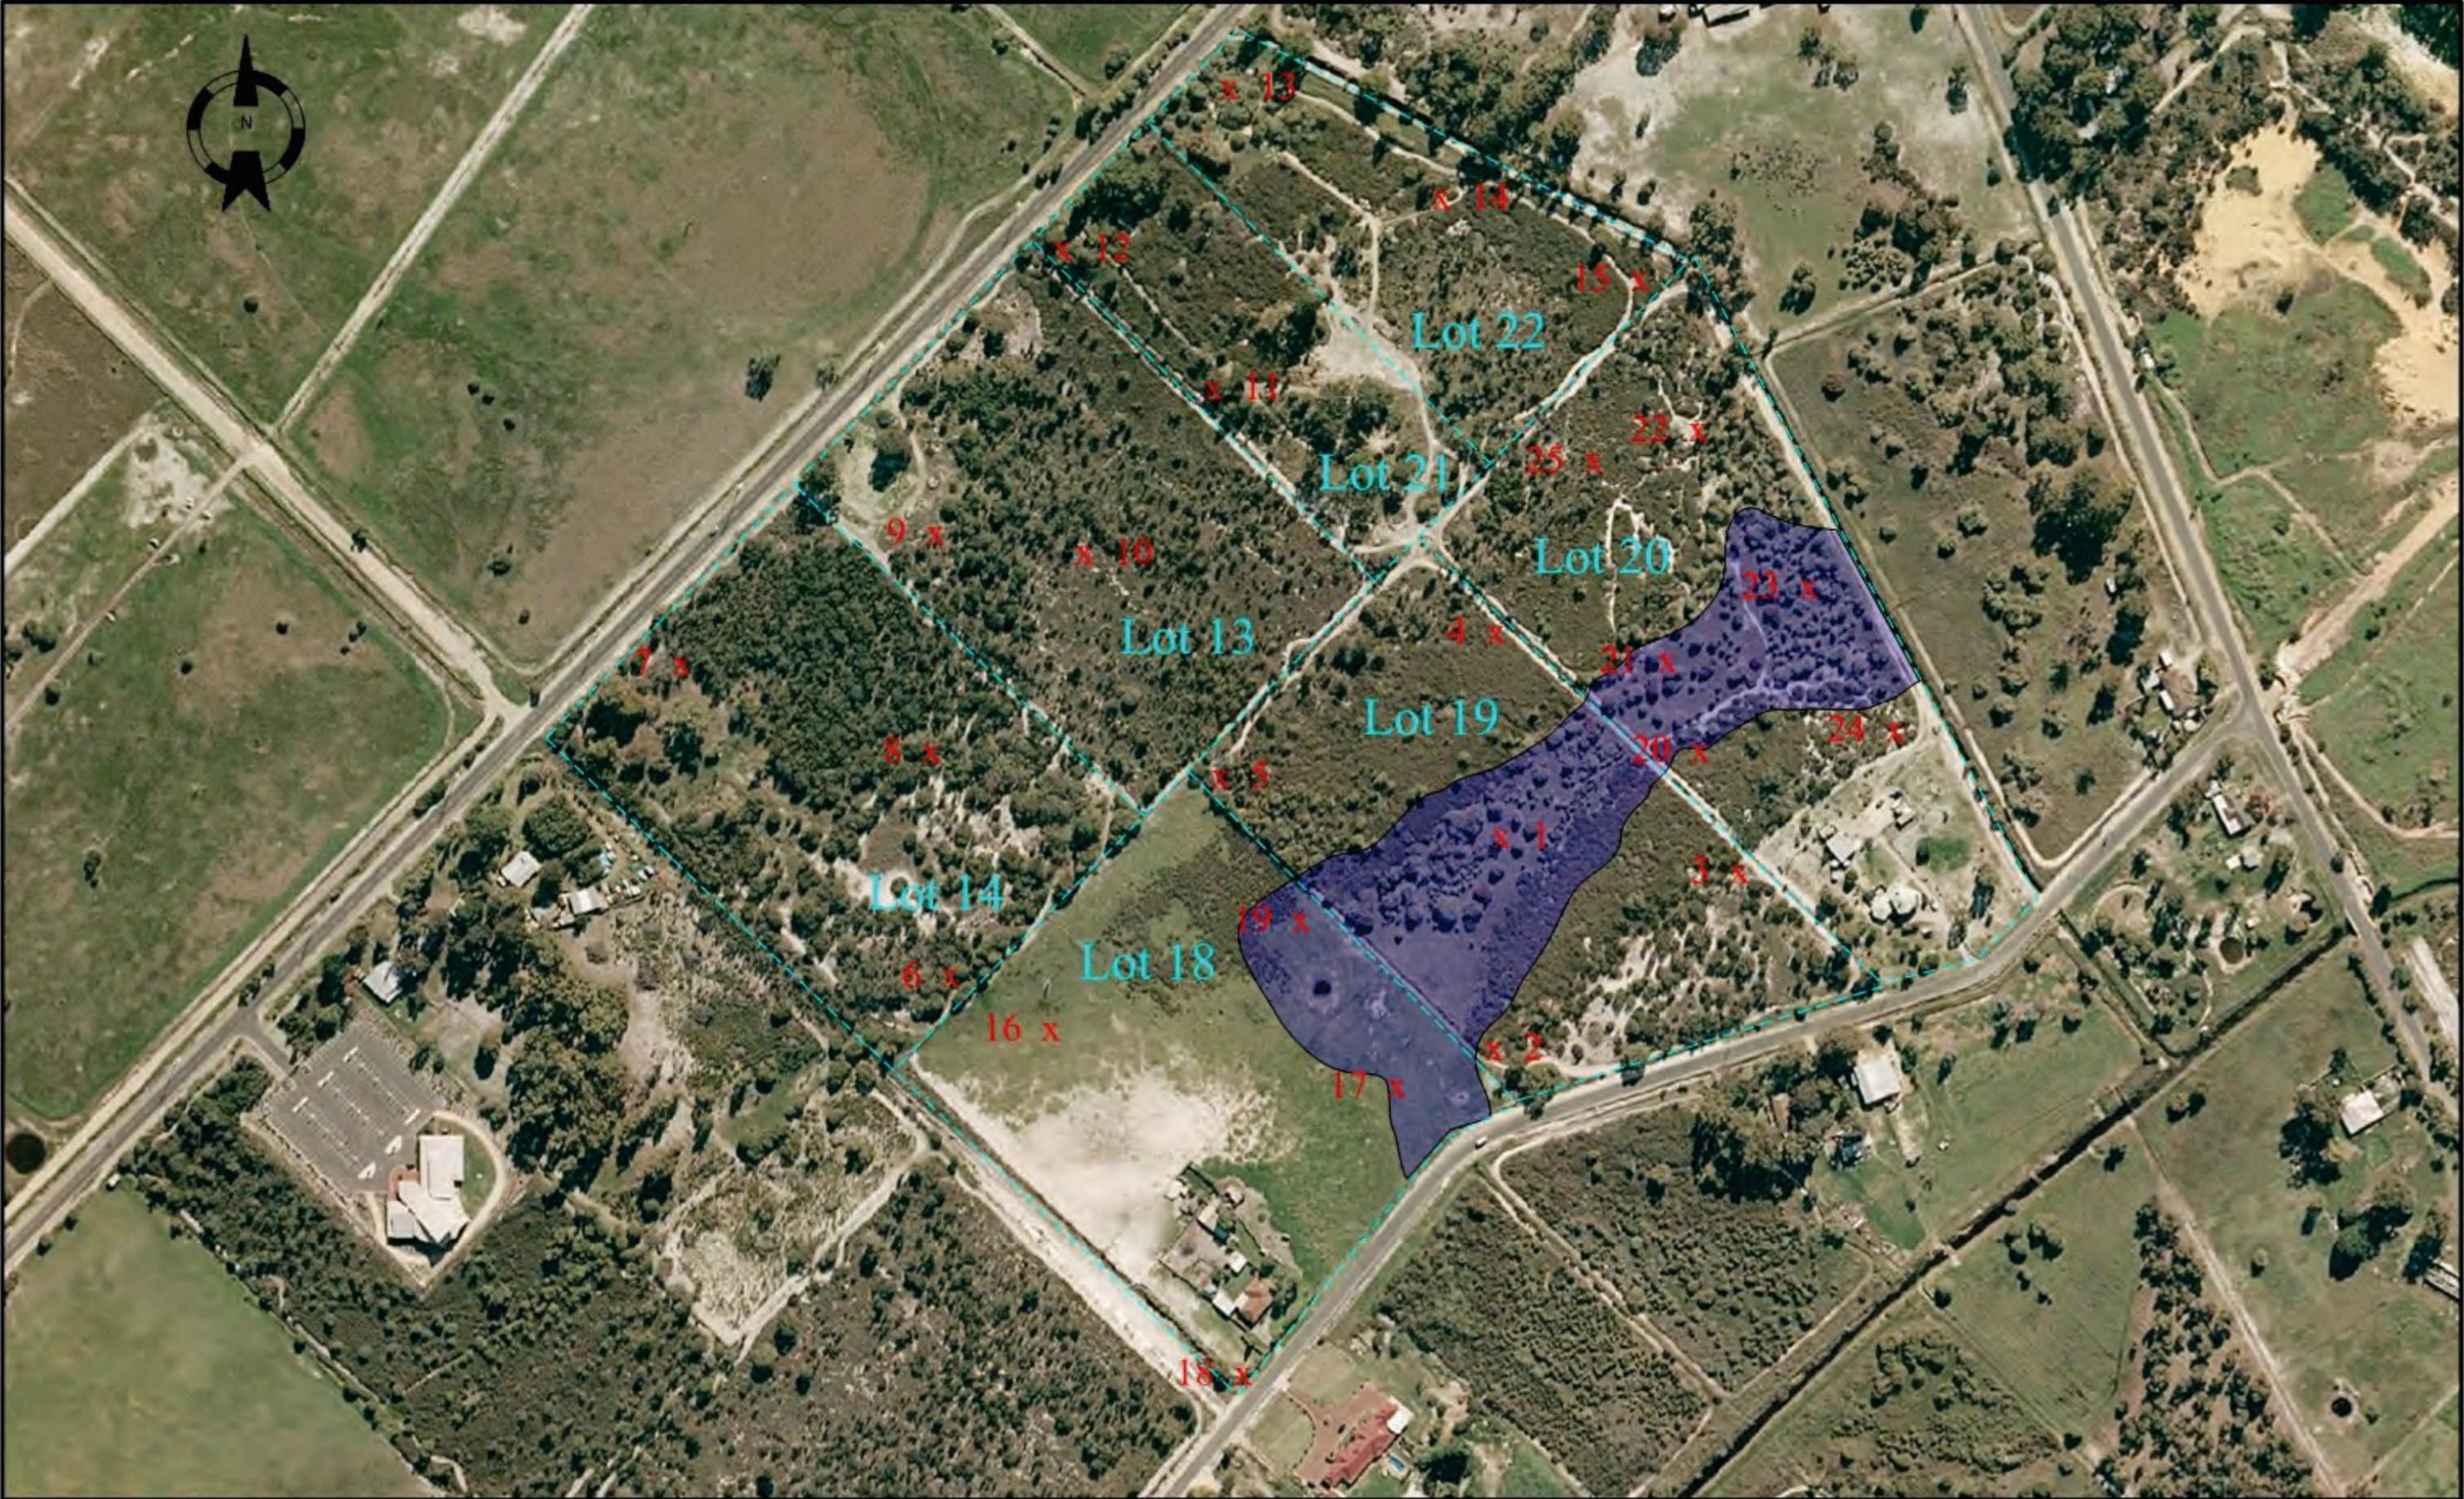
Figure 17 – Proposed Wetland Boundaries and Classification

Using the criteria of Bulletin 686, the wetland area defined previously, in our judgment should be a Multiple Use Wetland as the wetland functions, values and attributes have been seriously degraded such that they no longer serve any substantial ecological role.

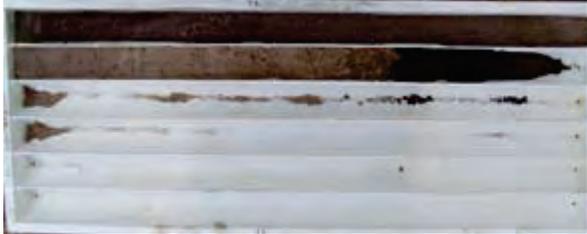
700	1500	422	0.16	0.00	Light brown, medium textured, Bassendean quarts sand over an impassable ferruginous induration "coffee rock".
DHW6

0	1000	328	-	-	Dark grey to grey, medium textured, Bassendean quarts sand, with organic material.
		1000	1600	424	-	-	Light brown to cream, medium to fine textured, Bassendean quarts sand.
		1600	1800	311	-	-	Brown, medium to fine textured, Bassendean quarts sand.
		1800	1900	306	-	-	Dark brown to black, medium to fine textured, Bassendean quarts sand over an impassable ferruginous induration "coffee rock".

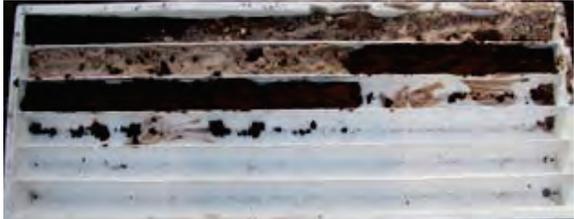
DHW22

0	250	497	-	-	Black to dark grey, medium textured, Bassendean quarts sand, with organic material.
		250	1600	512	-	-	Light grey to cream medium textured, Bassendean quarts sand
		1600	2600	507	-	-	Brown medium textured, Bassendean quarts sand
DHW23

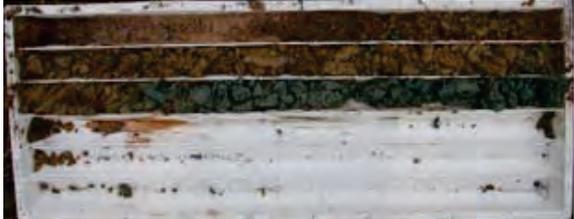
0	150	484	-	-	Black to dark grey, medium textured, Bassendean quarts sand, with organic material.
		150	500	478	-	-	Light grey to cream medium textured, Bassendean quarts sand
		500	950	316	-	-	Brown to cream medium textured, Bassendean quarts sand
		950	2200	274	-	-	Cream to orange fine textured Bassendean quarts sandy with ferruginous induration or "coffee rock" material
DHW24

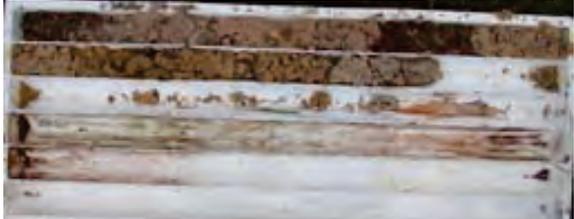
2200	3000	196	-	-	Grey to green fine textured Bassendean quarts sandy clay
		0	100	463	-	-	Black to dark grey, medium textured, Bassendean quarts sand, with organic material.
		100	600	421	-	-	Light grey to cream medium textured, Bassendean quarts sand
		600	800	381	-	-	Brown medium textured, Bassendean quarts sand

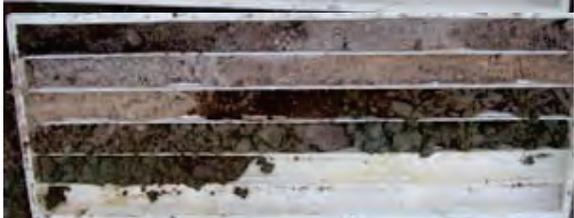
1000	1500	307	-	-	Cream to light brown fine textured Bassendean quarts sandy clay
		1500	1700	298	-	-	Cream fine textured Bassendean quarts sandy clay
		0	300	483	-	-	Black to dark grey, medium textured, Bassendean quarts sand, with organic material.
		300	1300	521	-	-	Light grey medium textured, Bassendean quarts sand
DHW25

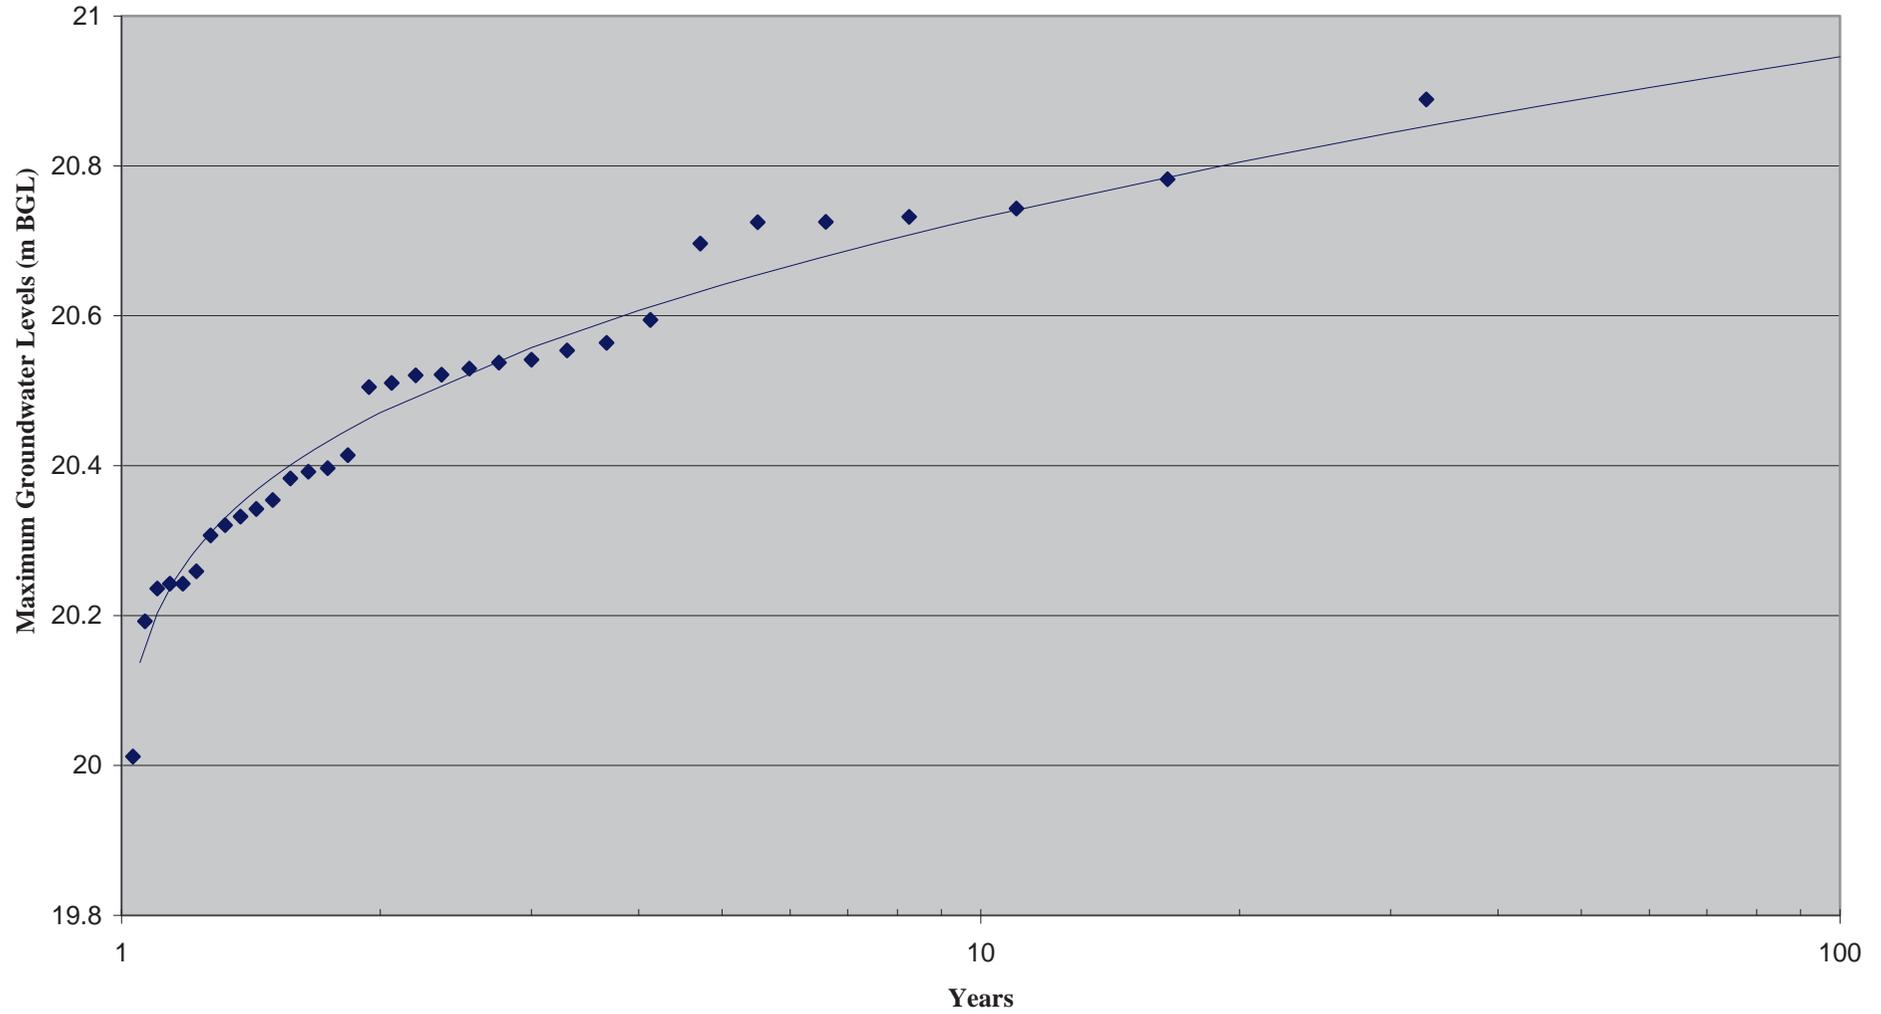
A semi-logarithmic plot of maximum groundwater levels in a well over time
