# **WETLAND MANAGEMENT PLAN**

**Lots 13, 14, 21 and 22 Southern River Road  
&  
Lots 18, 19 and 20 Matison Street  
Southern River**

**Precinct 3  
City of Gosnells**

**Dec 2011**

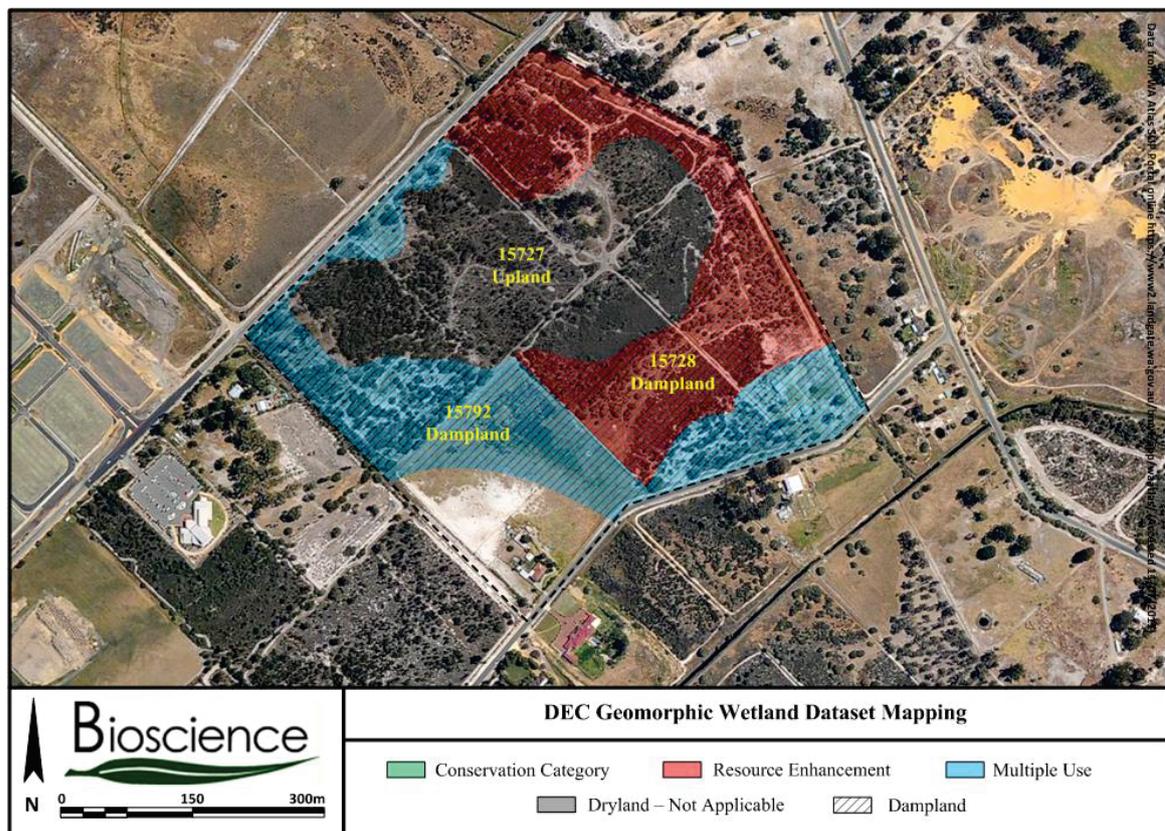
Figure 3: Geomorphic Wetland Dataset

The Geomorphic Wetlands Dataset displays the location, boundary, geomorphic classification and management category of wetlands on the Swan Coastal Plain. The information contained within the dataset was originally digitised from the *Wetlands of the Swan Coastal Plain Volume 2B Wetland Mapping, Classification and Evaluation: Wetland Atlas*, which was captured at a scale of 1:25,000 (Hill et al. 1996). According to the dataset two wetlands exist within the subject area, one Multiple Use Wetland (MUW) (15792) covering the perimeter along the north west, west and south eastern boundaries with a Resource Enhancement Wetland (REW) (15728) along the central south east and north eastern sides. An area in the center of the subject area is classified as a dryland (15727) and a small area in the southern corner not classified as a wetland (Figure 3).

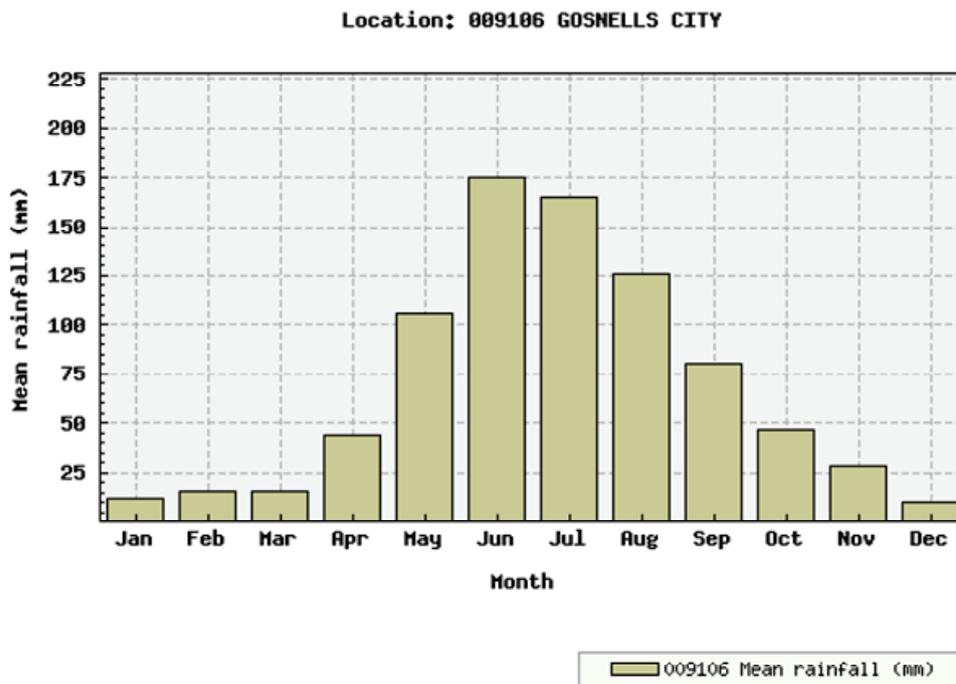
Figure 4: Average annual rainfall

The south west of Western Australia is characterised by a Mediterranean climate comprising hot dry summers and cool wet winters. According to the Bureau of Meteorology the average annual rainfall within the vicinity of the proposed development is 824.3 mm (Gosnells City No. 009106). The monthly distribution of rainfall indicates approximately 79% of the rainfall occurs during the months of May to September (Figure 4).

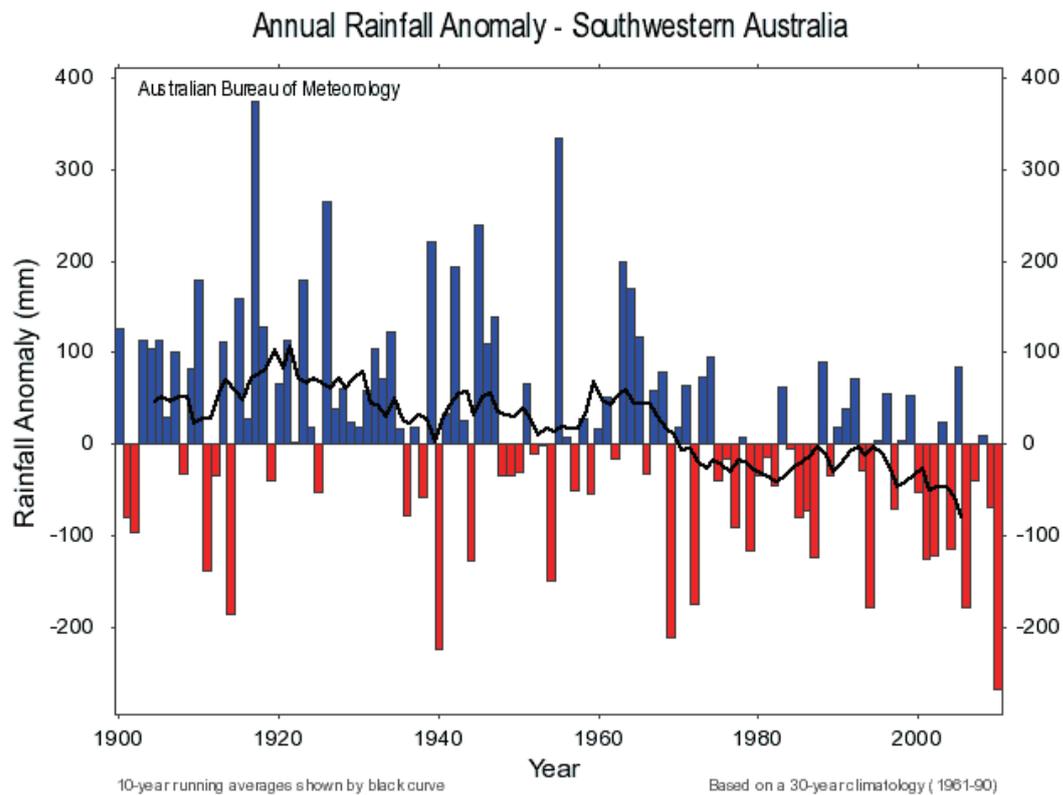
Figure 52: Annual rainfall anomaly for south-western Australia

Australia is one of the driest continents in the world and the affects of climate change are no more obvious than in south-western Australia. Time series charts such as figure 5 illustrate an excessive decrease in annual rainfall over the past 100 years. Decreasing rainfall and increasing temperatures over south-western Australia has had grim consequences for the Swan Coastal Plain's unique and diverse wetlands. These factors have left many wetlands dry due to decreased groundwater recharge and increased evaporation.

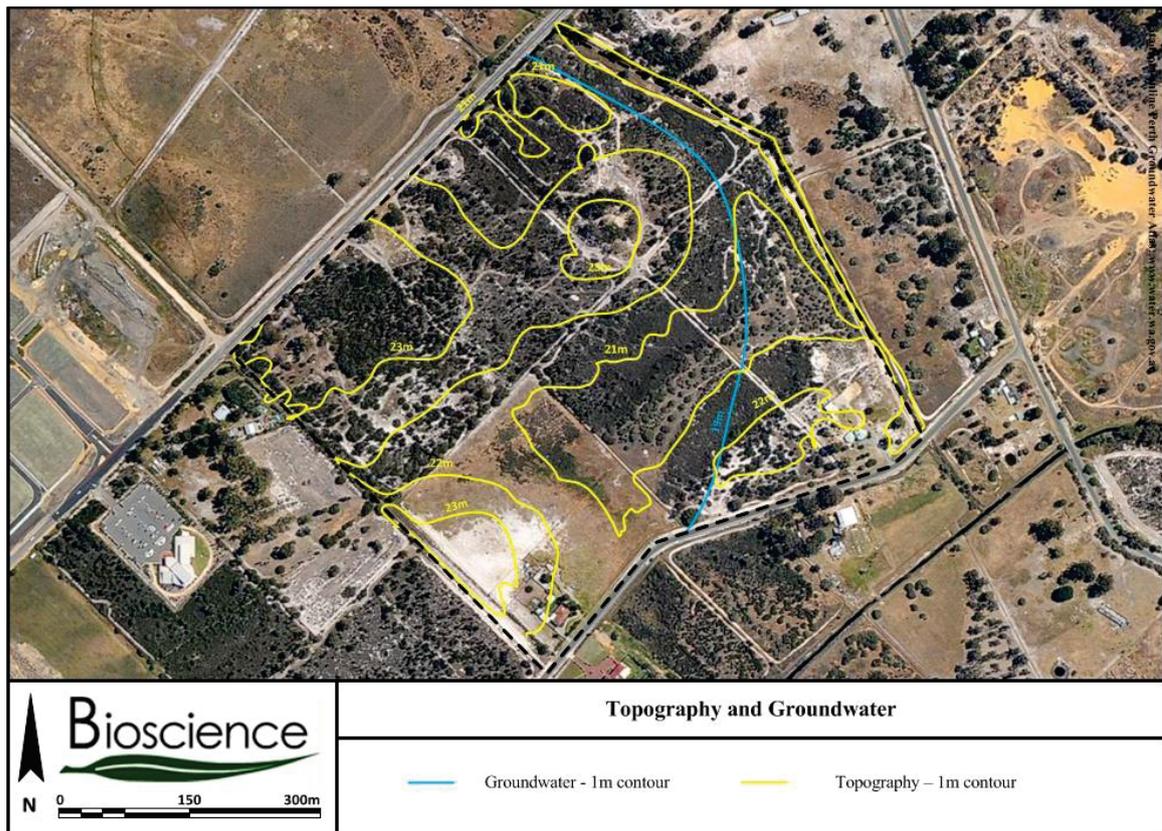
Figure 63: Topography and Groundwater

The subject area has low relief with some minor variations in topography. The area ranges from 21m AHD in the wetland areas to 23m AHD (Figure 6).

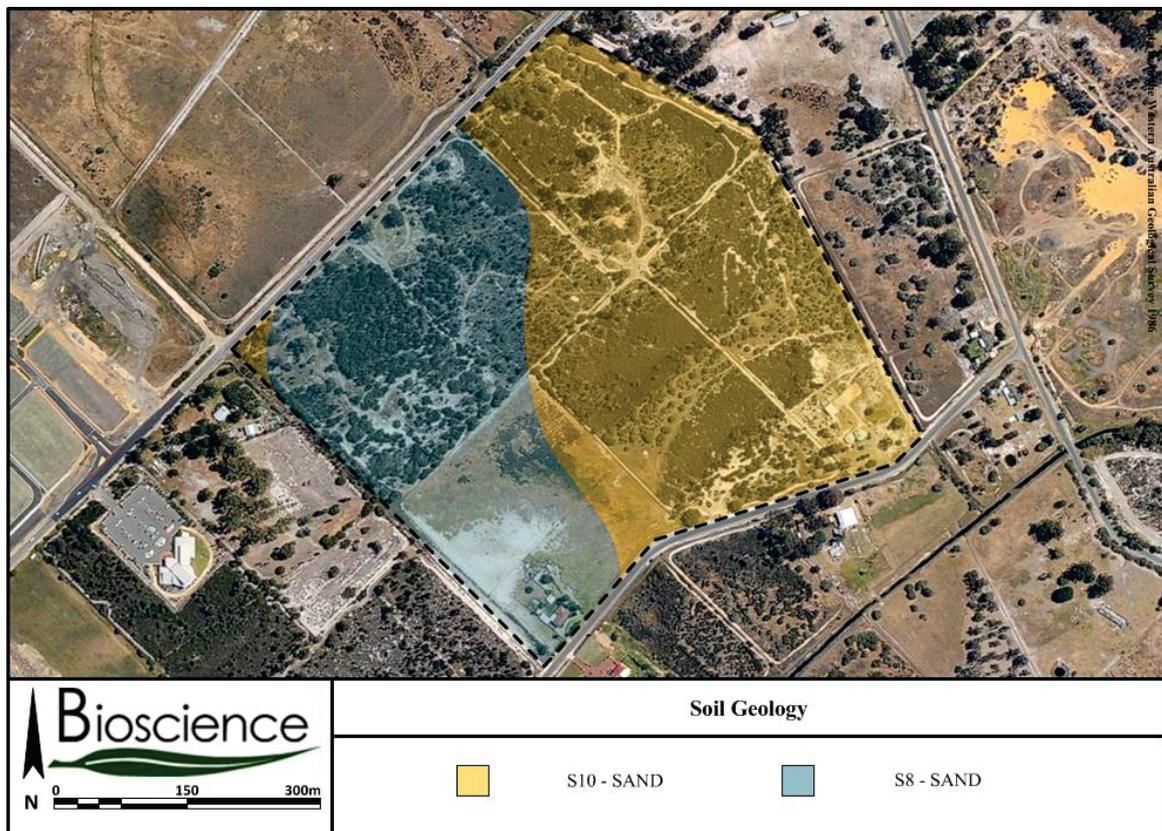
Figure 7: Soil geology

The geology at the site as per the Geological Survey of Western Australia 1:50000 Environmental Geological Series Armadale Map Sheets 2033 I and part of sheet 2033 IV are either (Figure 7):

S8 – SAND : White to pale grey at surface, yellow at depth, fine to medium grained, moderately sorted, subangular to subrounded, minor heavy minerals, or eolian origin

S10 – SAND: As S8 over sandy clay to clayey sand of the Guilford formation, of eolian origin

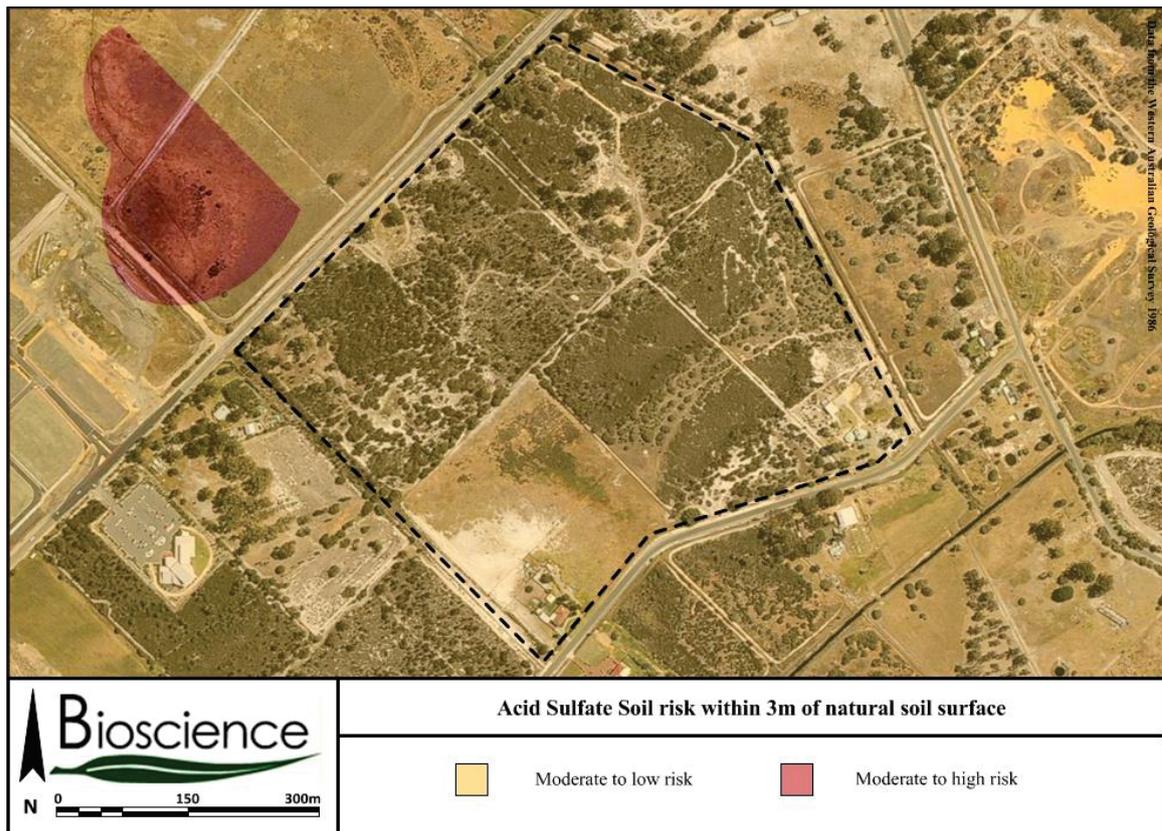
Figure 8: Acid Sulfate Soil risk map

DEC has compiled maps of ASS risk areas for several coastal regions of Western Australia. These maps are not an accurate representation of the risk areas but rather give a general indication and encourage site-specific investigations to determine management strategies. The land holds a moderate-low risk of acid sulfate soils within 3m of natural soil surface and a high-moderate risk beyond 3m (Figure 8).

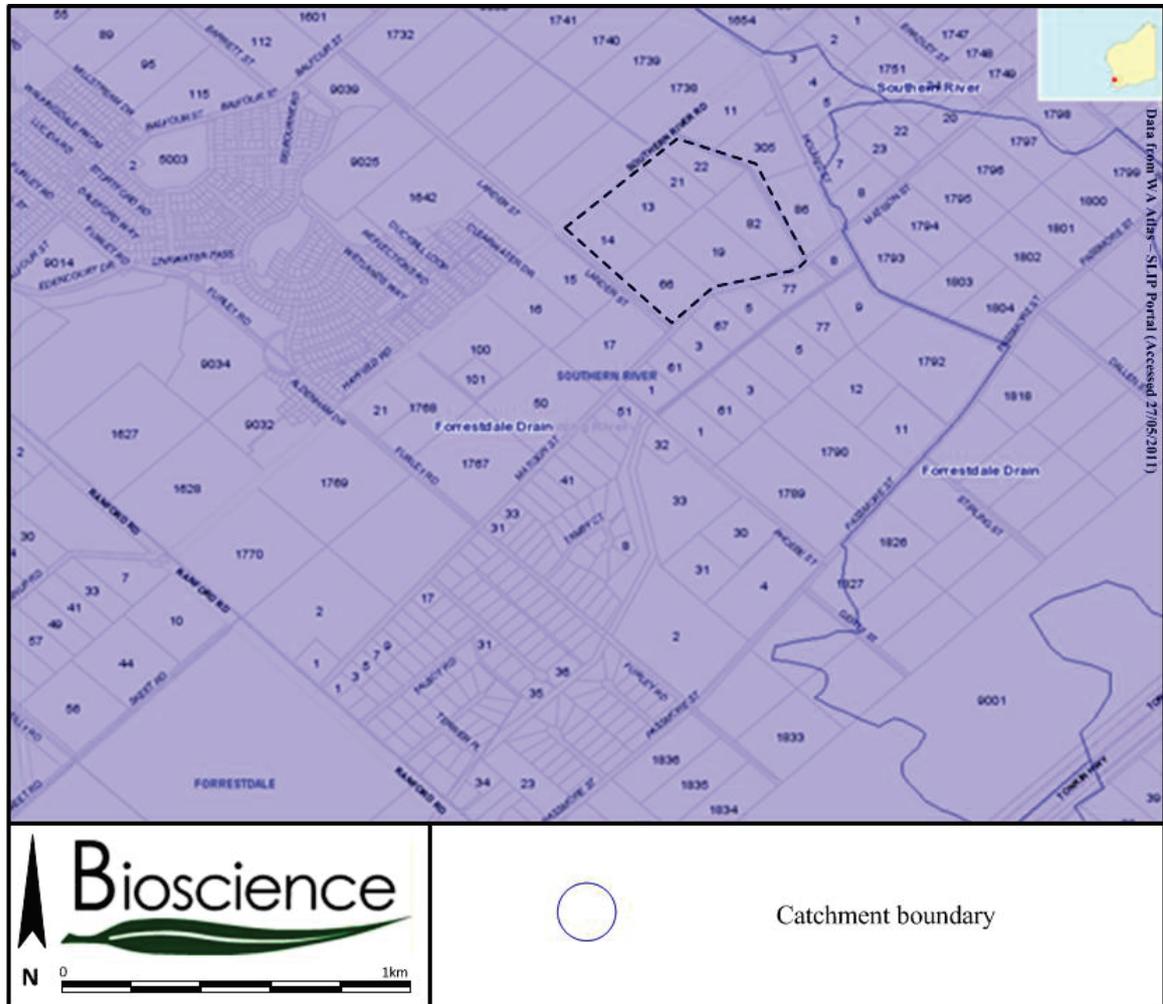
Figure 9: Catchments

The subject area is located in the north eastern part of the Forrestdale main drain subcatchment within the Swan-Avon - Canning River catchment in the South West Division. The Forrestdale main drain subcatchment covers an area of approximately 95

km<sup>2</sup> extending from Roe Highway to the north-west, Tonkin Highway to the east, around 3km south of Armadale road to the south, and past the Kwinana freeway to the west (Figure 9).

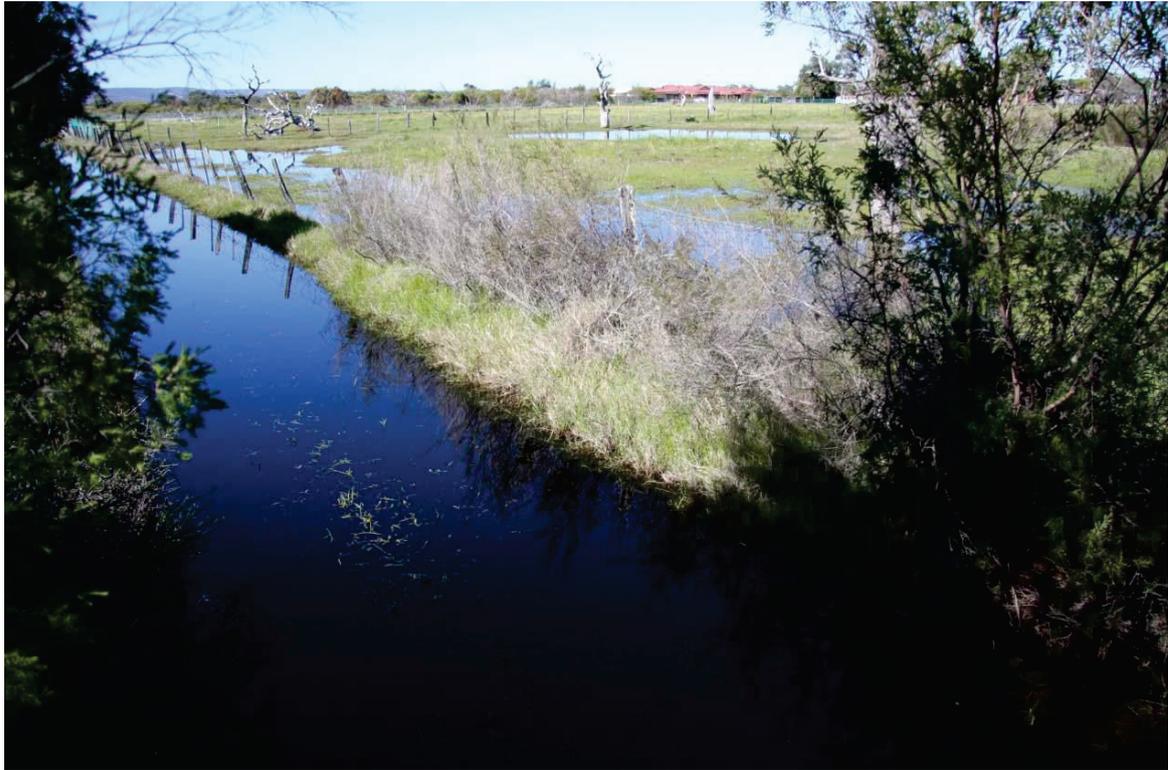
Image 1: Surface water on lots 18 and 19 (taken on the 4th September 2009).

Note: 2009 was a less than average rainfall year (745.8mm compared to 49 year average 824.1mm recorded at Gosnells City weather station)

AHD (DHW1 on the 12th June 2009). In relation to depth below ground level a maximum depth of 3.65m BGL (DHW 8 on the 12th June 2009) and a minimum of -0.04 m BGL or 0.04m above the natural ground level were recorded (DHW 19 on the 4th October 2009). (Image 1 and 2, Appendix 2).

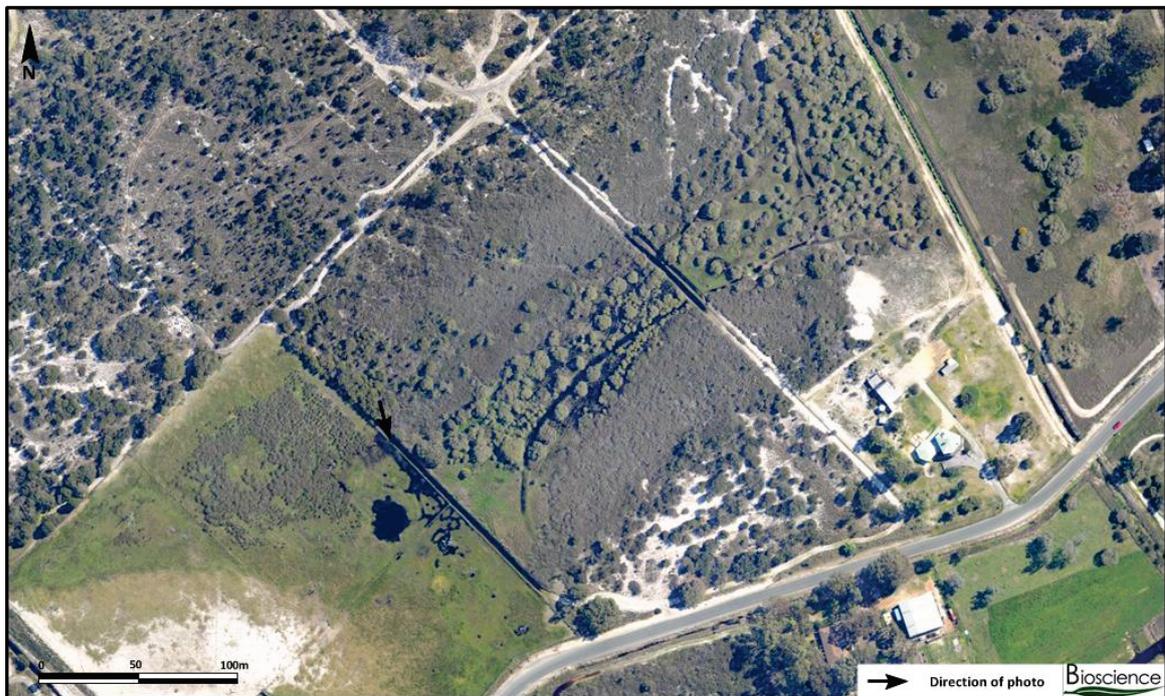
Image 2: Aerial photograph of wetland inundation (26 September 2009)
