Structure Plan – Maddington Kenwick Strategic Employment Area

Precinct 1

April 2019

This structure plan is prepared under the provisions of the City of Gosnells
Local Planning Scheme No. 6

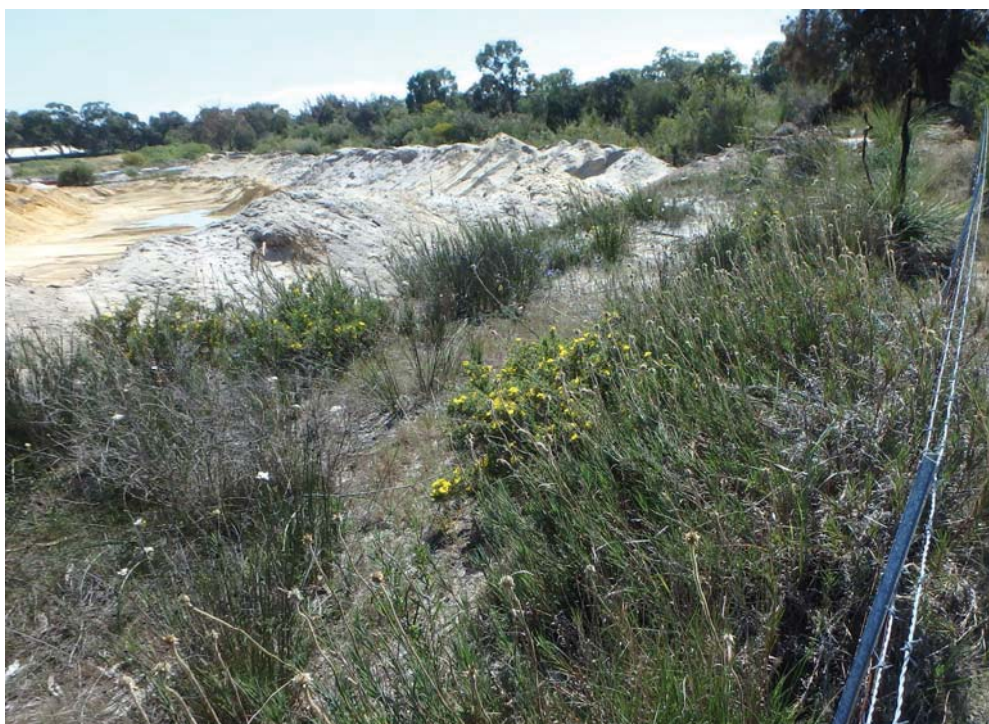
Plate 1: Plant community **AfDb** in 'good' condition

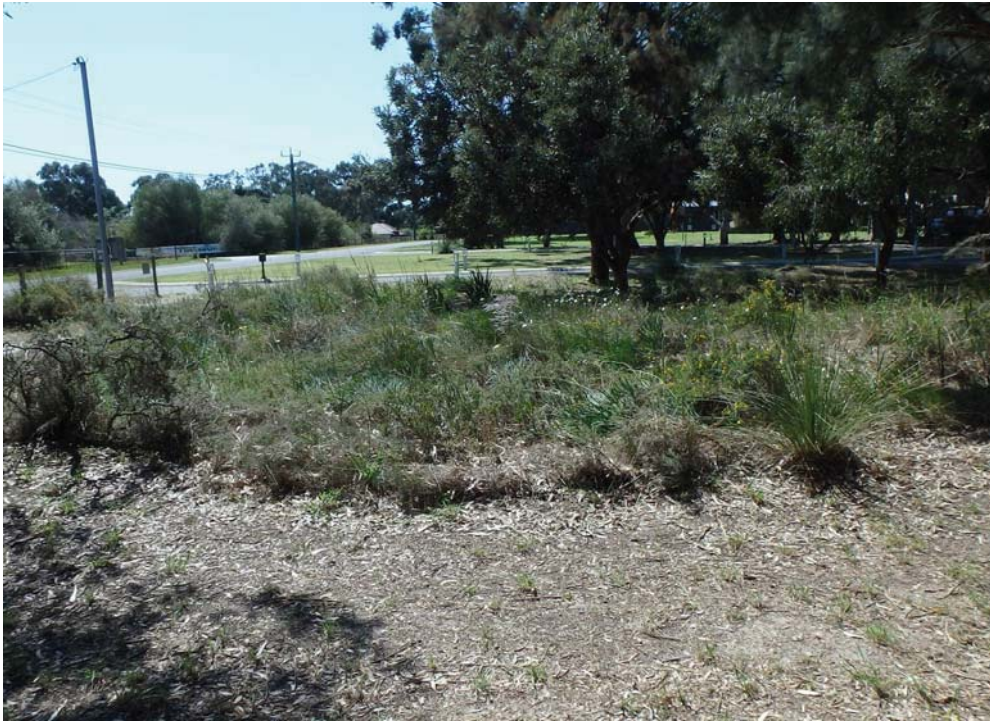
Plate 2: Plant community **AfSIDf** in 'very good' condition

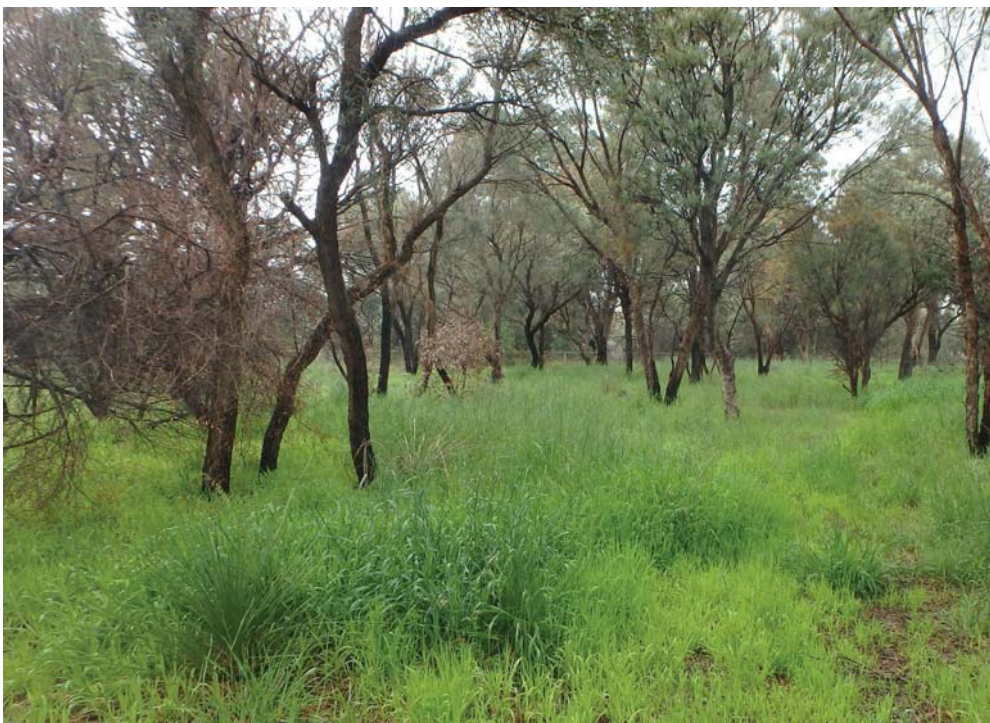
Plate 3: Plant community **BAf** in 'degraded' condition

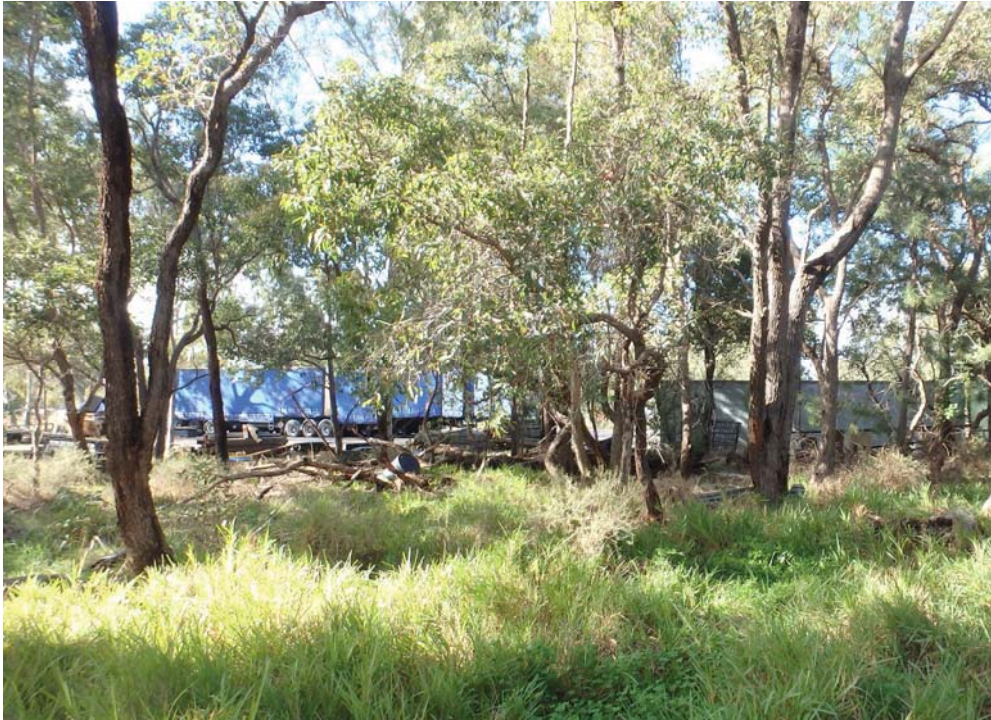
Plate 4: Plant community **CcHa** in 'degraded' condition

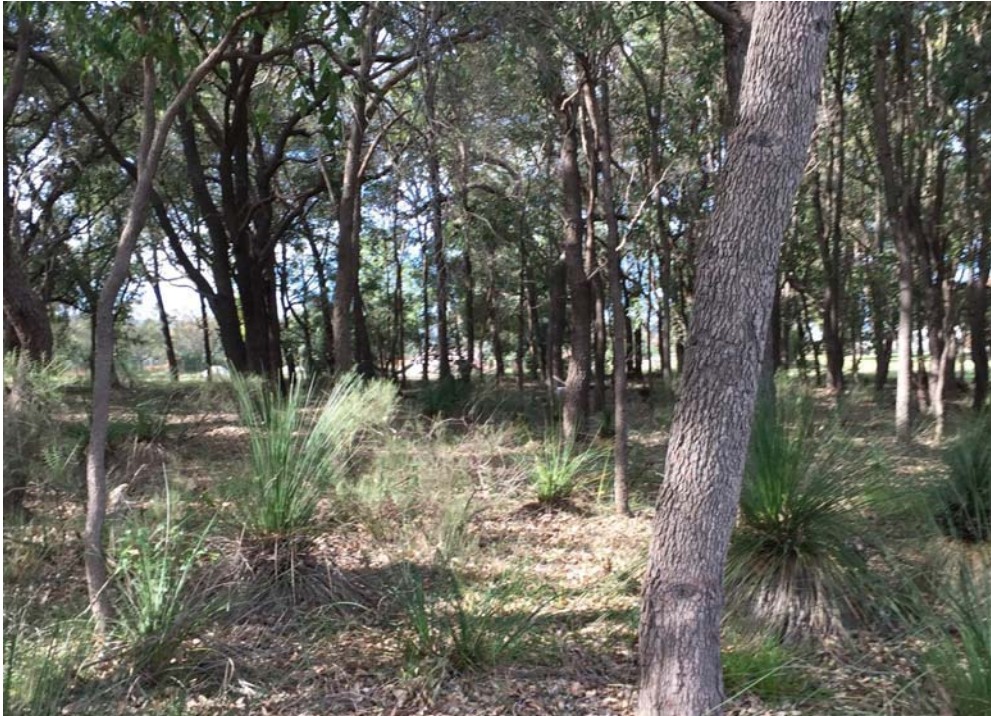
Plate 5: Plant community **CcXpMt** in 'very good' condition

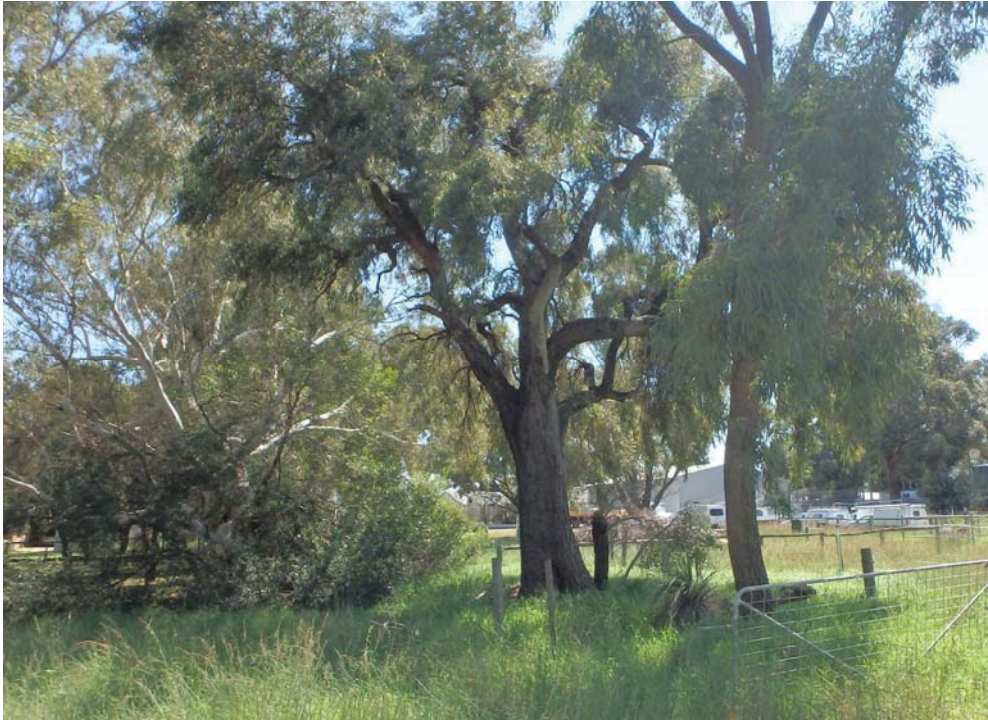
Plate 6: Plant community ***EEt** in 'degraded - completely degraded' condition

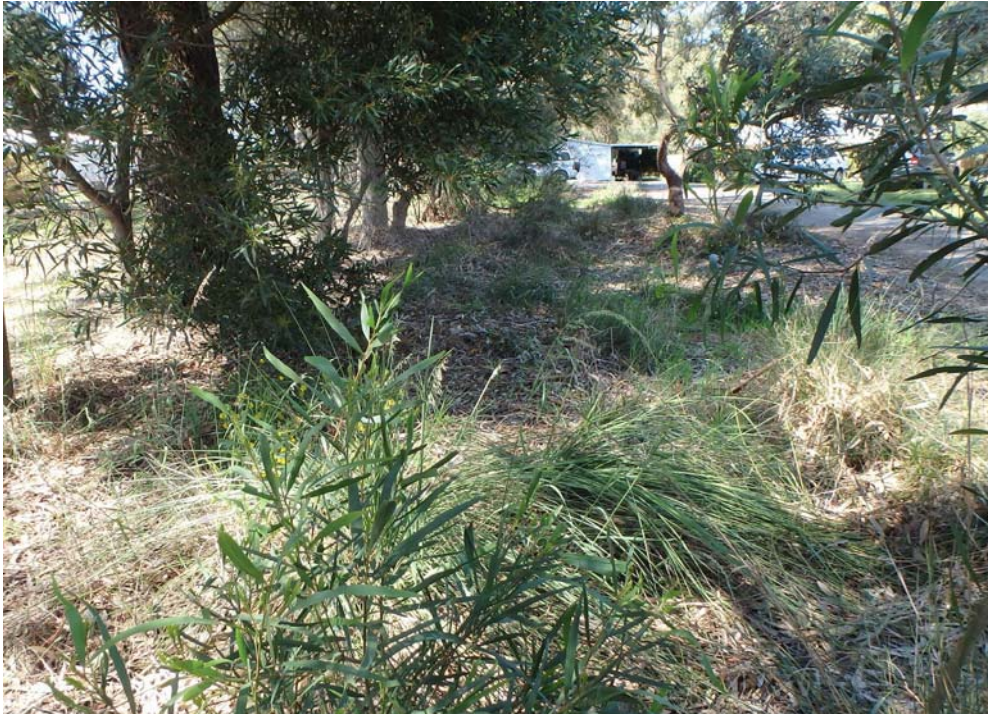
Plate 7: Plant community **EtBmSI** in 'good' condition

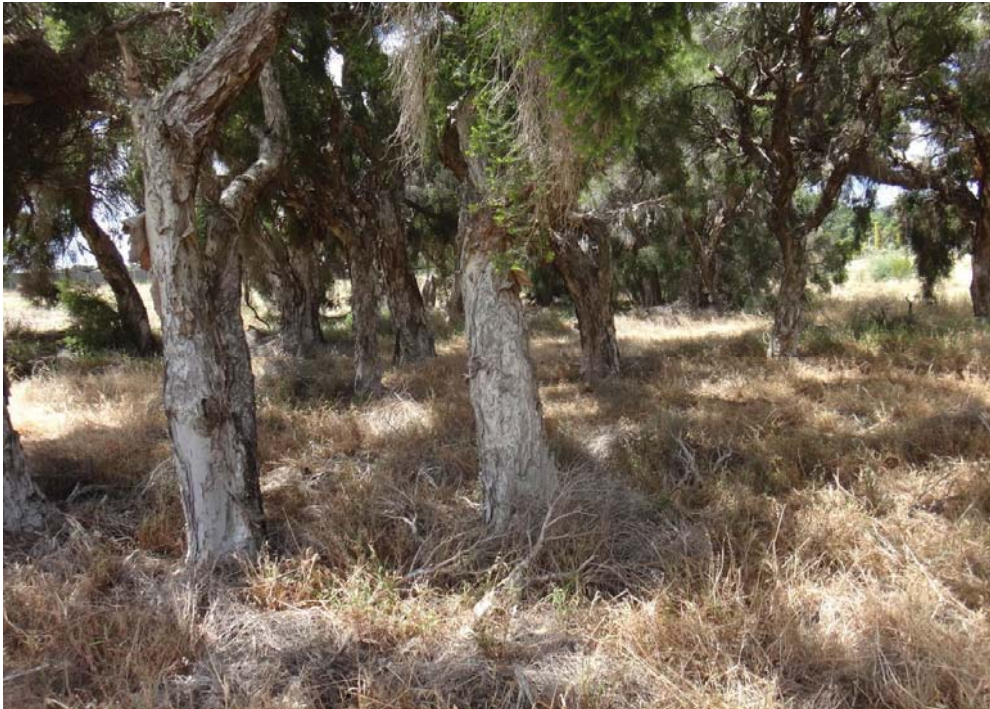
Plate 8: Plant community **Mp** in 'degraded' condition

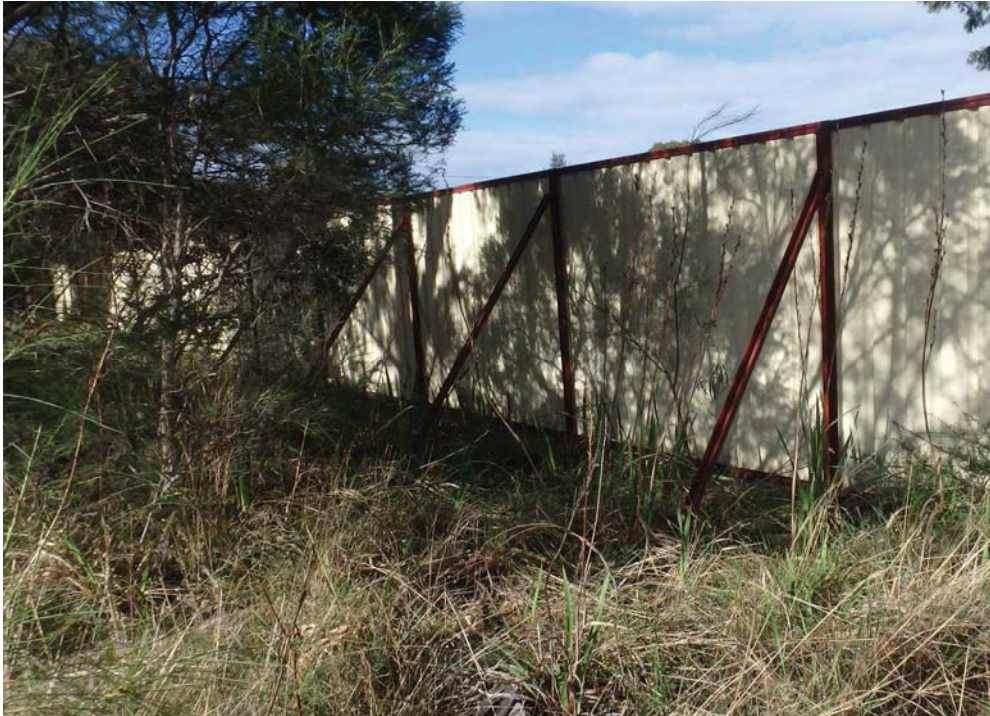
Plate 9: Plant community **MrVjLc** in 'degraded' condition

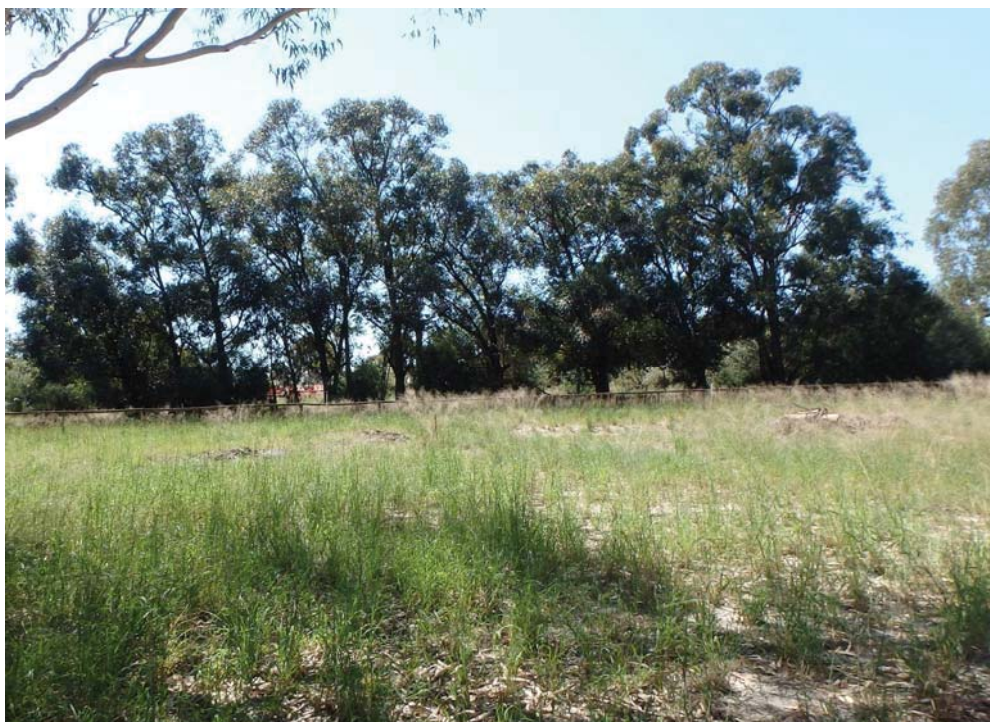
Plate 10: Non-native vegetation in 'completely degraded' condition

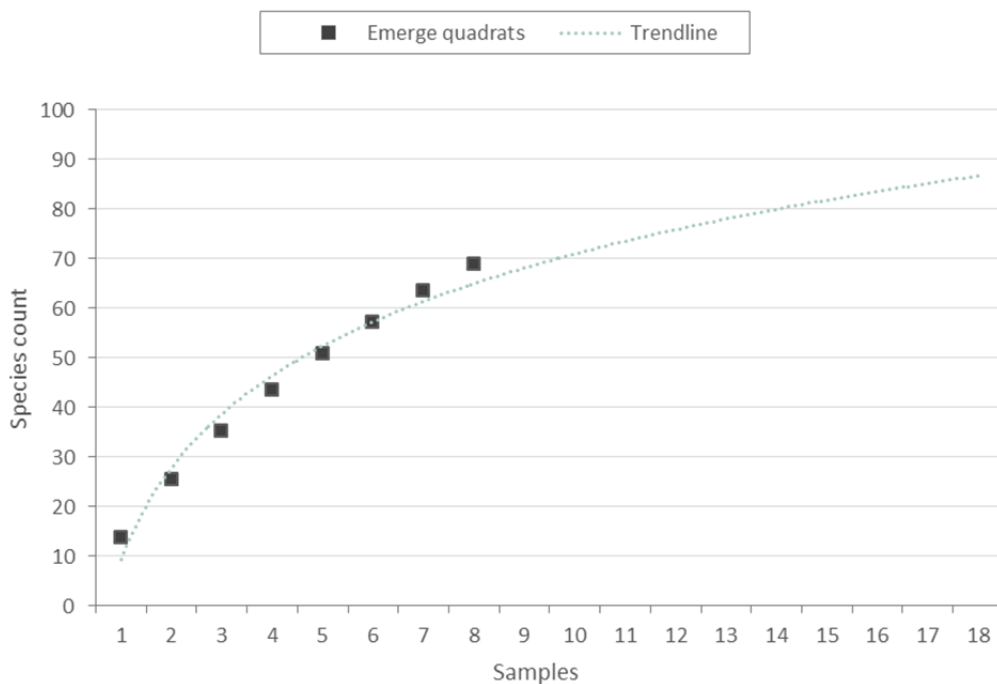
Species richness was estimated in Primer-6 to be 109 (Jackknife1). Based on the trend of the species accumulation curve approximately 20 to 30 samples would be required to capture that many species. Therefore, the 69 species recorded in the site indicates that approximately 63% of the estimated 109 species in the site were recorded. Given the small size and degraded condition of the majority of vegetation visited in the survey, and that non-native species which are included in the estimate were not a focus of the survey, 69 species is considered to be adequate to prepare a representative species inventory of native species within accessible lots.

Plate 11: Species accumulation curve derived from sample data ($y = 26.795\ln(x) + 9.3159$, $R^2 = 0.9734$)

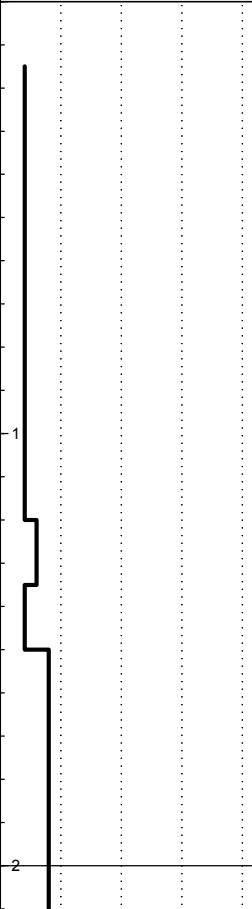
RL	Depth (m)	Description of Strata	Graphic Log	Sampling & In Situ Testing				Water	Dynamic Penetrometer Test (blows per 150mm)			
				Type	Depth	Sample	Results & Comments		5	10	15	20
22	0.05	<div>TOPSOIL - grey, fine to medium grained sandy topsoil with a trace of silt and rootlets, dry.</div> <div>SAND - medium dense, light grey, fine to medium grained sand with a trace of silt, dry.</div> <div>- becoming loose to medium dense from 0.7 m depth.</div> <div>- becoming medium dense from 1.8 m depth.</div>

20	2.0	Pit discontinued at 2.0m (collapse)										
19

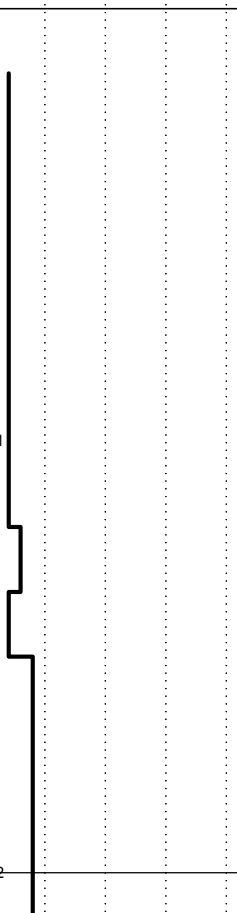
RL	Depth (m)	Description of Strata	Graphic Log	Sampling & In Situ Testing				Water	Dynamic Penetrometer Test (blows per 150mm)			
				Type	Depth	Sample	Results & Comments		5	10	15	20
22	0.05	<div>TOPSOIL - grey, fine to medium grained sandy topsoil with a trace of silt and rootlets, dry.</div> <div>SAND - medium dense, light grey, fine to medium grained sand with a trace of silt, dry.</div> <div>- becoming loose to medium dense from 0.7 m depth.</div> <div>- becoming medium dense from 1.8 m depth.</div>

20	2.0	Pit discontinued at 2.0m (collapse)										
19
