## City of Gosnells

# Access and Bushfire Management Plan Holmes Street Bushland North

D4 – 28 September 2016

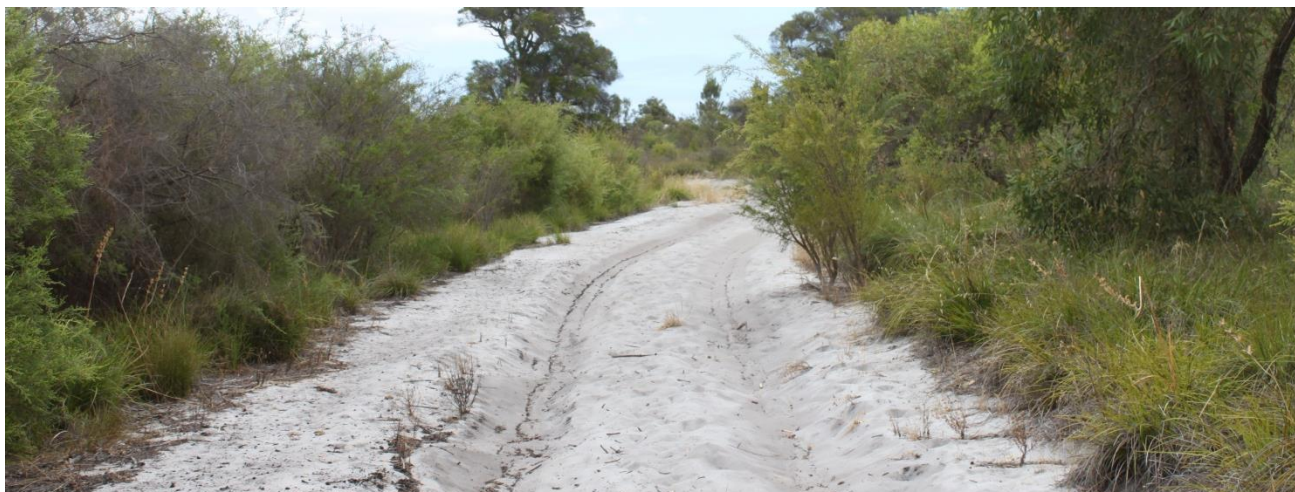
- to be made trafficable with material that provides a suitable, compact surface
- to be enhanced using material that minimises the potential for *Phytophthora* dieback movement such as compacted limestone, with further investigation by the City into the potential use of 'cracker dust' as an alternative material with potentially greater inhibition of *Phytophthora* dieback
- to be appropriately engineered and of suitable width and height to accommodate fire emergency vehicles
- to provide good field of view to users to enhance safety and safety perception.

All redundant FATs and walk tracks should be decommissioned and revegetated. The placement of logs on these tracks will assist in deterring access and guiding user access to upgraded SFATs

**Figure 6:** Sandy track

| Recommendation | |
|---|---|
| <b>RW 18</b> | The decommissioning of FATs and other informal walk tracks will include the placing of logs at the ends of tracks to deter vehicle and pedestrian access, prior to rehabilitation. |

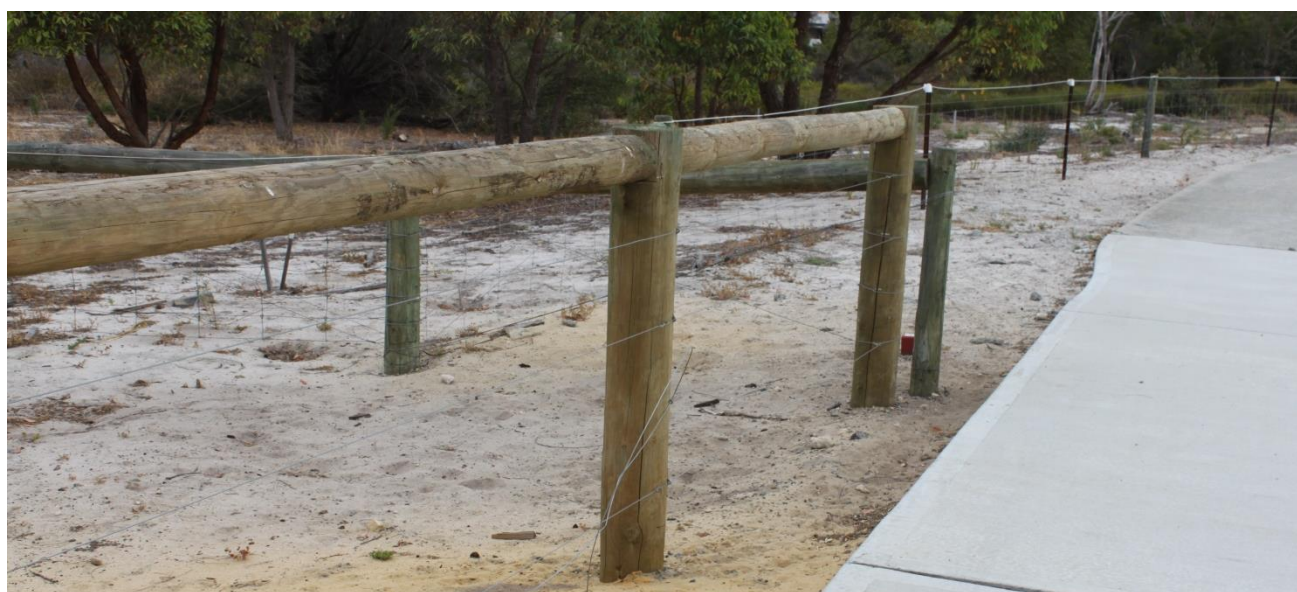
**Figure 8:** Post and rail fence

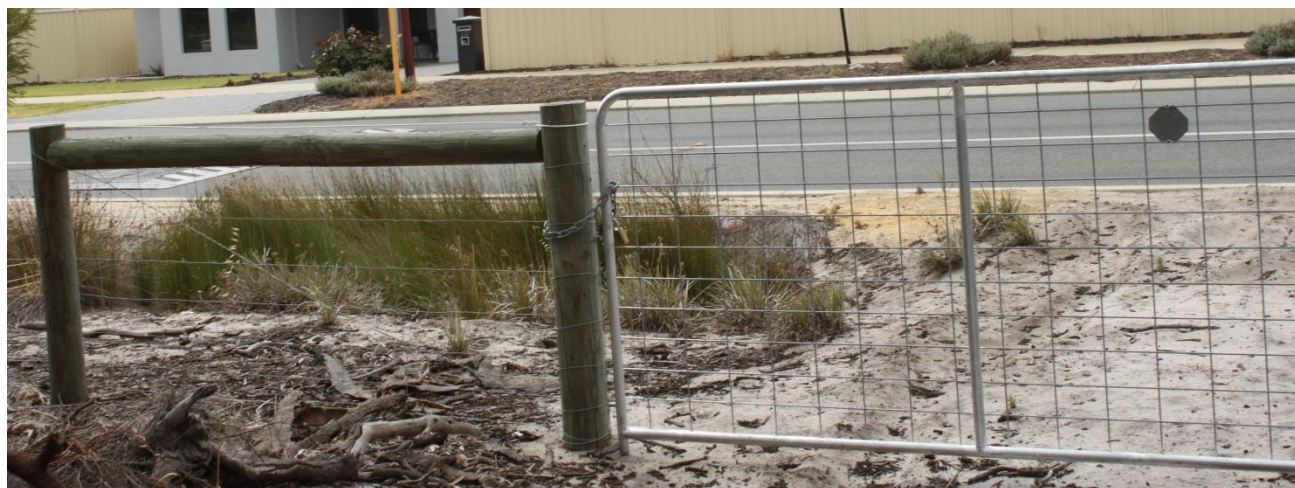
**Figure 12:** Locked gate – note no crossover in place

Additionally, appropriate crossovers will need to be constructed at gate locations around the site perimeter that are sandy, with mountable kerbs replacing any non-mountable kerbs. Crossovers can be constructed from limestone, concrete. Costings are included in Section 8.0.

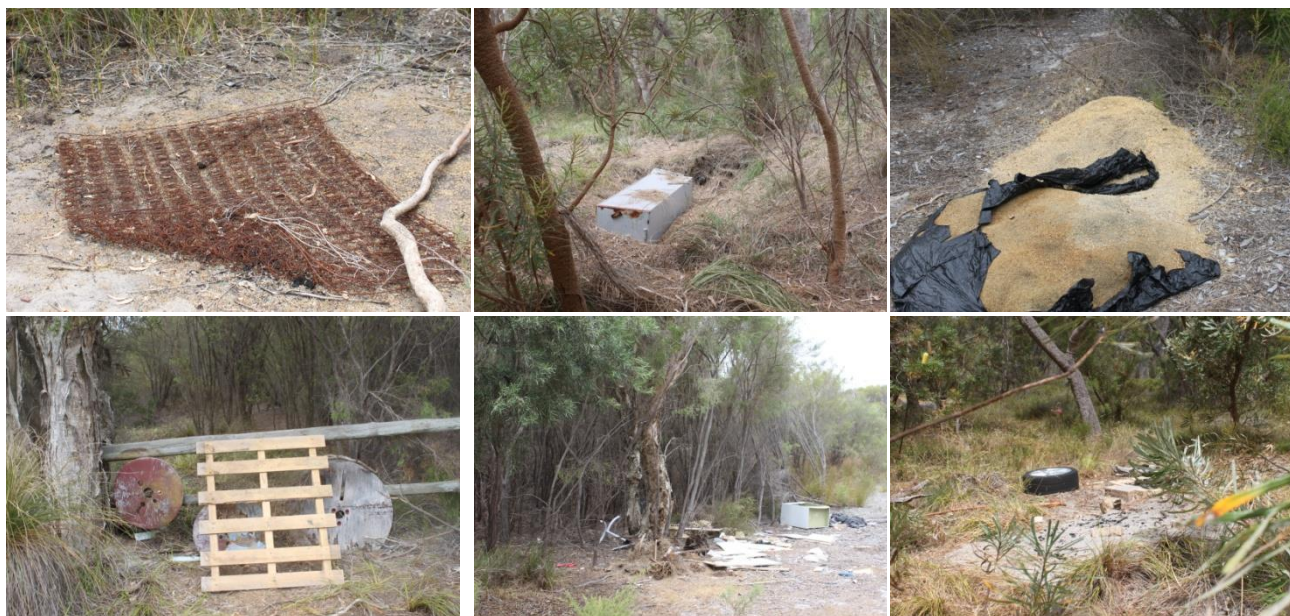
Rubbish dumping was the most common disturbance activity noted during the site assessment, with green waste and household rubbish of varying descriptions found in all areas (Figure 15). Rubbish dumping was worse in areas near residential housing particularly where access was easier due damaged fencing, unfenced areas or unlocked vehicle gates, reinforcing the requirement standardised fencing and maintenance.

**Figure 15:** Illegal rubbish dumping observed in HSBN

Rubbish and other dumped materials identified around the HSBN perimeter should be removed immediately prior to the installation of fencing. Other areas of identified dumping should be programmed to be cleaned up following the upgrading of vehicular access to the bushland. It is recommended that the City of Gosnells promptly remove rubbish noted during site inspection activities, and program where necessary follow-up remedial activities such as weed management and revegetation.

| Recommendations | |
|---|---|
| <b>AB 17</b> | The City of Gosnells should promptly remove rubbish noted during site inspection activities, and where necessary program follow-up remedial activities such as weed management and revegetation. |

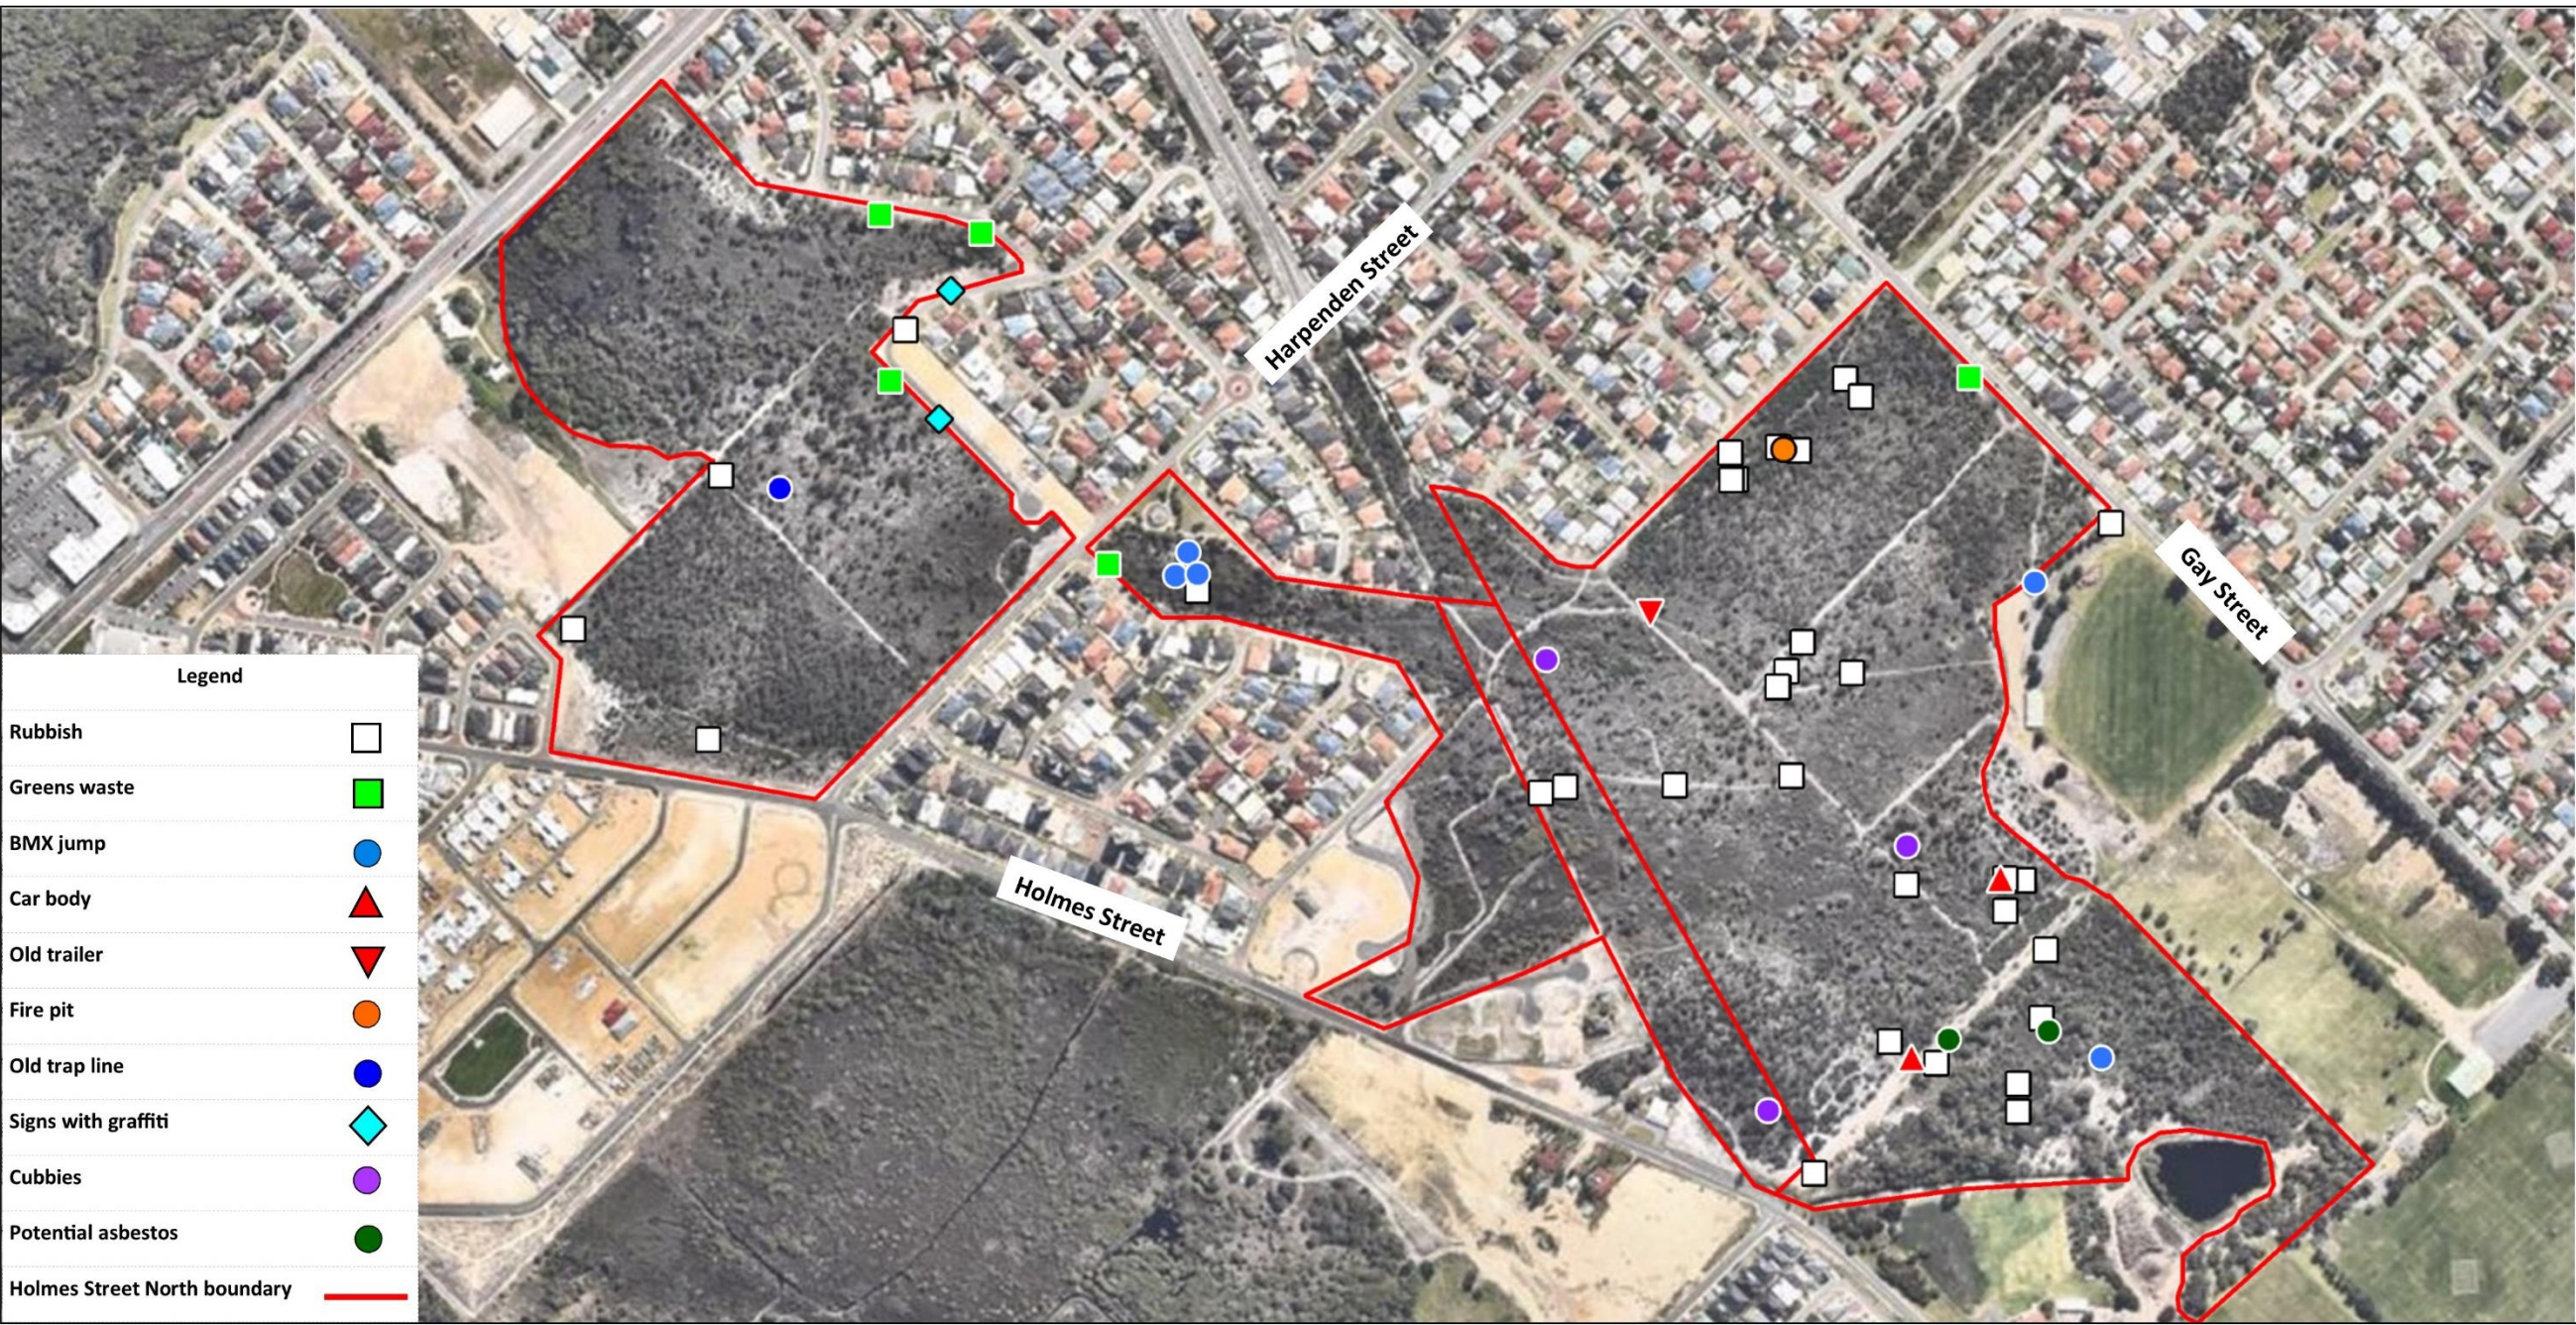
The creation of BMX jumps is a common disturbance in bushland areas. If left unattended, these disturbances grow in size, damaging vegetation and providing an ideal situation for weeds to take hold. It is recommended that the City address, as a matter of priority, BMX activity in the HSBN as soon as it becomes aware of it. This will help to avoid the problems associated with larger developments and assist to gradually get the message across that this type of activity is not tolerated in the HSBN.

**Figure 16:**  
**Disturbances**  
**Holmes Street Bushland North**

| Recommendation | |
|---|---|
| <b>AB 18</b> | As a matter of priority, the City should remove BMX jumps and other such developments in the HSBN as soon as practical after it becomes aware of the activity. |

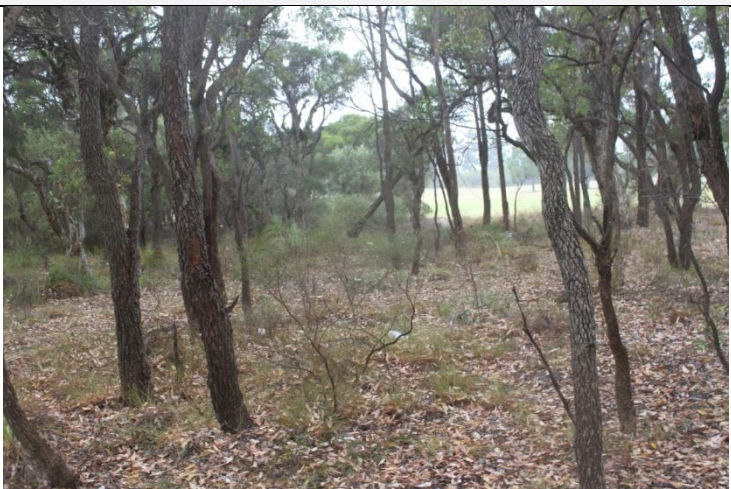
| Vegetation Classification | Description | Photograph |
|---|---|---|
| B5 Woodland | Trees 10-30 m high; 10- 30% foliage cover dominated by eucalyptus; understory low trees to tall shrubs typically dominated by Acacia, Callitris or Casuarina | |

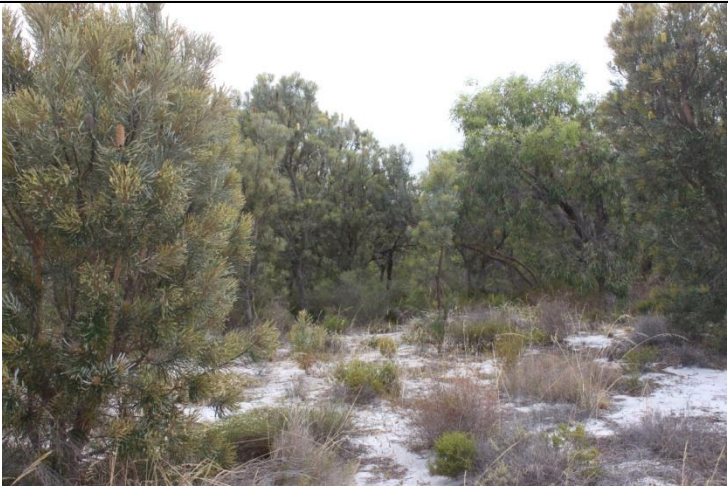
| <b>Vegetation Classification</b> | <b>Description</b> | <b>Photograph</b> |
|---|---|---|
| B7 Low Woodland | Low trees and shrubs 2 – 10 m high; foliage cover less than 10%; dominated by eucalypts and acacias. Often has a grass understory or low shrubs. Acacia and Casuarina woodlands grade to Atriplex shrublands in the arid and semi - arid zones. | |

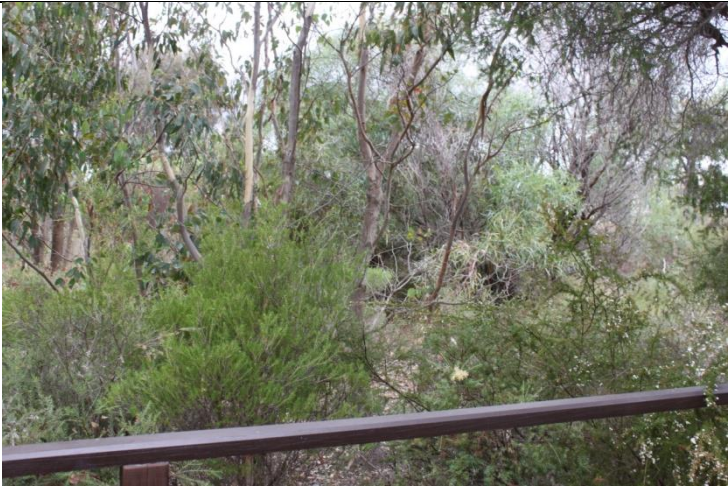
| <b>Vegetation Classification</b> | <b>Description</b> | <b>Photograph</b> |
|---|---|---|
| D13 Closed Scrub | Found in wet areas and/or areas affected by poor soil fertility or shallow soils; > 30% foliage cover. Shrubs > 2 m high, typical of coastal wetlands and tall heaths. | |

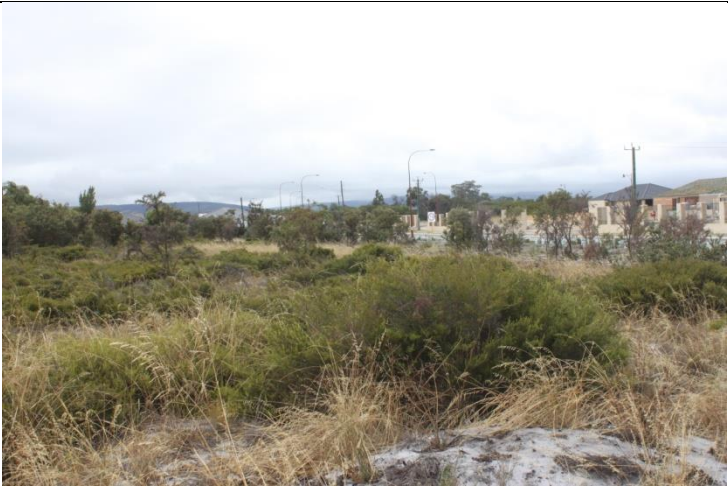
| <b>Vegetation Classification</b> | <b>Description</b> | <b>Photograph</b> |
|---|---|---|
| D14 Open Scrub | Shrubs > 2 m; 10 – 30% foliage cover with a mixed species composition. | |

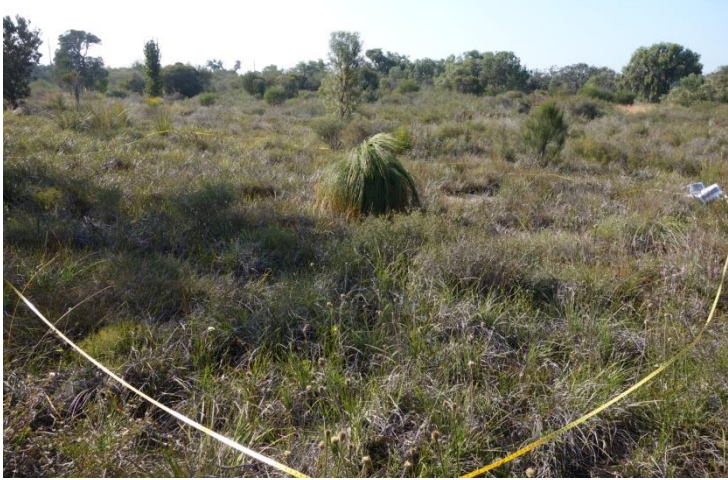
| Vegetation Classification | Description | Photograph |
|---|---|---|
| G21 Closed Tussock Grassland | All forms, including situations with shrubs and trees if the over storey foliage cover is < 10% | |

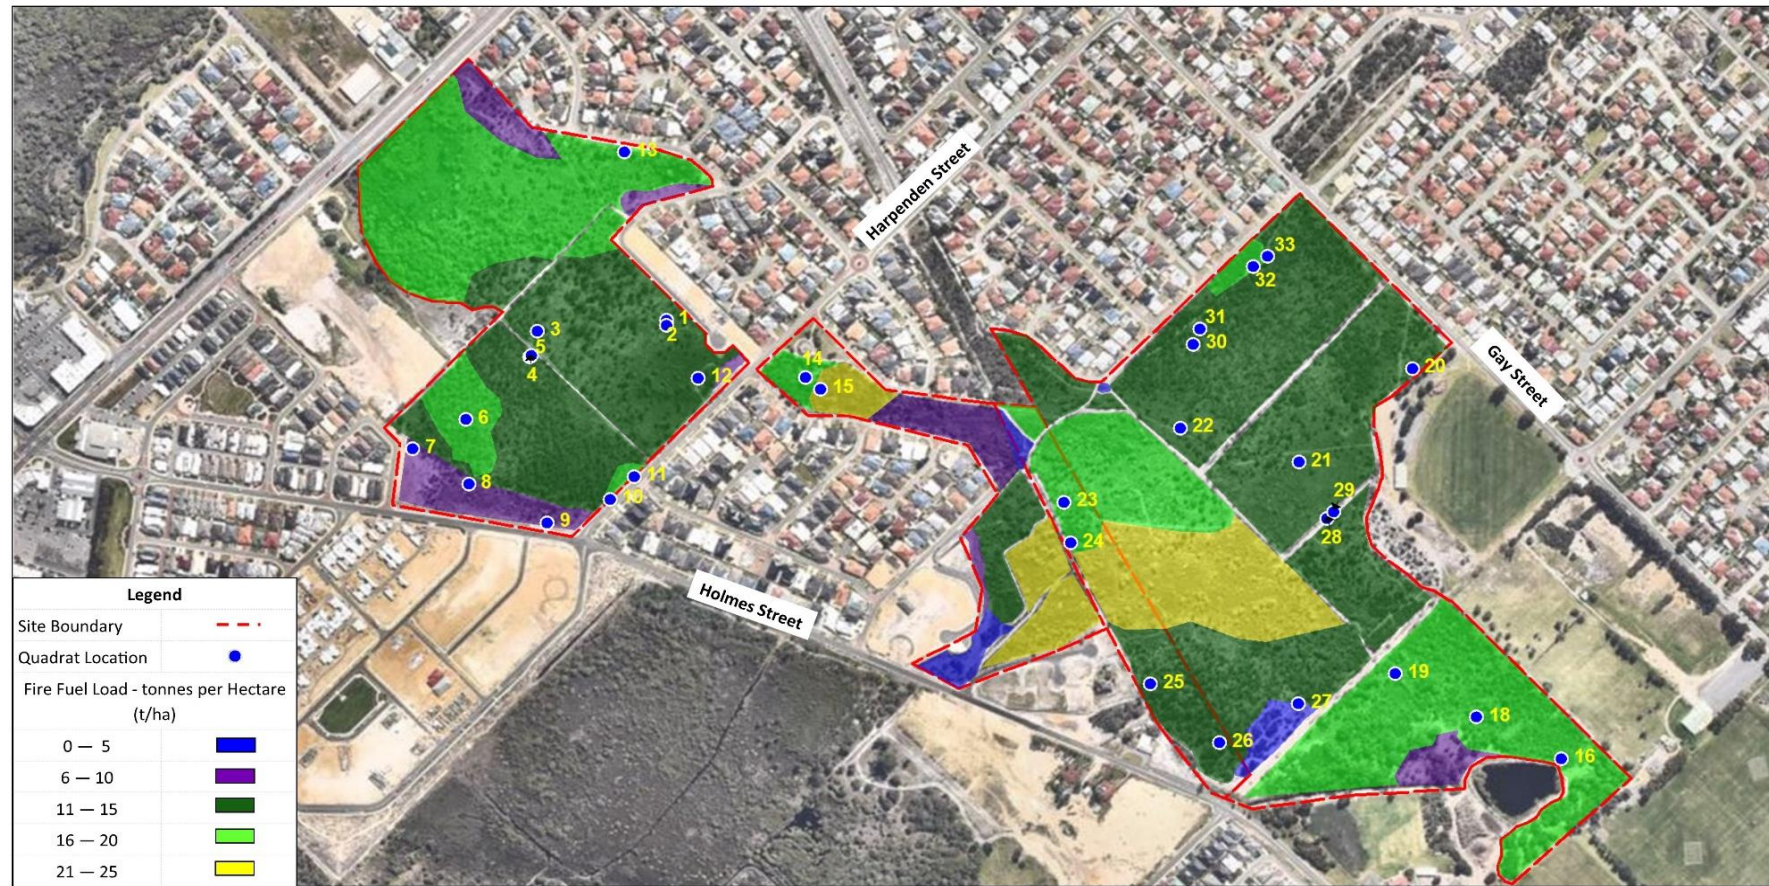
Lower fire-fuel loads were recorded in locations with areas of managed parkland (0 – 5 tonnes per hectare) and higher fuel loads observed in areas with deeper areas of leaf litter, dead twigs and branches (up to 25 tonnes per hectare), with the average across the site 12.8 tonnes per hectare. Figure 19 shows quadrat locations and fire fuel loads, and photographs of each quadrat are provided in Appendix 2.

**Figure 19:**  
**Fire fuel Load—Tonnes per Hectare (t/ha)**  
**Holmes Street Bushland North**

An understanding of bushfire fuel loads is key to both fire management and fire suppression. Assessments of fuel loads and bushfire hazard are provided in Figures 18 and 19 respectively. This is a snapshot of a dynamic situation which requires periodic updating. It is recommended that the City maintain the currency of fuel load mapping, in particular, by updating baseline mapping to capture fuel reduction arising from unplanned bushfire or planned fuel reduction burns. It is also recommended that fuel load is reassessed and mapped on a regular basis.

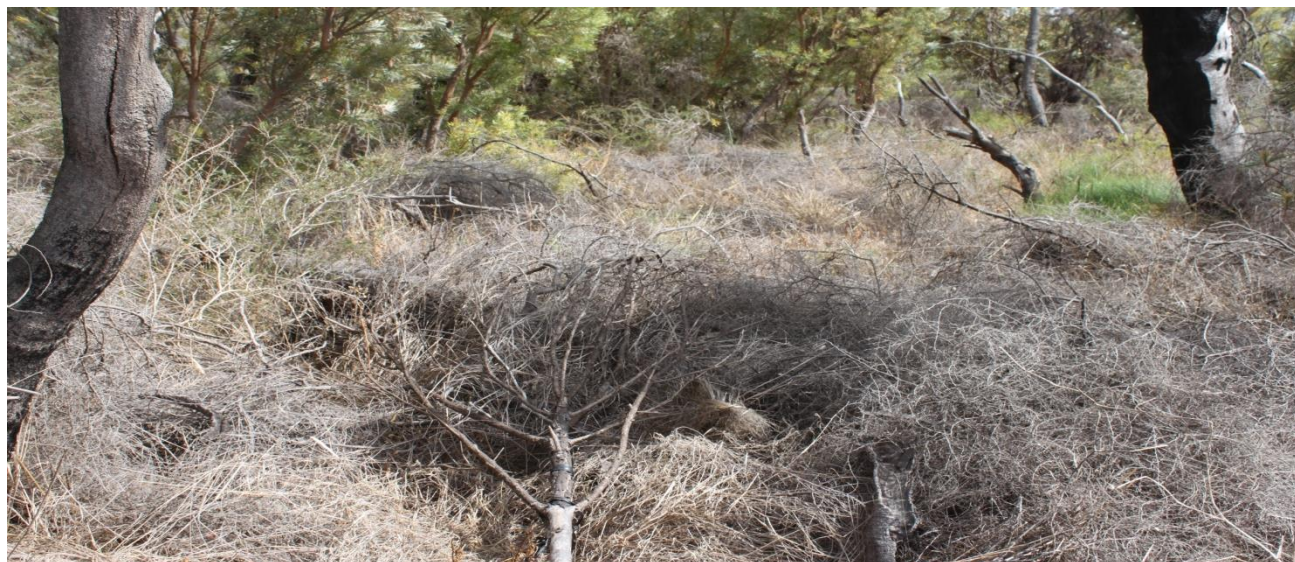
**Figure 25:** Near surface fuel load in the vicinity of Harpenden Street fence, Lots 9000, 9002

Fire fuel load reduction can include controlled burns (Section 6.9.4), ongoing weed control in areas of infestation by chemical, mechanical or manual means, slashing of weeds in open pasture areas and the manual removal of dead and fallen trees, shrubs, branches and leaf litter in high fuel load areas (Figure 25). Review of fire fuel load should occur annually where fire fuel load has previously been recorded above 8 – 15 t/ha, with areas having lower loads reviewed every 2 – 3 years.

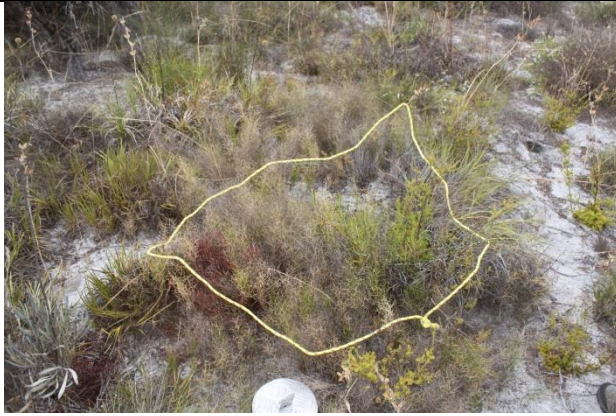
Quadrat 1 = 10.5 t/ha

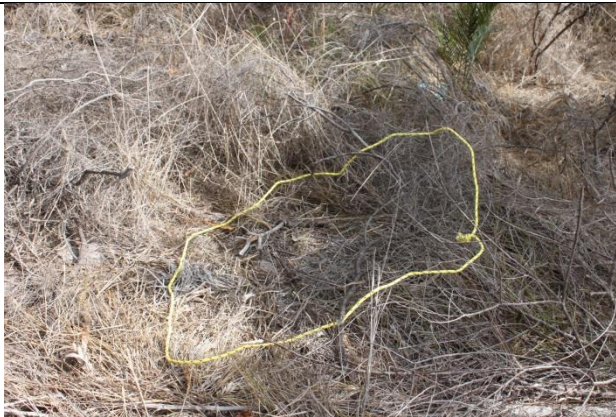
Quadrat 10 = 21.5 t/ha

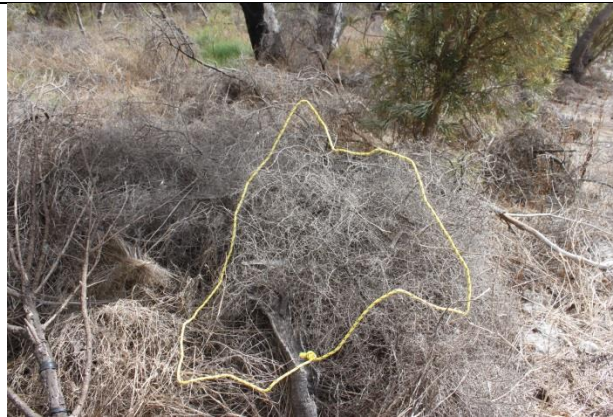
Quadrat 11 = 21.5 t/ha
